DESKTOP STUDY OF EXISTING BUILDINGS

OUDE MOLEN PRECINCT, CAPE TOWN

08 December 2020

Draft Report - Revision 03

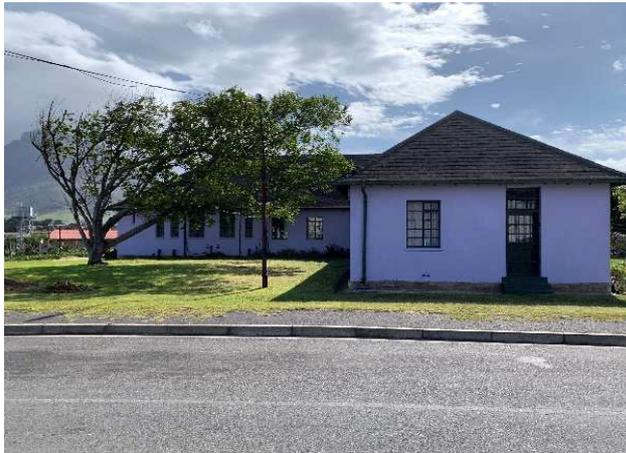
Figure 4: Block A - View of Exterior from Street (SVA, 2020)

RETAIN / DEMOLISH STRUCTURE	Retain
OCCUPIED / VACANT	Occupied
DESCRIPTION OF PLACE / CONTEXT	
Single story plastered brick modest structure with slate roof and steel-frame windows. Structure is somewhat isolated from the rest of the precinct being located on the northern boundary.	
GENERAL NOTES:	
Slate roof is a modern addition - original clay tile roof has been replaced at some point.	
RECOMMENDATIONS:	
General maintenance on roofs/gutters.	
The building is well suited for shared accommodation, a school or offices.

The block is in good condition and should be retained. It is well suited for shared accommodation such as a backpackers/guest house, or to house students. It could also be used as office space for businesses or small workshop spaces. It could also possibly be adapted and used by a school as well.

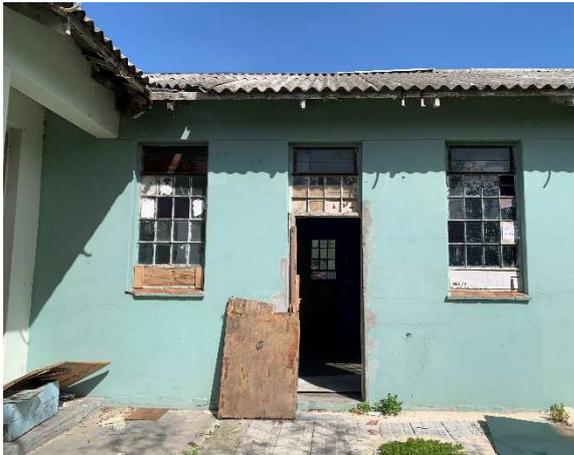
Figure 24: Block B - Unit B1. Exterior View. (SVA, 2020).

OCCUPIED / VACANT	Vacant
DESCRIPTION OF PLACE / CONTEXT	
Building was once a single-storey brick structure.	
GENERAL NOTES:	
Building is generally in a state of ruin.	
RECOMMENDATIONS:	
Roof could contain asbestos - investigation required if alterations are going to take place.	
The building is well suited for residential uses, schools, offices, workshops/studios, boutique retail, etc.

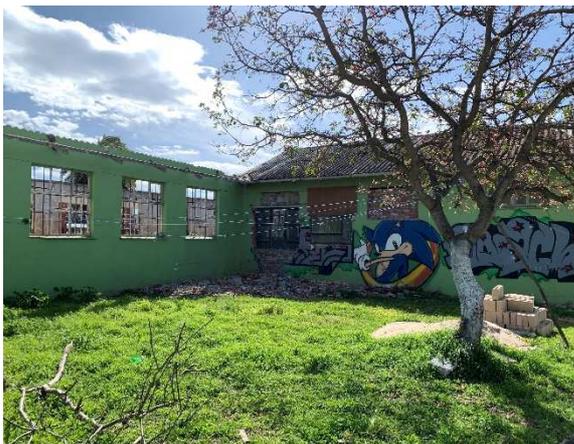
Majority of the structure has burnt down at some point in time and what remains is in poor condition. Most of the building is vacant, but there are a number of families living in the parts that have a roof.

Figure 28: Block B - Exterior Condition. (SVA, 2020).

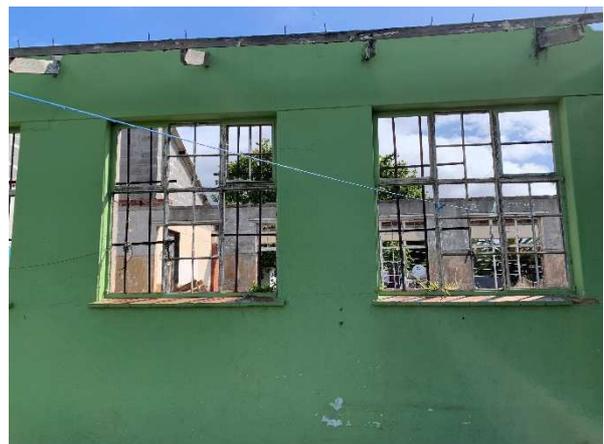
Figure 29: Block B - Exterior Condition. (SVA, 2020).

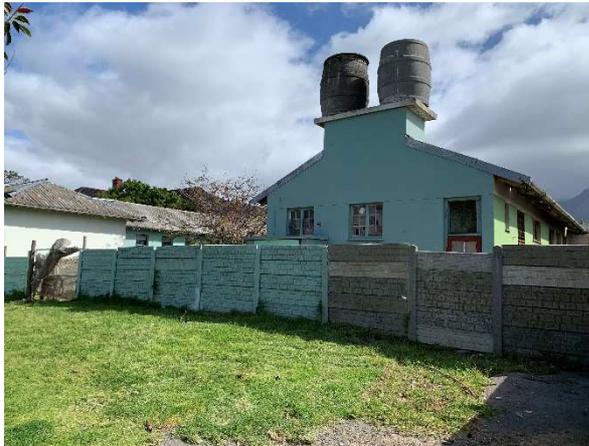
Figure 30: Block B - Unit B2. Exterior View. (SVA, 2020).

OCCUPIED / VACANT	Vacant
DESCRIPTION OF PLACE / CONTEXT	
Single story plastered brick modest structure with clay roof and steel-frame windows.	
GENERAL NOTES:	
Building is generally in fair condition overall. Lack of regular maintenance evident.	
RECOMMENDATIONS:	
Roof could contain asbestos - investigation required if alterations are going to take place.	
The building is well suited for residential uses, schools, offices, workshops/studios, boutique retail, etc.

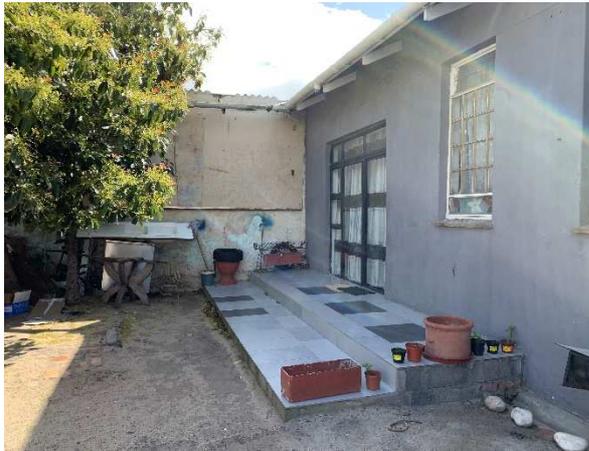
Figure 32: Block B - Unit B5. Exterior View. (SVA, 2020).

DESCRIPTION OF PLACE / CONTEXT	
Single story plastered brick modest structure with clay roof and steel-frame windows.	
GENERAL NOTES:	
Structure is in fair overall condition with lack of maintenance evident to exterior.	
RECOMMENDATIONS:	
Buildings requires roof and general exterior maintenance.	
The building is well suited for residential uses, schools, offices, workshops/studios, boutique retail, etc.

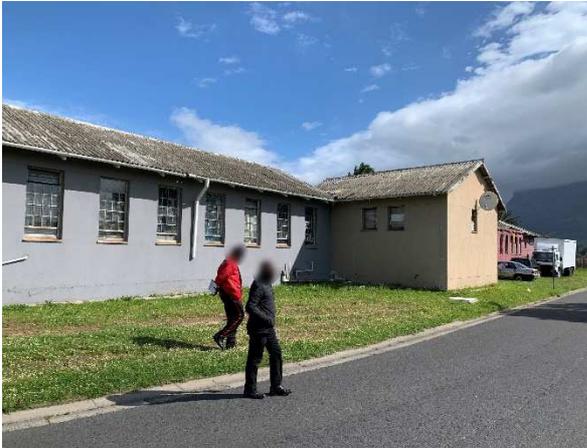
Figure 36: Block B - Unit B6. Exterior View. (SVA, 2020).

DESCRIPTION OF PLACE / CONTEXT	
Single story plastered brick modest structure with clay roof and steel-frame windows.	
GENERAL NOTES:	
Structure is in fair overall condition with little maintenance evident to exterior. Lack of regular maintenance evident.	
RECOMMENDATIONS:	
Buildings requires roof and general maintenance. Roof could contain asbestos - investigation required if alterations are going to take place.	
The building is well suited for residential uses, schools, offices, workshops/studios, boutique retail, etc.

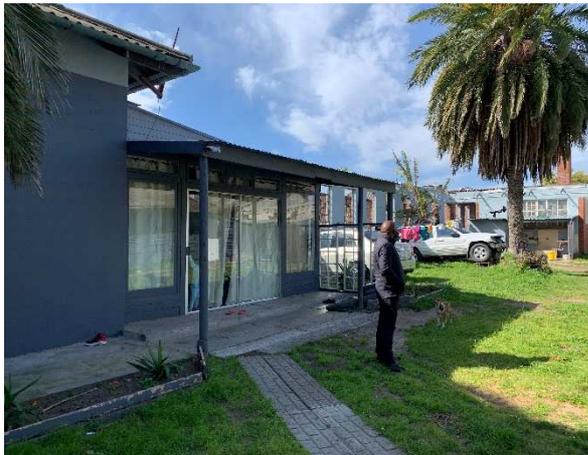
Figure 38: Block B - Unit B7. Exterior View. (SVA, 2020).

OCCUPIED / VACANT	Occupied
DESCRIPTION OF PLACE / CONTEXT	
Single story plastered brick modest structure with clay roof and steel-frame windows.	
GENERAL NOTES:	
Structure is in fair overall condition with little maintenance evident to exterior. Lack of regular maintenance evident.	
RECOMMENDATIONS:	
Urgent Action: Buildings require roof and general maintenance. Roof could contain asbestos - investigation required if alterations are going to take place.	
The building is well suited for residential uses, schools, offices, workshops/studios, boutique retail, etc.

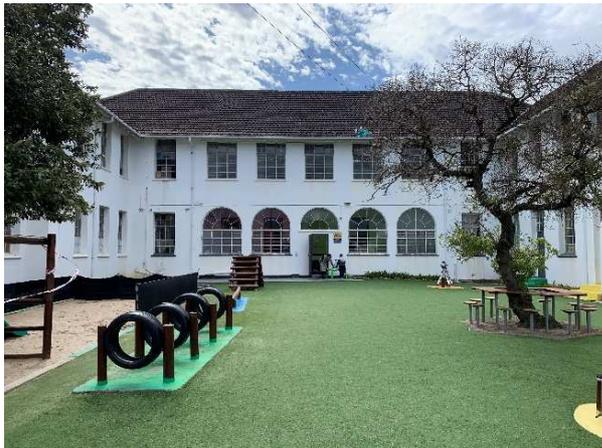
Figure 47: Block C - Unit C1 & C8. Exterior View. (SVA, 2020).

GENERAL CONDITION - INTERIOR:	
Interior	Good
General Comments:	
Interior is generally well maintained and of good integrity.	
RETAIN / DEMOLISH STRUCTURE	Retain
OCCUPIED / VACANT	Occupied
DESCRIPTION OF PLACE / CONTEXT	
2-story plastered brick structure with clay tile roof, wooden floors and timber-frame windows.	
GENERAL NOTES:	
Facility appears in good condition	
RECOMMENDATIONS:	
General roof and exterior maintenance.	
The building is well suited for residential uses, schools, offices, workshops/studios, or boutique retail,

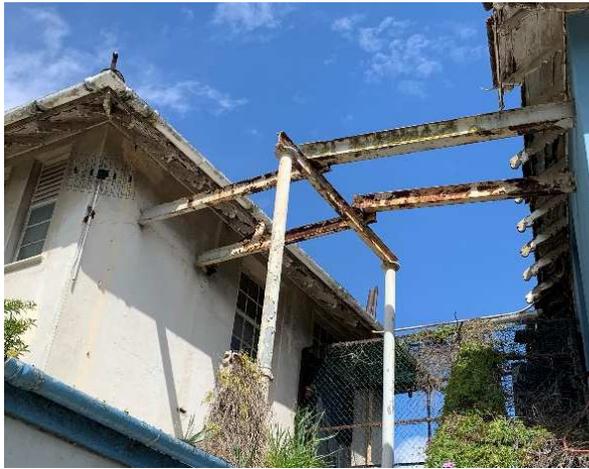
Figure 62: Block C - Unit C7. Exterior View of Roof Structure. (SVA, 2020).

Interior is in poor condition overall.	
RETAIN / DEMOLISH STRUCTURE	Retain
OCCUPIED / VACANT	Occupied
DESCRIPTION OF PLACE / CONTEXT	
2-storey plastered brick structure with clay tile roof, wooden floors and timber-frame windows.	
GENERAL NOTES:	
Lack of regular maintenance evident - structure has deteriorated considerably over the years.	
RECOMMENDATIONS:	
Structural assessment of roof required. General roof and exterior maintenance.	
The building is well suited for residential uses, schools, offices, workshops/studios, or boutique retail,

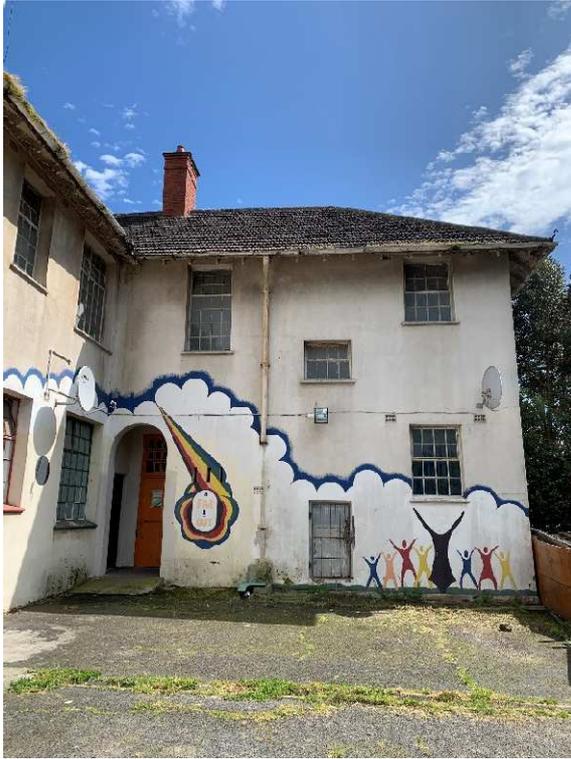
Figure 66: Block C - Unit C8/1 & C8/2. Exterior View. (SVA, 2020).

Interior	Poor
General Comments:	
Interior is in poor condition overall.	
RETAIN / DEMOLISH STRUCTURE	Retain
OCCUPIED / VACANT	Occupied
DESCRIPTION OF PLACE / CONTEXT	
2-story plastered brick structure with clay tile roof, wooden floors and timber-frame windows.	
GENERAL NOTES:	
Lack of regular maintenance evident - structure has deteriorated considerably over the years.	
RECOMMENDATIONS:	
Structural assessment of roof required. General roof and exterior maintenance.	
The building is well suited for residential uses, schools, offices, workshops/studios, or boutique retail,

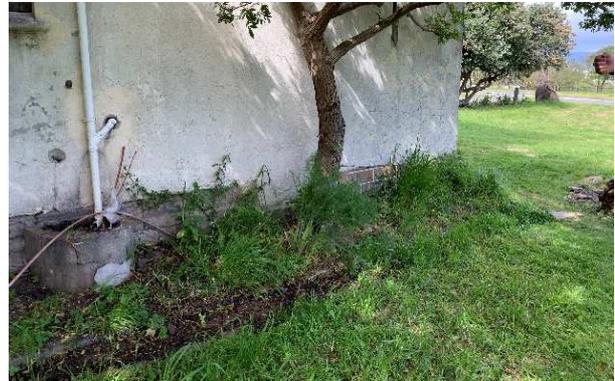
OCCUPIED / VACANT	Occupied
DESCRIPTION OF PLACE / CONTEXT	
2-story plastered brick structure with clay tile roof, wooden floors and timber-frame windows.	
CURRENT USE:	
Current use/s	Residential
GENERAL NOTES:	
Ongoing Sewer drainage issues and roof leaks. Lack of regular maintenance evident.	
RECOMMENDATIONS:	
General roof and exterior maintenance.	
The building is well suited for residential uses, schools, offices, workshops/studios, or boutique retail.

Figure 69: Block C - Unit C9. Exterior View, residents noted issues with leaking sewage (SVA, 2020).

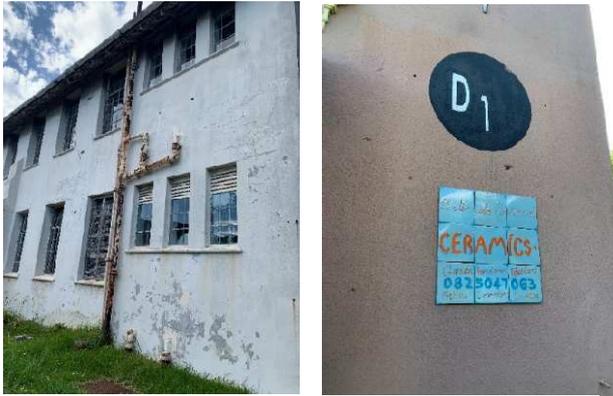
Figure 74: Block D - Unit D1. Exterior Views. (SVA, 2020).

General Comments:	
Possibly the best-preserved original interior of the entire Medical Facility	
RETAIN / DEMOLISH STRUCTURE	Retain
OCCUPIED / VACANT	Occupied
DESCRIPTION OF PLACE / CONTEXT	
2-story plastered brick structure with slate tile roof, wooden floors and timber-frame windows.	
GENERAL NOTES:	
Lack of regular maintenance evident.	
RECOMMENDATIONS:	
General roof and exterior maintenance.	
The building is well suited for residential uses, schools, offices, workshops/studios, boutique retail.

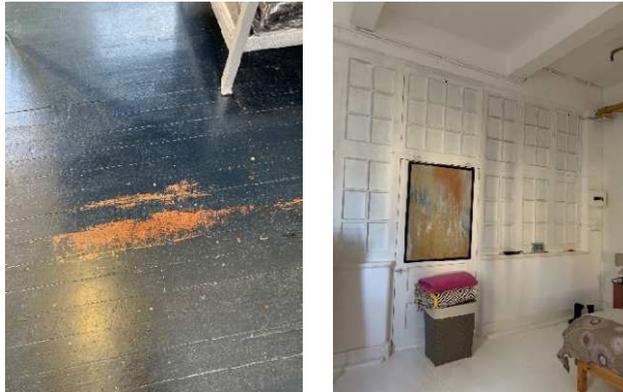
Figure 84: Views of Interior Floor Condition and Painted Windows

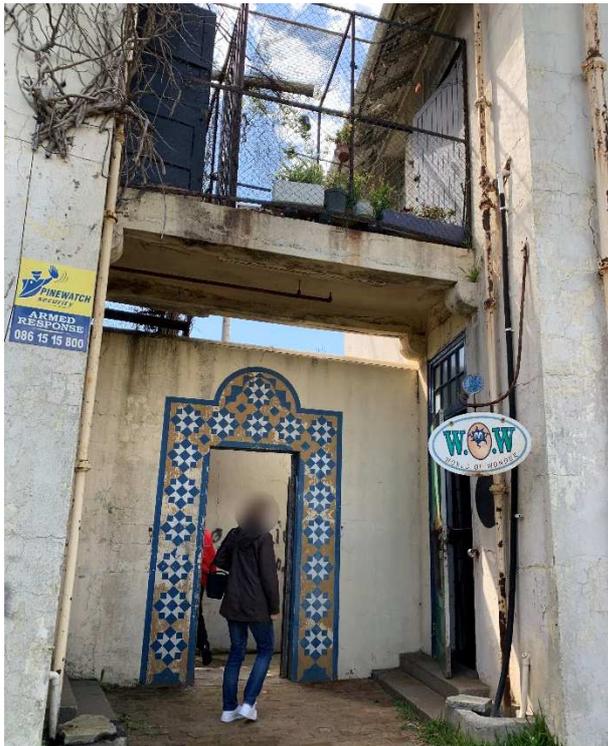
Figure 86: Block D - Unit D3. Exterior View (SVA, 2020).

Interior	n/a
General Comments:	
Not able to access interior at the time of assessment.	
RETAIN / DEMOLISH STRUCTURE	Retain
OCCUPIED / VACANT	Occupied
DESCRIPTION OF PLACE / CONTEXT	
2-story plastered brick structure with clay tile roof, wooden floors and timber-frame windows.	
GENERAL NOTES:	
Lack of regular maintenance evident.	
RECOMMENDATIONS:	
General roof and exterior maintenance. Structural assessment required on some of the external bridge links.	
The building is well suited for residential uses, schools, offices, workshops/studios, boutique retail.

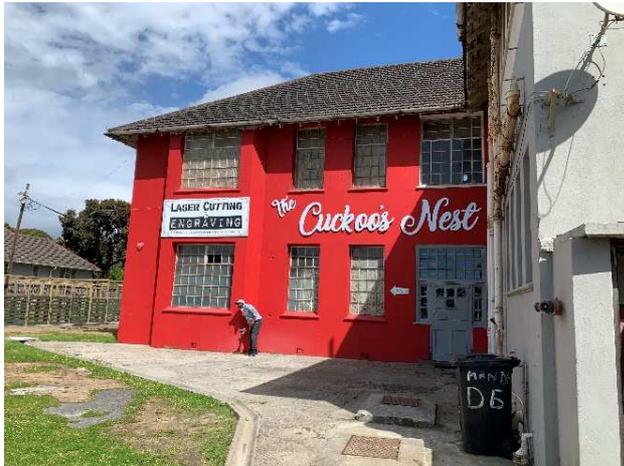
Figure 90: Block D - Unit D 4, 5, 7. Exterior View. (SVA, 2020).

GENERAL CONDITION - INTERIOR:	
Interior	Fair
General Comments:	
Building interior is in fair condition overall.	
RETAIN / DEMOLISH STRUCTURE	Retain
OCCUPIED / VACANT	Occupied
DESCRIPTION OF PLACE / CONTEXT	
2-story plastered brick structure with clay tile roof, wooden floors and timber-frame windows.	
GENERAL NOTES:	
Lack of regular maintenance evident.	
RECOMMENDATIONS:	
General roof and exterior maintenance.	
The building is well suited for residential uses, schools, offices, workshops/studios, boutique retail.

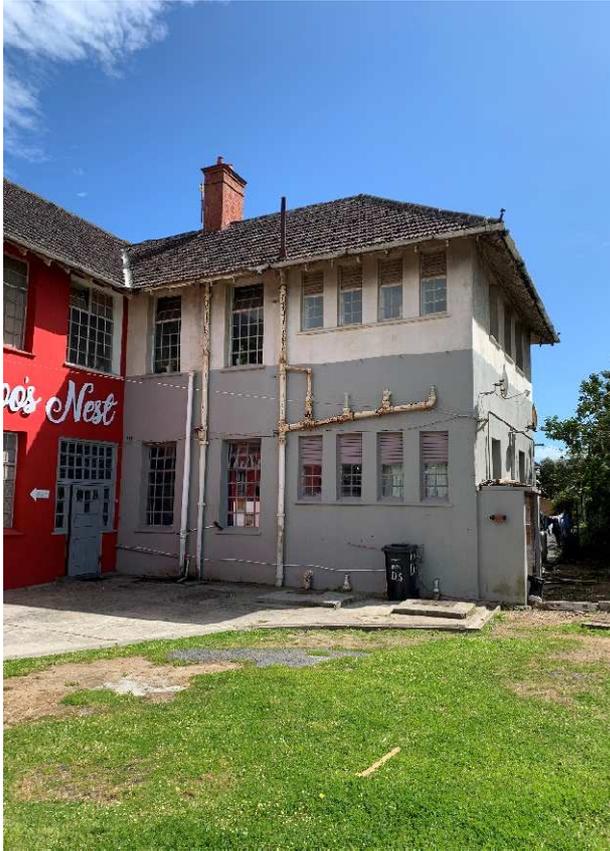
Figure 98: Block D - Unit D6. Exterior View. (SVA, 2020).

RETAIN / DEMOLISH STRUCTURE	Retain
OCCUPIED / VACANT	Occupied
DESCRIPTION OF PLACE / CONTEXT	
2-story plastered brick structure with clay tile roof, wooden floors and timber-frame windows.	
GENERAL NOTES:	
Lack of regular maintenance evident.	
RECOMMENDATIONS:	
General roof and exterior maintenance.	
The building is well suited for residential uses, schools, offices, workshops/studios, boutique retail.

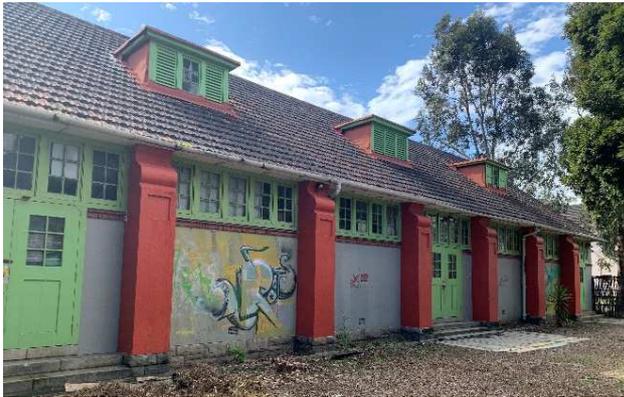
Figure 114: Block E. Exterior View (SVA, 2020).

NAME AND LOCATION:	
Stand number/s	26439
Township	Pinelands, Cape Town
Street address	Oude Molen Eco-Village - Unit E
GIS reference	33°56'19.53"S / 18°29'21.35"E
Name of place	"Yes We Can" Sport and Jazz Foundation
Previous/alternative name/s	n/a
Unit Number	Block E and adjacent vacant land
ARCHITECT	DATE OF COMPLETION
Unknown	1920s
BUILDING STYLE	BUILDING TYPE
Decorative	Mess Hall
TITLE DEED INFORMATION	
n/a	
NOTABLE SITE FEATURES	
Well-developed courtyard gardens albeit with lack of regular maintenance. Views toward river on the west.	
ENVIRONMENT	
Surrounding buildings are of larger scale - 2 storeys in height.	
PREVIOUS USE	CURRENT USE
Mess Hall	Multi-purpose Hall
GENERAL CONDITION - EXTERIOR:	
Roofs	Good/ Fair
Walls	Good/ Fair
Doors / Windows	Fair
General Comments:	
Building exterior is in fair condition overall	
GENERAL CONDITION - INTERIOR:	
Interior	Good/ Fair
General Comments:	
Interior if generally well maintained and mostly original

RETAIN / DEMOLISH STRUCTURE	Retain
OCCUPIED / VACANT	Occupied
DESCRIPTION OF PLACE / CONTEXT	
Single Storey structure with high ceilings comprising a large hall and supporting spaces.	
GENERAL NOTES:	
Building is unique within its context and generally well preserved in terms of its original features.	
RECOMMENDATIONS:	
General roof and exterior maintenance.	
Unit E is a large hall with supporting spaces. Its use should ideally be maintained as such and used for gatherings and indoor activities.

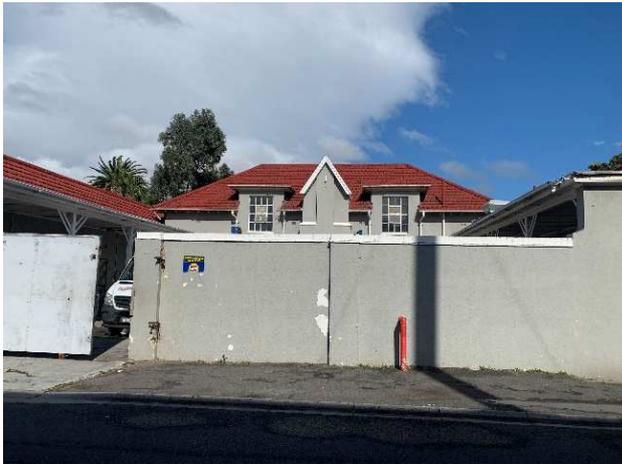
Figure 120: Unit E-1. View from the street. (SVA, 2020).

OCCUPIED / VACANT	Occupied
DESCRIPTION OF PLACE / CONTEXT	
Single Storey structure with high ceilings comprising a large hall and supporting spaces.	
GENERAL NOTES:	
Building is unique within its context and generally well preserved in terms of its original features	
RECOMMENDATIONS:	
General roof and exterior maintenance.	
Unit E-1 is a large spacious double volume room with supporting spaces. It is well suited for a large kitchen, workshop space or commercial functions.

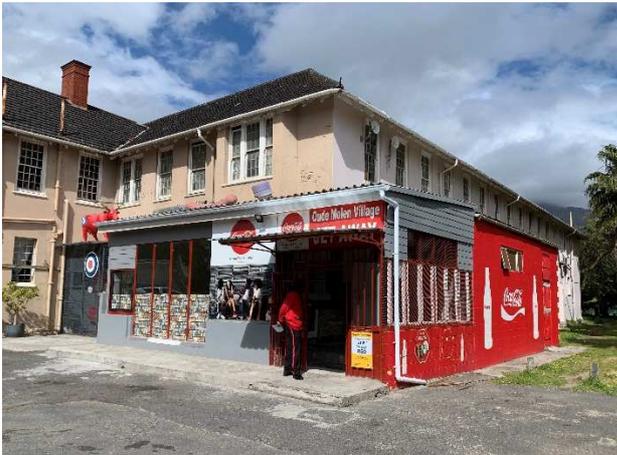
Figure 128: Block F - Unit F1. Exterior View, (SVA, 2020).

This Café is a later addition and is not part of the original ward building.	
GENERAL NOTES:	
Lack of regular maintenance evident.	
RECOMMENDATIONS:	
General roof and exterior maintenance.	
The building is well suited for residential uses, schools, offices, workshops/studios, or boutique retail.

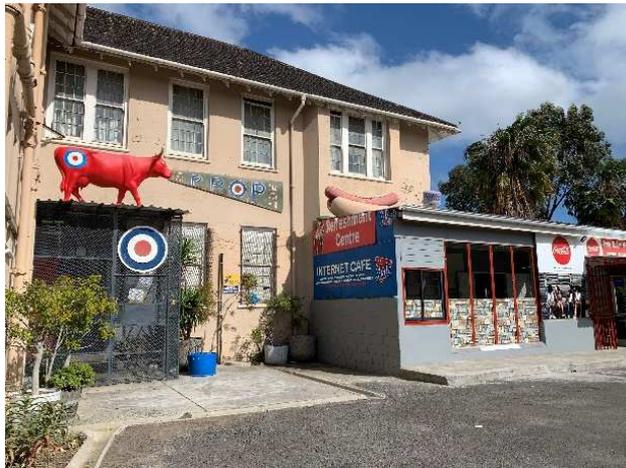
Figure 131: Block F - Unit F2, 3 & 8. Exterior View. (SVA, 2020).

General Comments:	
Building interior is fairly good condition overall.	
RETAIN / DEMOLISH STRUCTURE	Retain
OCCUPIED / VACANT	Occupied
DESCRIPTION OF PLACE / CONTEXT	
2-story plastered brick structure with clay tile roof, wooden floors and timber-frame windows.	
GENERAL NOTES:	
Lack of regular exterior maintenance evident.	
RECOMMENDATIONS:	
General roof and exterior maintenance.	
The building is well suited for residential uses, schools, offices, workshops/studios, or boutique retail.

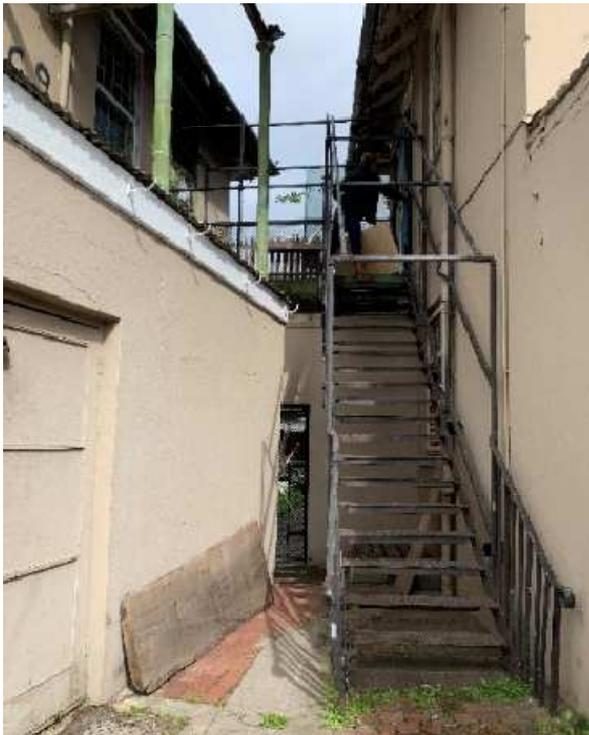
Figure 150: Block F - Unit F10. Exterior View (SVA, 2020).

General Comments:	
Building interior is fairly good condition overall.	
RETAIN / DEMOLISH STRUCTURE	Retain
OCCUPIED / VACANT	Occupied
DESCRIPTION OF PLACE / CONTEXT	
2-story plastered brick structure with clay tile roof, wooden floors and timber-frame windows.	
GENERAL NOTES:	
Lack of regular maintenance evident.	
RECOMMENDATIONS:	
General roof and exterior maintenance.	
The building is well suited for residential uses, schools, offices, workshops/studios, or boutique retail.

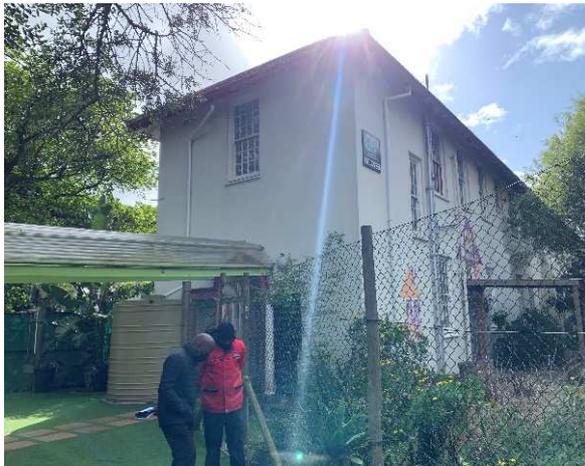
Figure 155: Block G -Unit G1. Exterior View. (SVA, 2020).

RETAIN / DEMOLISH STRUCTURE	Retain
OCCUPIED / VACANT	Occupied
DESCRIPTION OF PLACE / CONTEXT	
2-story plastered brick structure with clay tile roof, wooden floors and timber-frame windows.	
GENERAL NOTES:	
Lack of regular exterior maintenance evident.	
RECOMMENDATIONS:	
General roof and exterior maintenance.	
The building is well suited for residential uses, schools, offices, workshops/studios, or boutique retail.

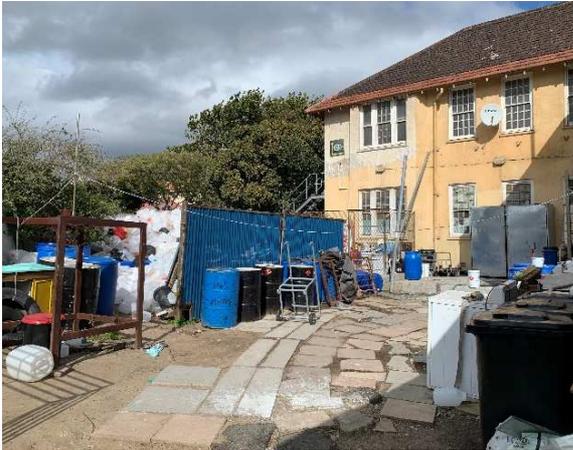
Figure 161: Block G - Unit G2. Exterior View. (SVA, 2020).

RETAIN / DEMOLISH STRUCTURE	Retain
OCCUPIED / VACANT	Occupied
DESCRIPTION OF PLACE / CONTEXT	
2-stoery plastered brick structure with clay tile roof, wooden floors and timber-frame windows.	
GENERAL NOTES:	
Lack of regular exterior maintenance evident.	
RECOMMENDATIONS:	
General roof and exterior maintenance.	
The building is well suited for residential uses, schools, offices, workshops/studios, or boutique retail.

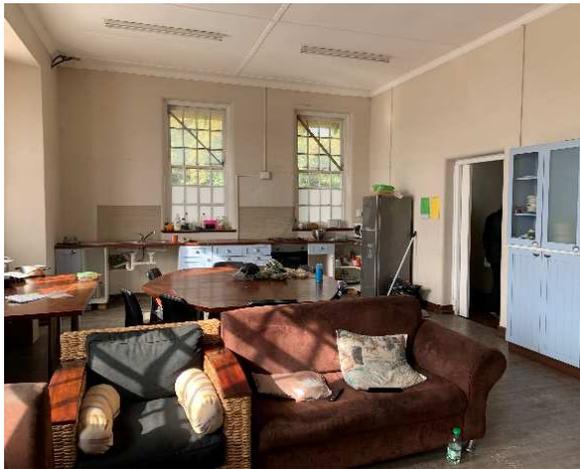
Figure 188: Block G - Unit G11. Interior Views. (SVA, 2020).

RETAIN / DEMOLISH STRUCTURE	Retain
OCCUPIED / VACANT	Occupied
DESCRIPTION OF PLACE / CONTEXT	
2-storey plastered brick structure with clay tile roof, wooden floors and timber-frame windows.	
GENERAL NOTES:	
Lack of regular exterior maintenance evident.	
RECOMMENDATIONS:	
General roof and exterior maintenance.	
The building is well suited for residential uses, schools, offices, workshops/studios, or boutique retail.

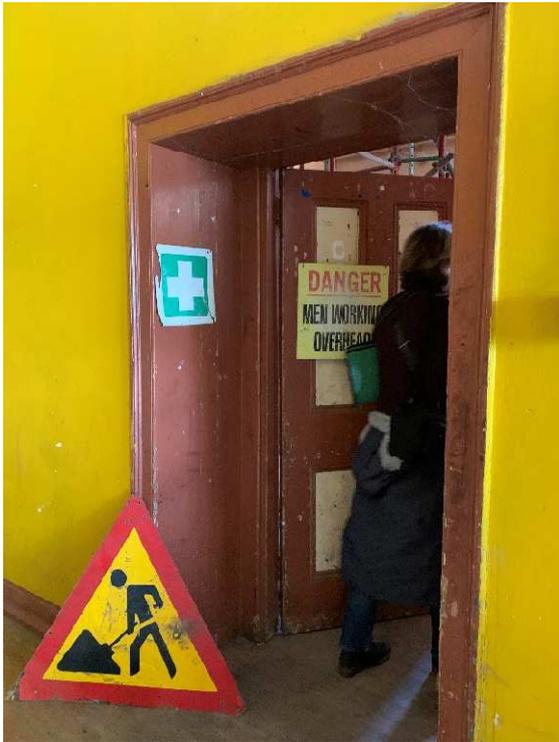
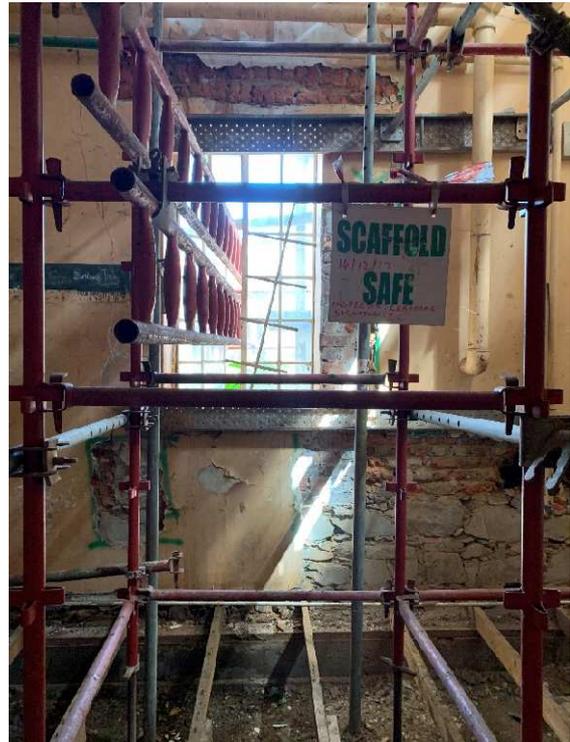
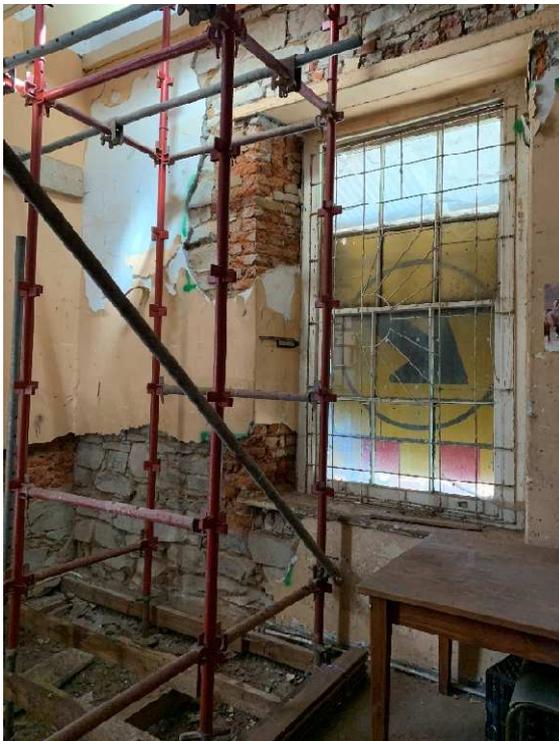
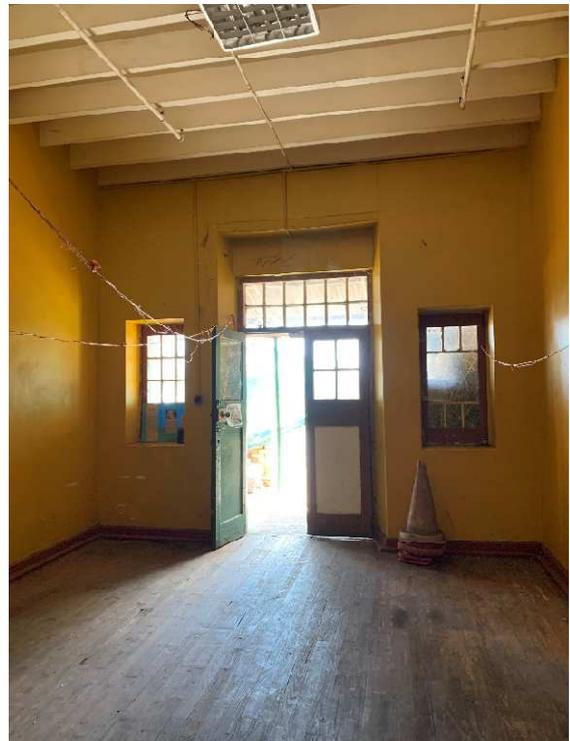
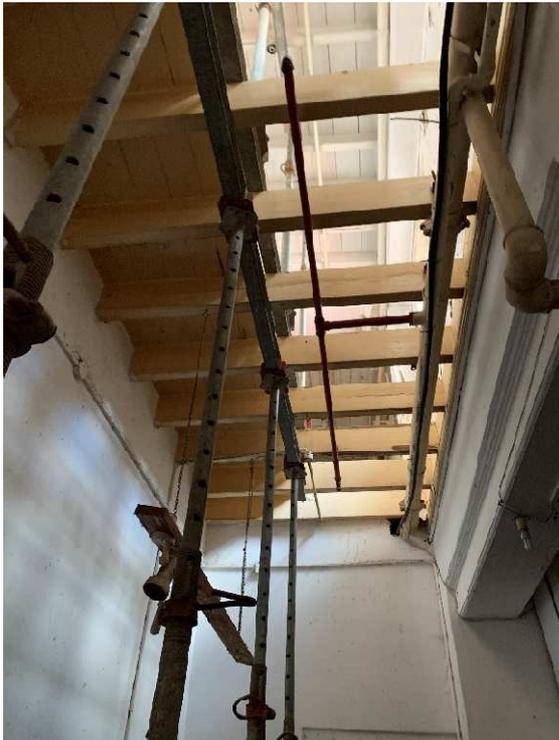
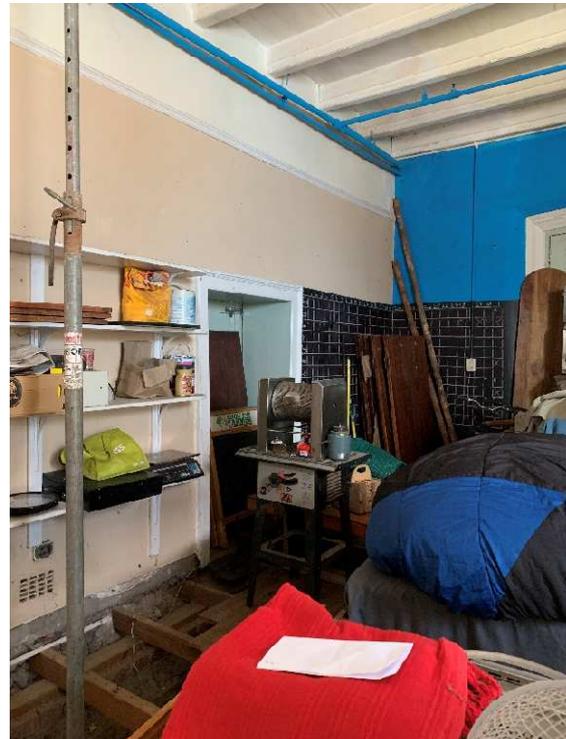
Despite its heritage and historical significance the structure has suffered partial collapse in recent years due to ongoing lack of maintenance and is in urgent need of repair in order to preserve its integrity.

Exterior is in poor condition overall and in a state of collapse.	
RETAIN / DEMOLISH STRUCTURE	Retain
OCCUPIED / VACANT	Vacant
DESCRIPTION OF PLACE / CONTEXT	
2-story plastered brick structure with clay tile roof, wooden floors and timber-frame windows.	
GENERAL NOTES:	
Structure is of very high heritage and historical significance.	
RECOMMENDATIONS:	
Urgent Action: Structure requires urgent roof repairs as well structural integrity stabilisation of existing walls in order to limit further damage.	
The building is well suited for a museum / tourist visitors centre.

Figure 200: Block H - Unit H1. Interior Condition. (SVA, 2020).

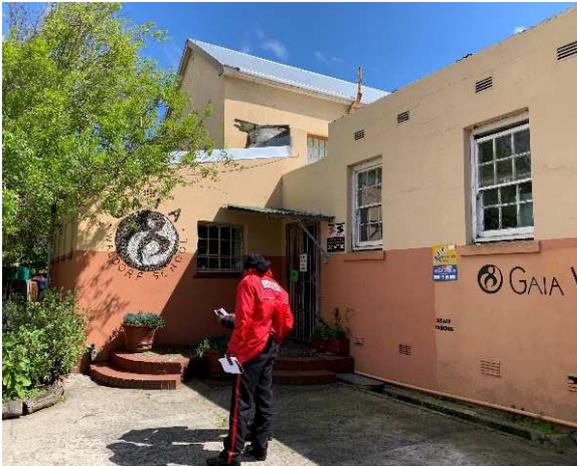
Figure 212: Block H - Gaia Waldorf School. Exterior View. (SVA, 2020).

GENERAL NOTES:	
Lack of regular exterior maintenance evident.	
RECOMMENDATIONS:	
General roof and exterior maintenance.	
This building could be used as a coffee shop/small restaurant, education, artist's studios, or boutique retail.

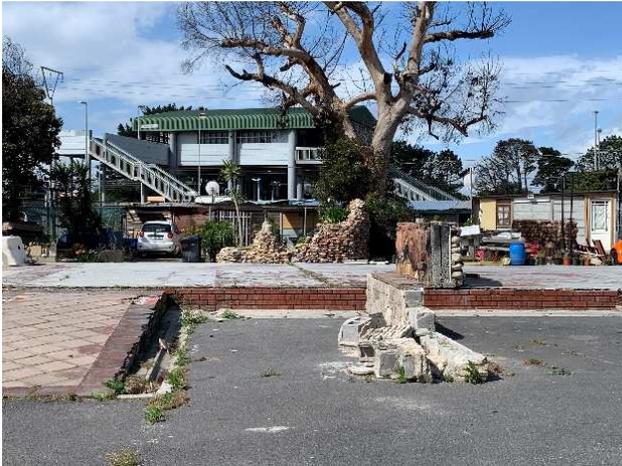
Figure 223: Block I - View of Site. (SVA, 2020).

Block I is a much later addition to the complex of buildings. It comprises series of prefabricated shed-like structures, similar to the buildings at Block T and Block U. The structure burned down in 2019 and all that remains at present is a concrete base. There is a small café / tuckshop on the site.

NAME AND LOCATION:	
Stand number/s	26439
Township	Pinelands, Cape Town
Street address	Oude Molen Eco-Village - Unit I01/02
GIS reference	33°56'23.70"S / 18°29'24.00"E
Name of place	Eden Resort
Previous/alternative name/s	n/a
Unit Number	I01/I02
ARCHITECT	DATE OF COMPLETION
n/a	n/a
BUILDING STYLE	BUILDING TYPE
n/a	n/a
TITLE DEED INFORMATION	
n/a	
NOTABLE-SITE FEATURES	
Site is vacant	
ENVIRONMENT	
Ruin / Burnt down	
PREVIOUS USE	CURRENT USE
Eden Resort - Waffle Shop	Vacant / Ruin
GENERAL CONDITION - EXTERIOR:	
Roofs	n/a
Walls	n/a
Doors / Windows	n/a
General Comments:	
n/a	
GENERAL CONDITION - INTERIOR:	
Interior	n/a
General Comments:	
n/a	
RETAIN / DEMOLISH STRUCTURE	Demolish
OCCUPIED / VACANT	Vacant
DESCRIPTION OF PLACE / CONTEXT	
Structure burned down back in early 2019 and is currently a ruin.	
GENERAL NOTES:	
Site is essentially vacant - offers development potential	
RECOMMENDATIONS:	
This structure has already been demolished as a result of fire damage. The remaining small shed type structures could be demolished and the site used for new development.

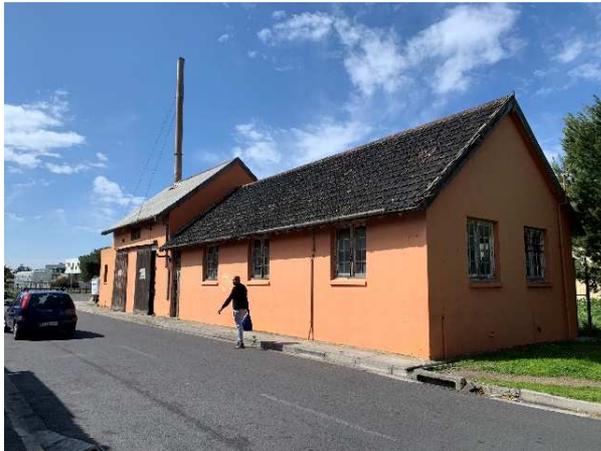
Figure 226: Block L - Exterior View. (SVA, 2020).

OCCUPIED / VACANT	Partly occupied
DESCRIPTION OF PLACE / CONTEXT	
Surrounding buildings are of predominantly larger scale - 2 storeys in height.	
GENERAL NOTES:	
Interior boasts original boiler equipment which appears well preserved overall. Part of the building is currently being used as security offices.	
RECOMMENDATIONS:	
Urgent Action: Building requires urgent maintenance and preservation of original boiler equipment which is of historical and heritage value.	
This small building is well suited for a coffee shop/roastery, artist's studio, or boutique retail.
