ARCHAEOLOGICAL IMPACT ASSESSMENT OUDE MOLEN VILLAGE, ERF 26439-RE, CAPE TOWN

HWC REF: 21022615SB0330E

submitted in terms of Section 38(4) of the NHRA (1999) for
OUDE MOLEN PRECINCT, ERF 26439-RE,
ALEXANDER ROAD, PINELANDS, CAPE TOWN

FINAL AIA

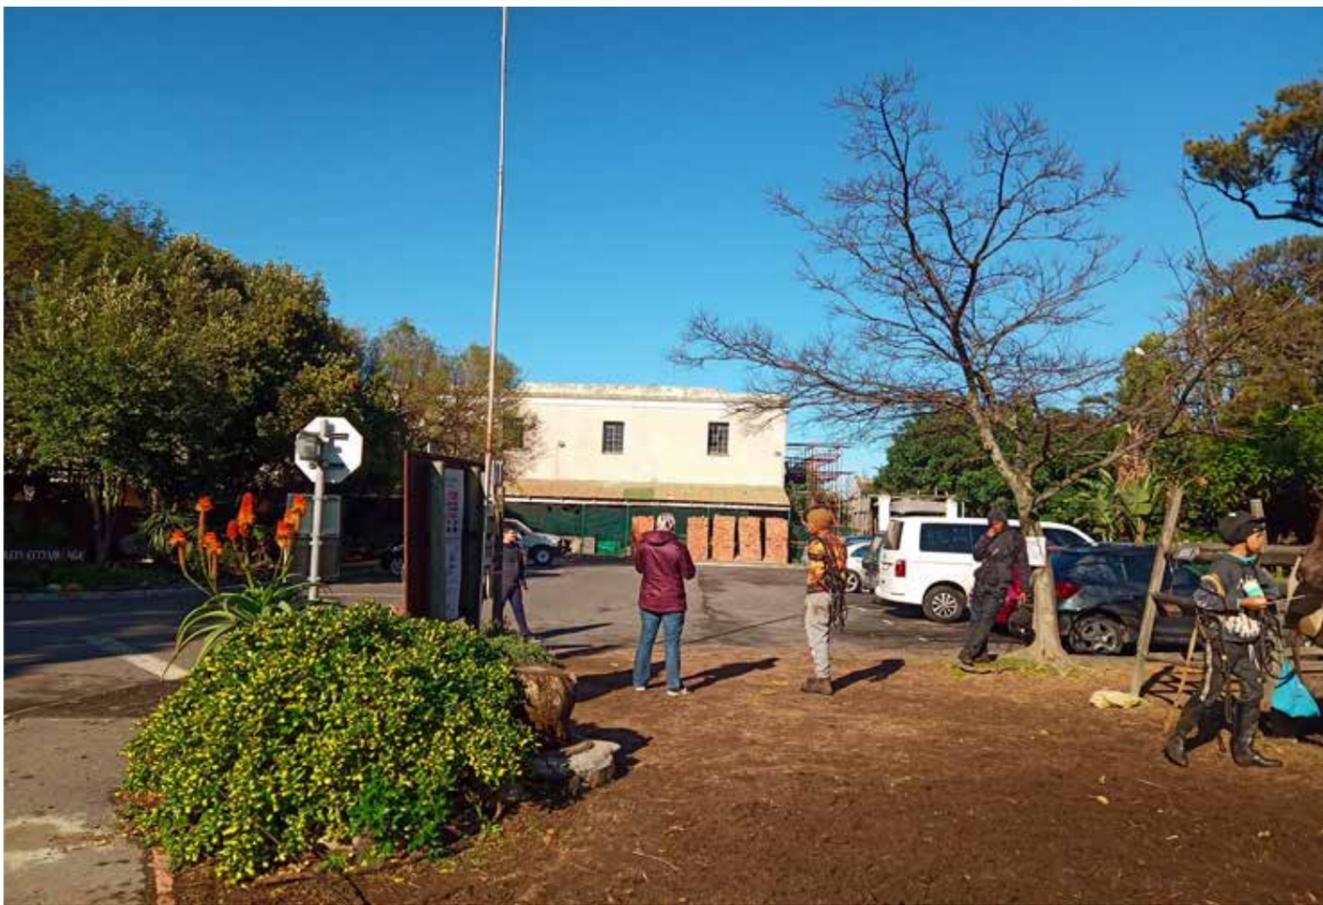
Figure 5. View towards homestead, mill house portion visible, view to south (Gibbs, 2023)

The homestead is the main historic structure on site, with other C20th buildings related to the C20th mental institution on site (Figure 5 to Figure 8). A variety of micro-enterprises occupy the site, including include a public swimming pool, horse riding school, kindergartens and schools, coffee shops, care homes and similar (Figure 9 to Figure 13). A portion of the site, south east of the homestead, is occupied by a Goringhaicona kraal with indigenous and vegetable gardens and ritual spaces.

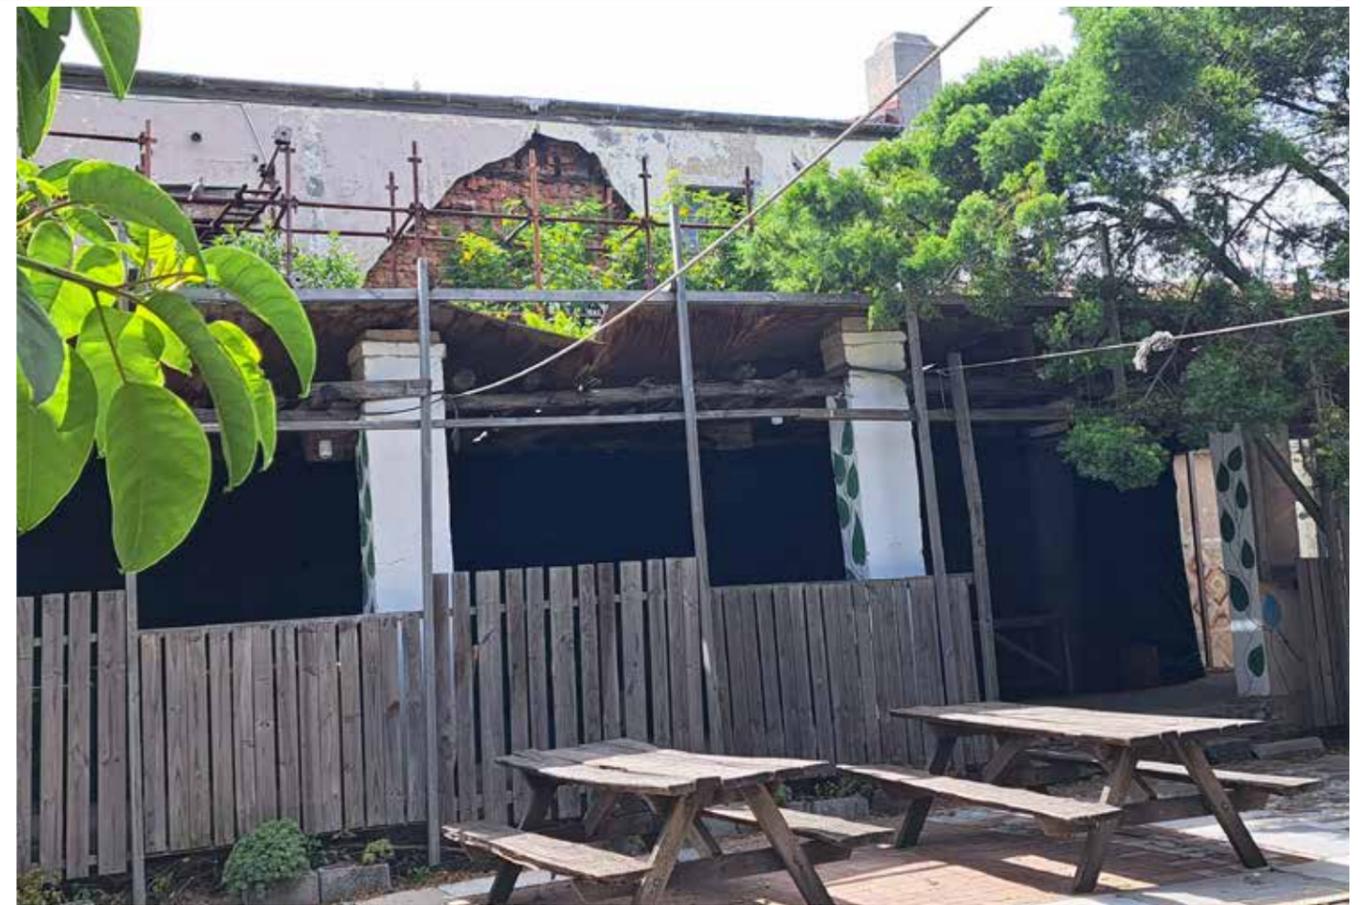
Figure 7. View of west facing facade of mill house (Postlethwayt, 2023)

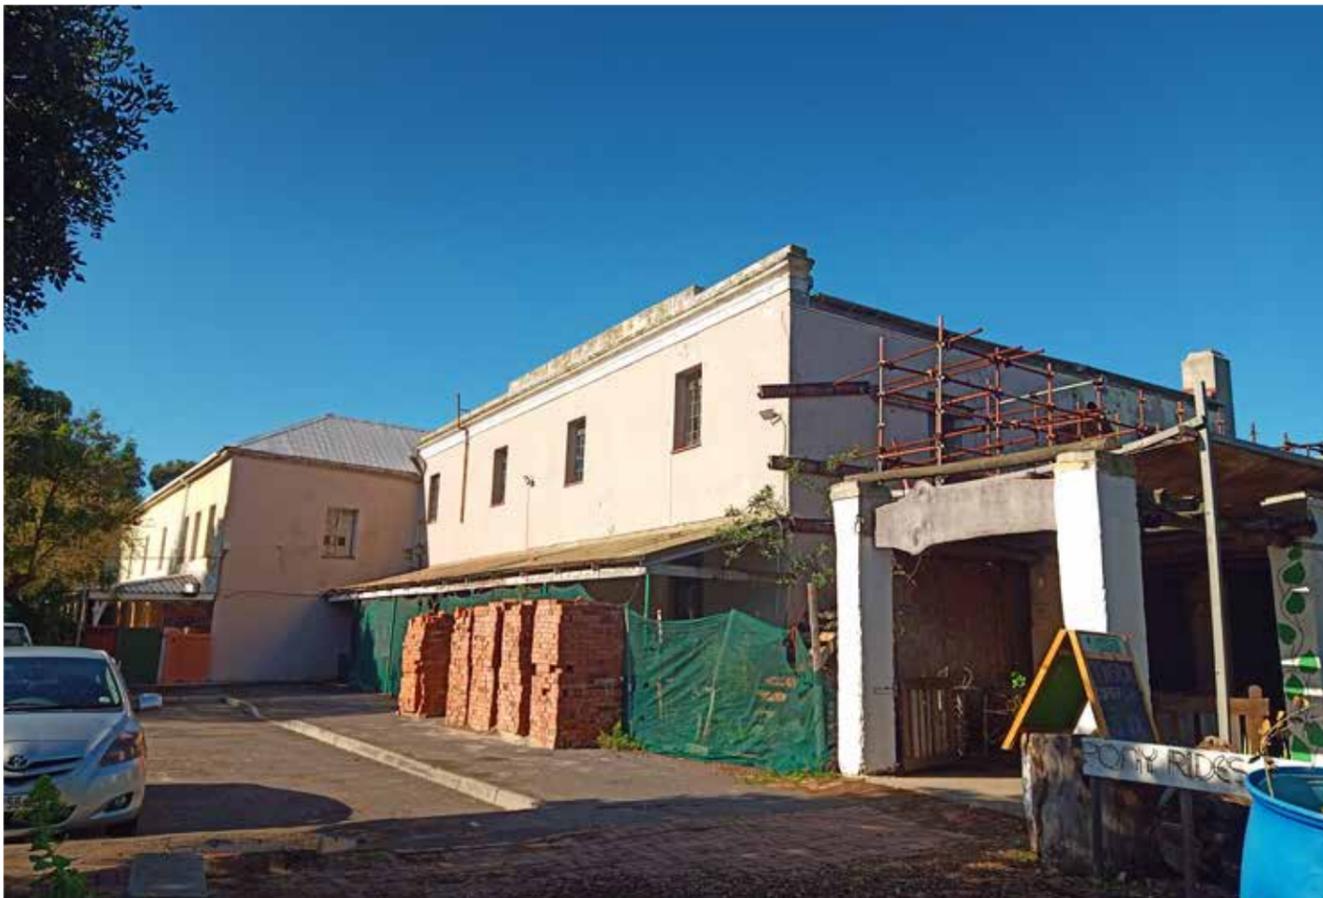
Figure 6. View of mill house and extended homestead, view to south east (Gibbs, 2023)

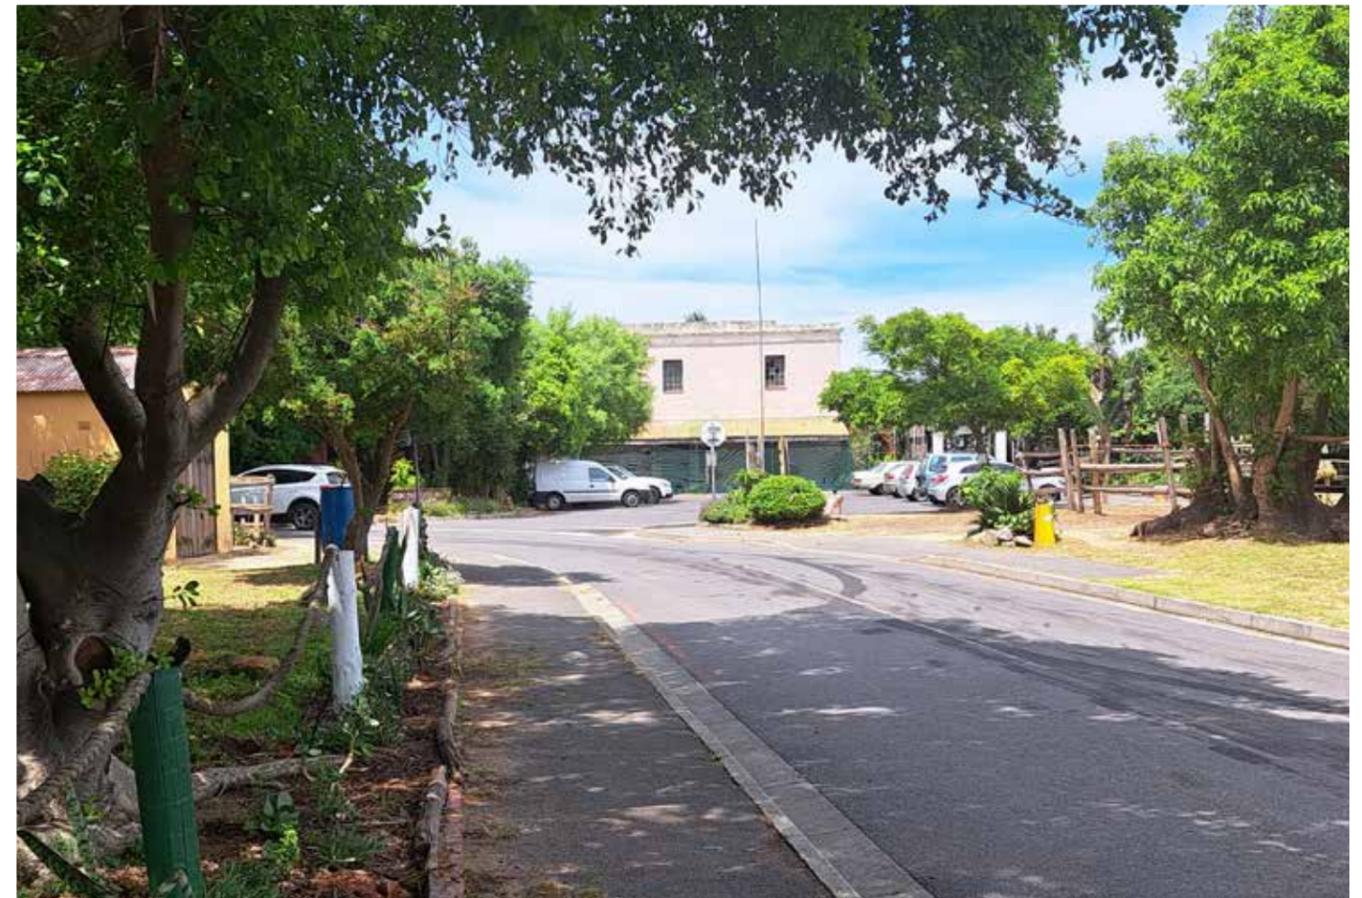
Figure 8. View towards homestead from approach avenue, view to south (Postlethwayt, 2023)

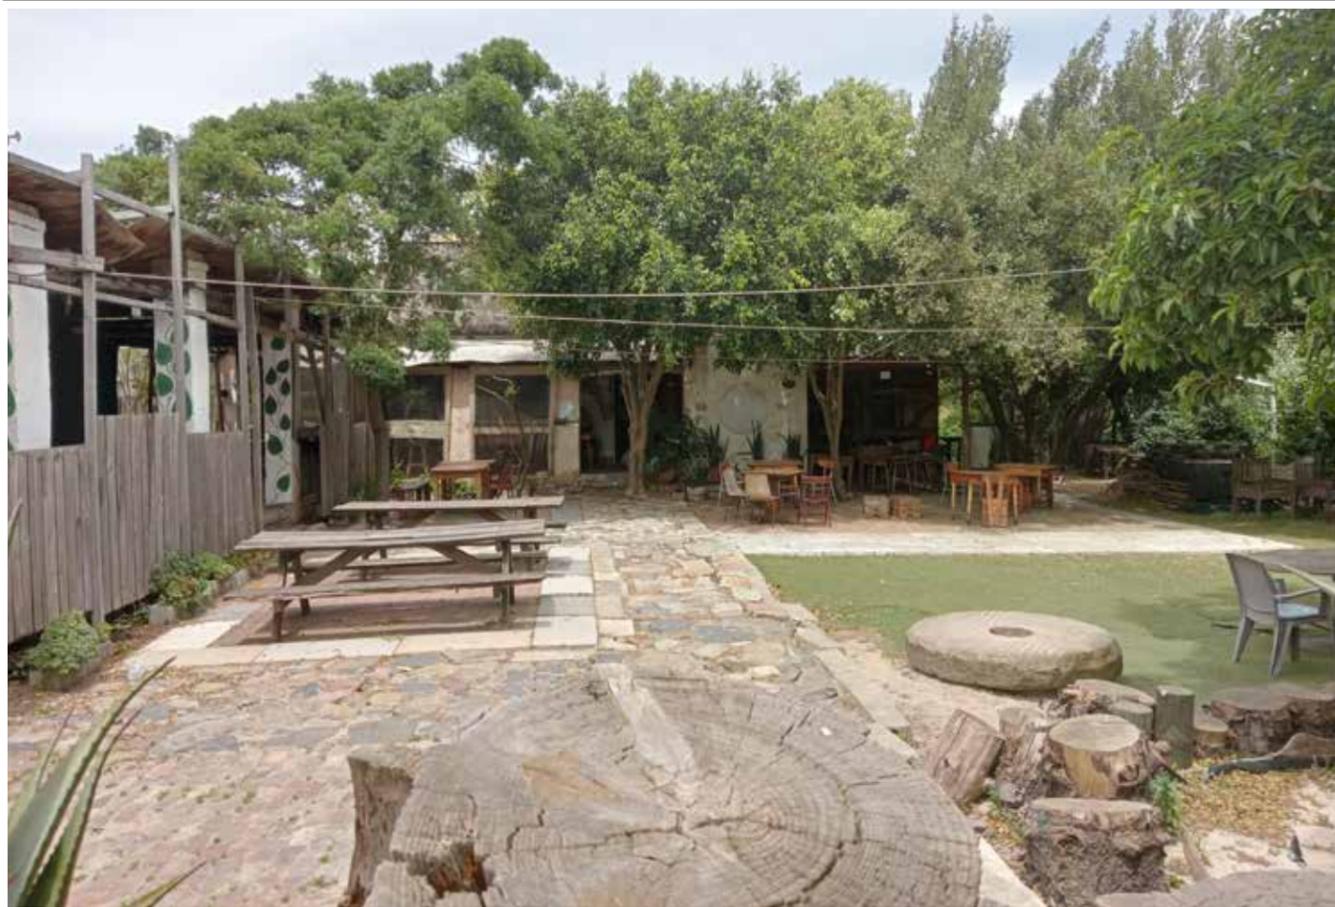
Figure 9. Outside seating immediately west of homestead, view to south; note mill stone (Gibbs, 2023)

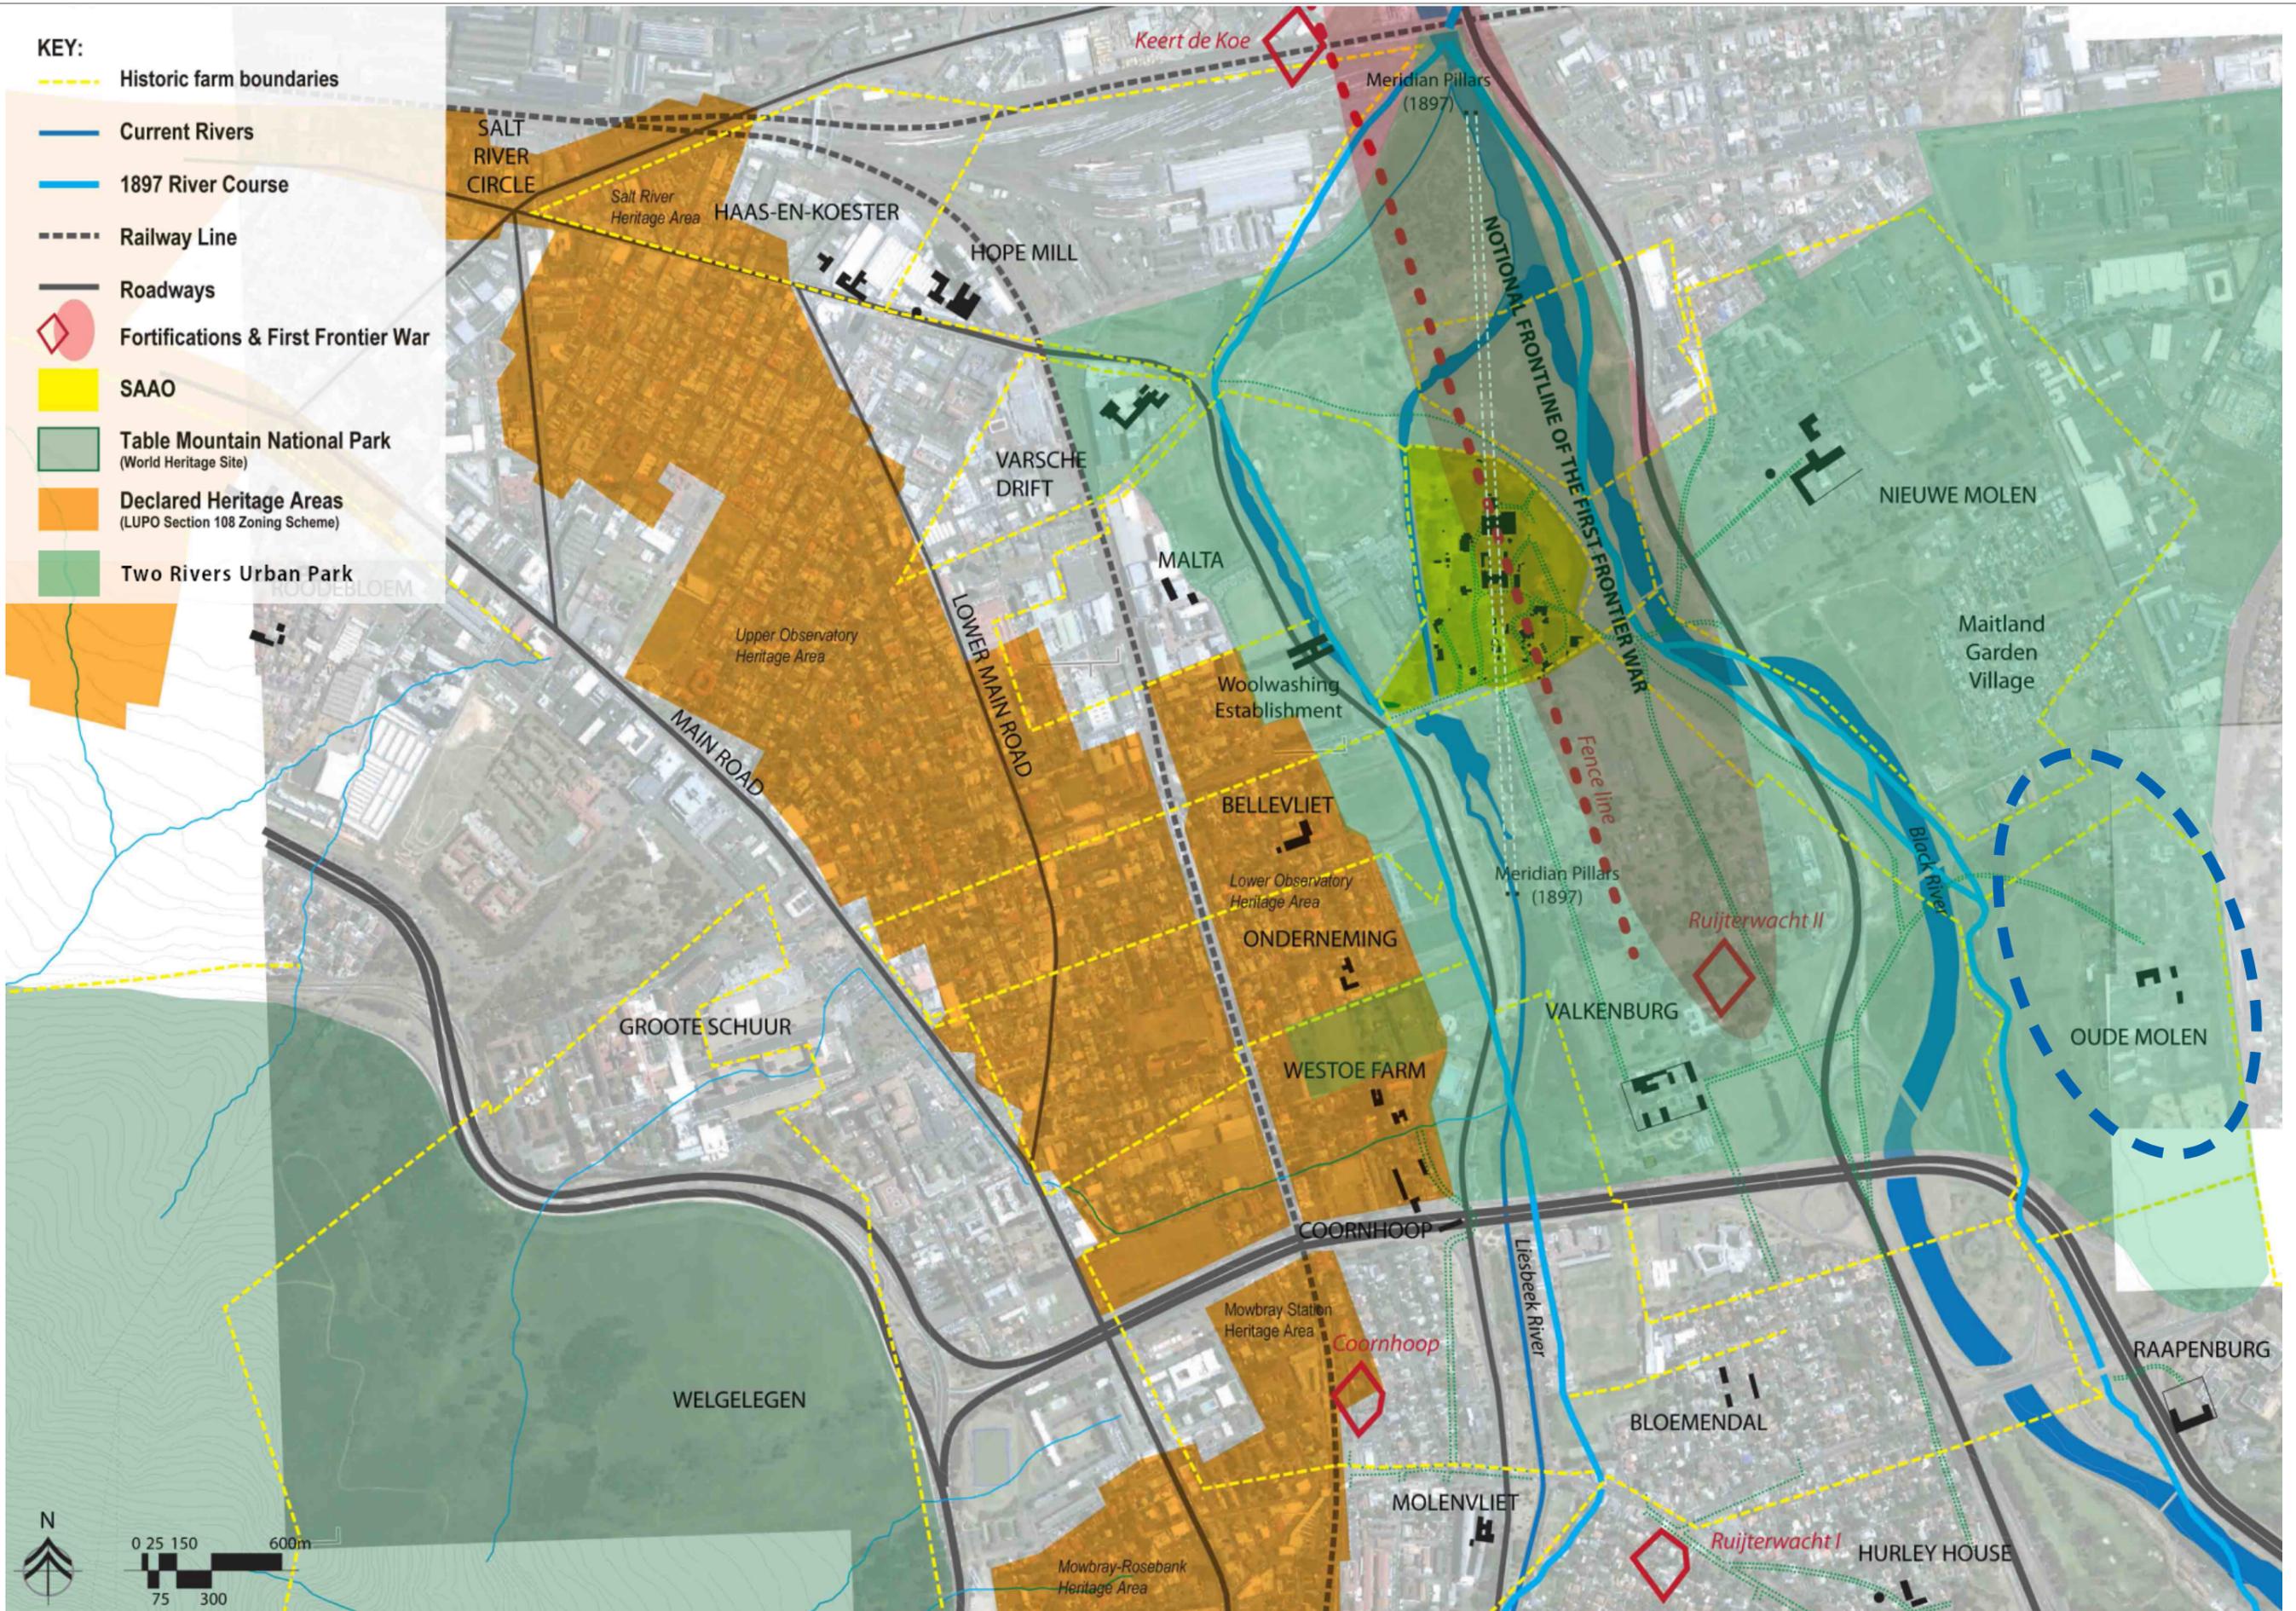
Figure 18. Historical Archaeological Potential Diagram; the subject site indicated in blue; the dotted red line indicates the possible alignment of the cattle barrier (after Winter, 2017: 9)

Mapping overlays seem to indicate the study site outside of the line of early Dutch fortifications, either in the form of the defensive line, or a redoubt, but it certainly falls within the frontier landscape of tension and conflict (Figure 18).

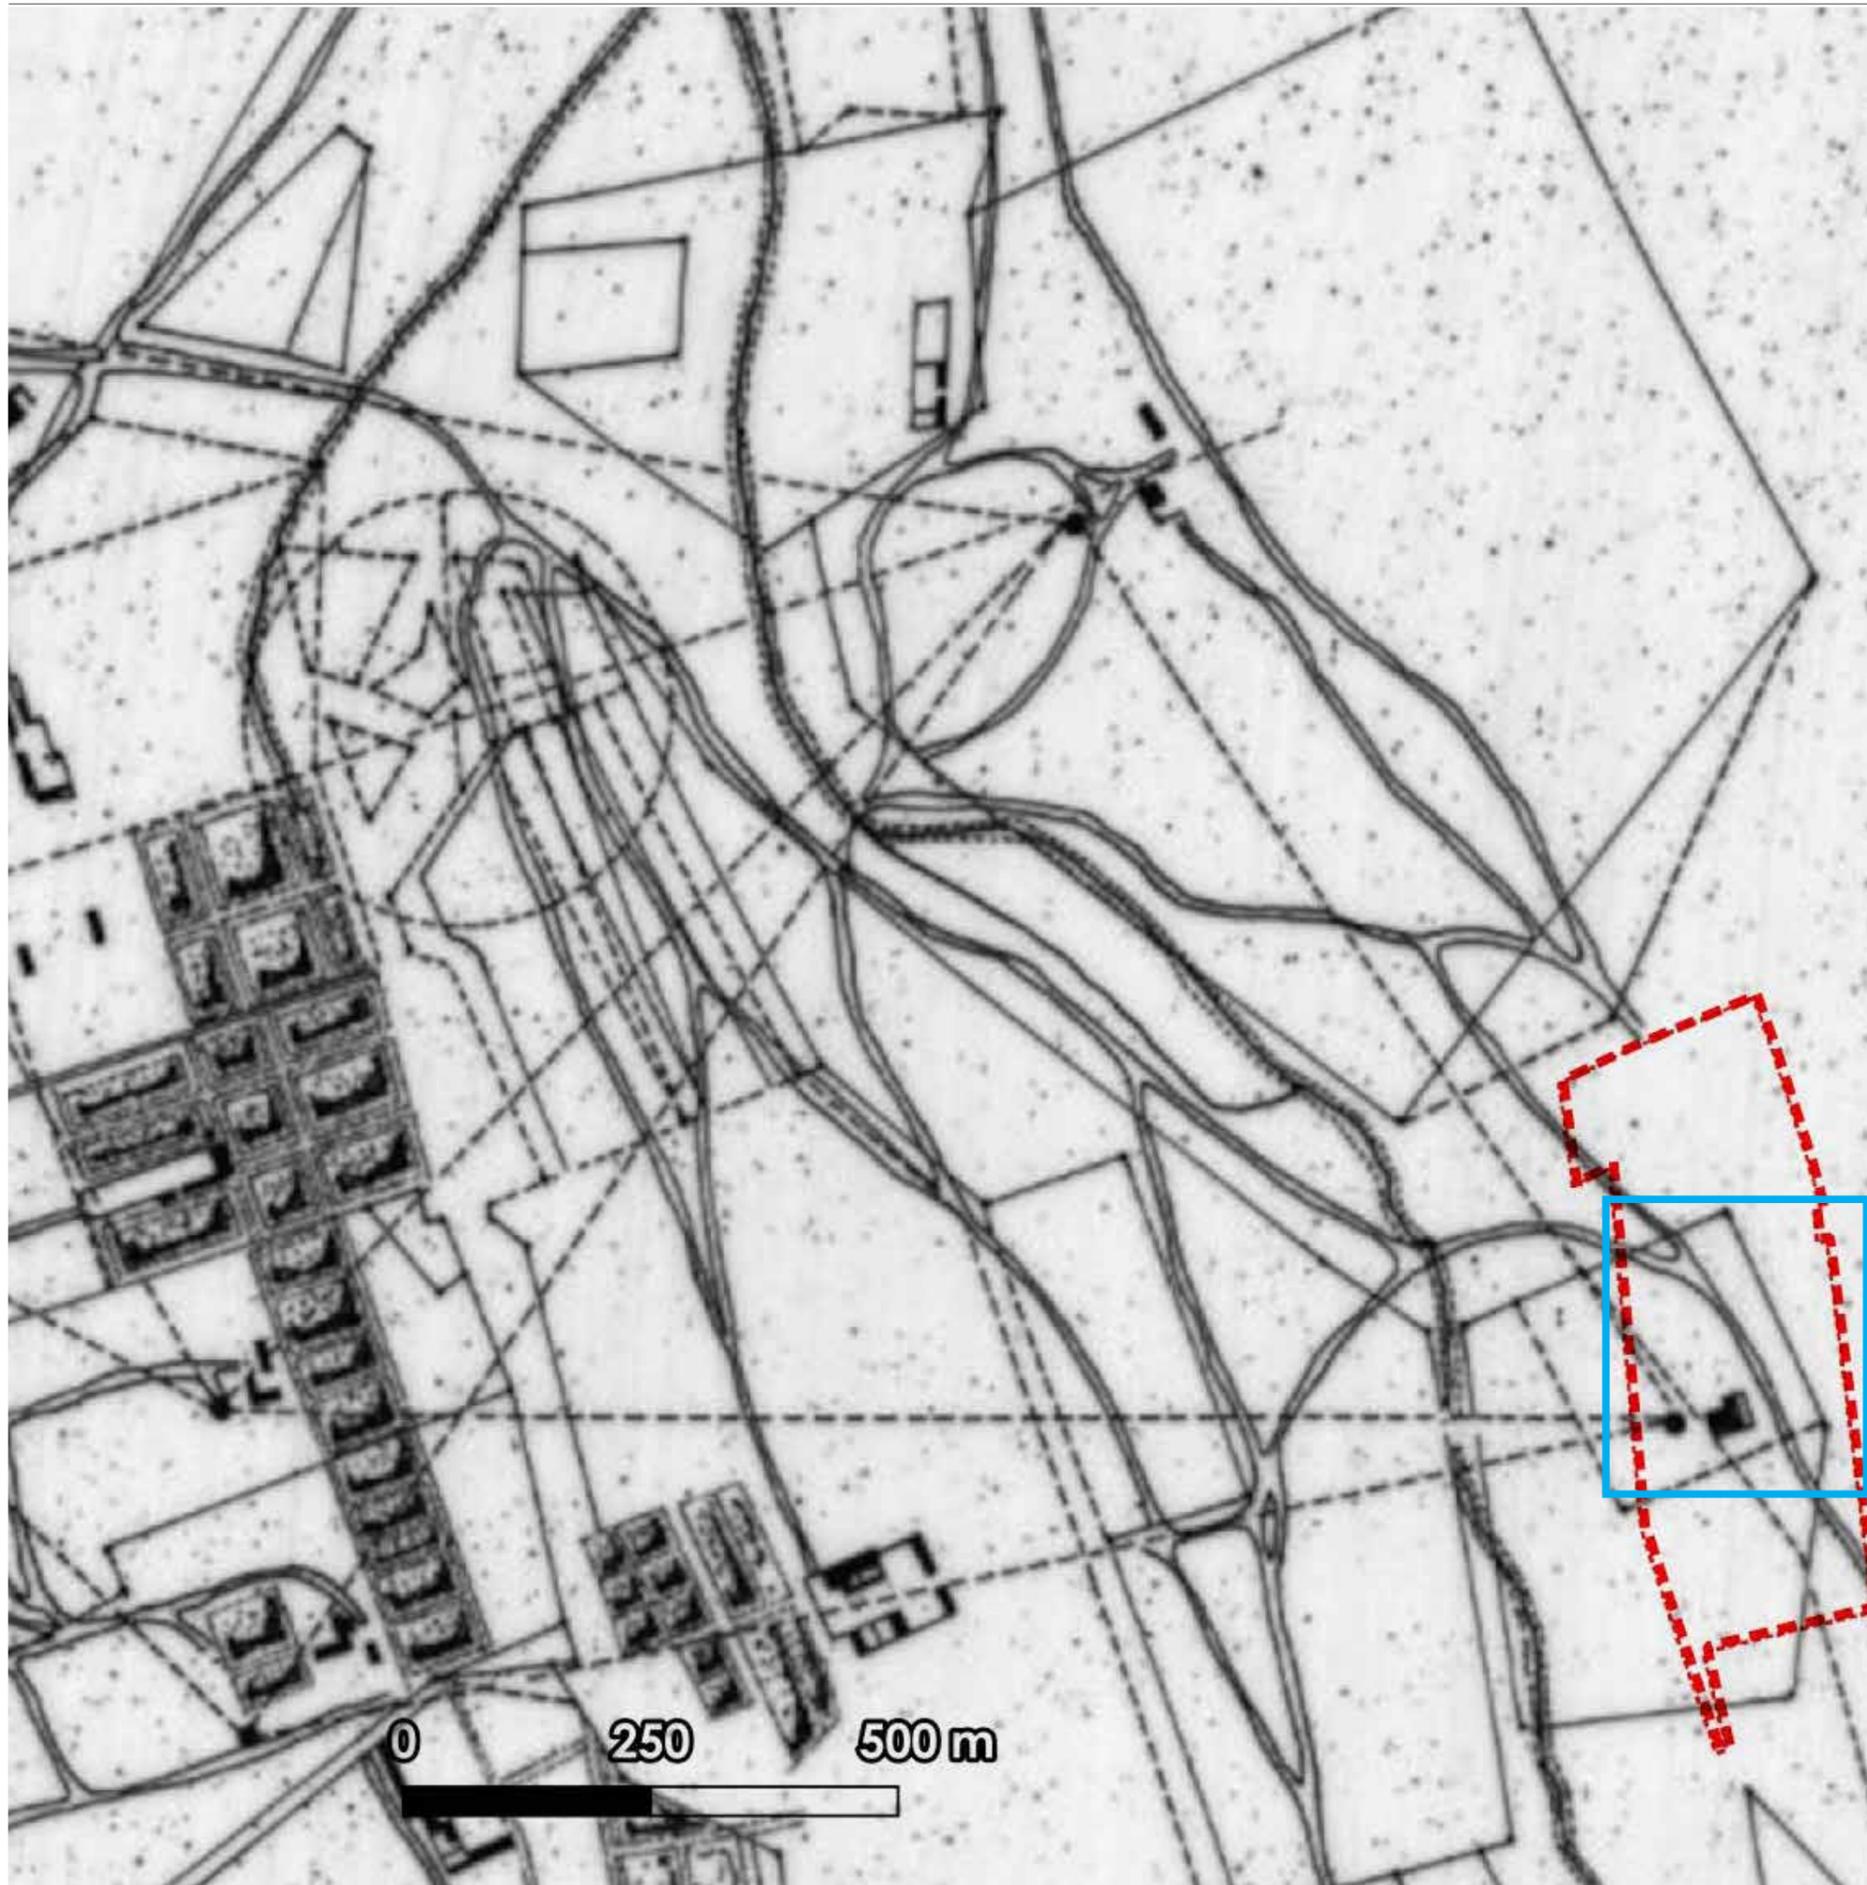
Figure 20. Thibault Map of 1812, showing the extent of the Oude Molen property and the location of the mill and farmhouse; inset in blue at top right shows detail of the mill and house for comparison with Figure 21 (RSA, 2023)

The extent and position of the mill and the other buildings on site is first depicted in various plans from the early C19th, and is captured some detail in a painting of 1803, although some details differ in each instance (Figure 20 to Figure 23).

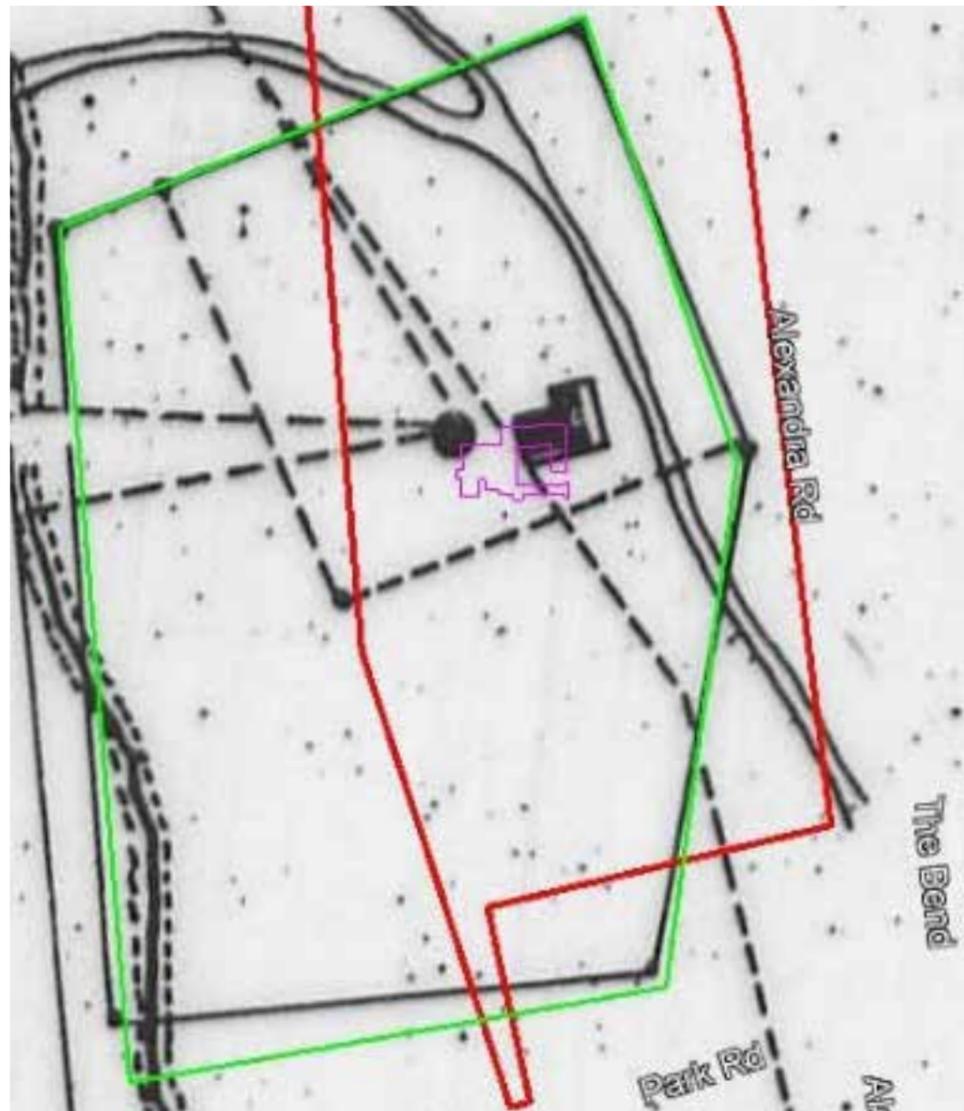
Figure 24. O'Donoghue's (2022:55) overlays showing: "Approximate location of OMP site (red) indicated on 1812-3 Thibault survey; existing actual Block H footprint in pink, and 1802 de Vries extended property in green. The mill appears to have been used as a survey point by Thibault (dotted lines) (Source: City of Cape Town, 1977 compilation and tracing; 1802 property mapped from Chief Surveyor-General diagram nr. 9415/1950)"

Comparison of early surveys only seems to reveal that substantial misalignment exists in the relative positions of the property boundaries and the locations provided for the mill house and windmill (Figure 24 and Figure 25).

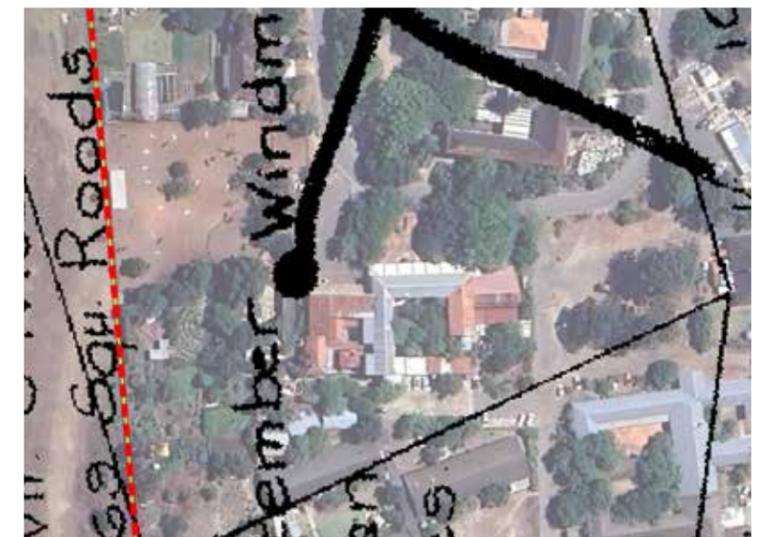
Figure 26. Detail of the 1812 (top) and 1831 (above) surveys showing the proximity of the mill as mapped, to the north western extent of the current homestead as depicted on Google Earth (RSA, 2023)

The precise location of any remnant of the mill therefore remains open to a degree of speculation, but would certainly be located in the area to the west of the homestead, as identified by previous studies. Further to this, a substantial structure like the mill, built specifically to withstand high Cape winds, with a base of some 8-10m in diameter, would have had extensive foundations, and thus we can expect stone foundations, brickwork and/or foundation cut and fill deposits to remain below current ground level.

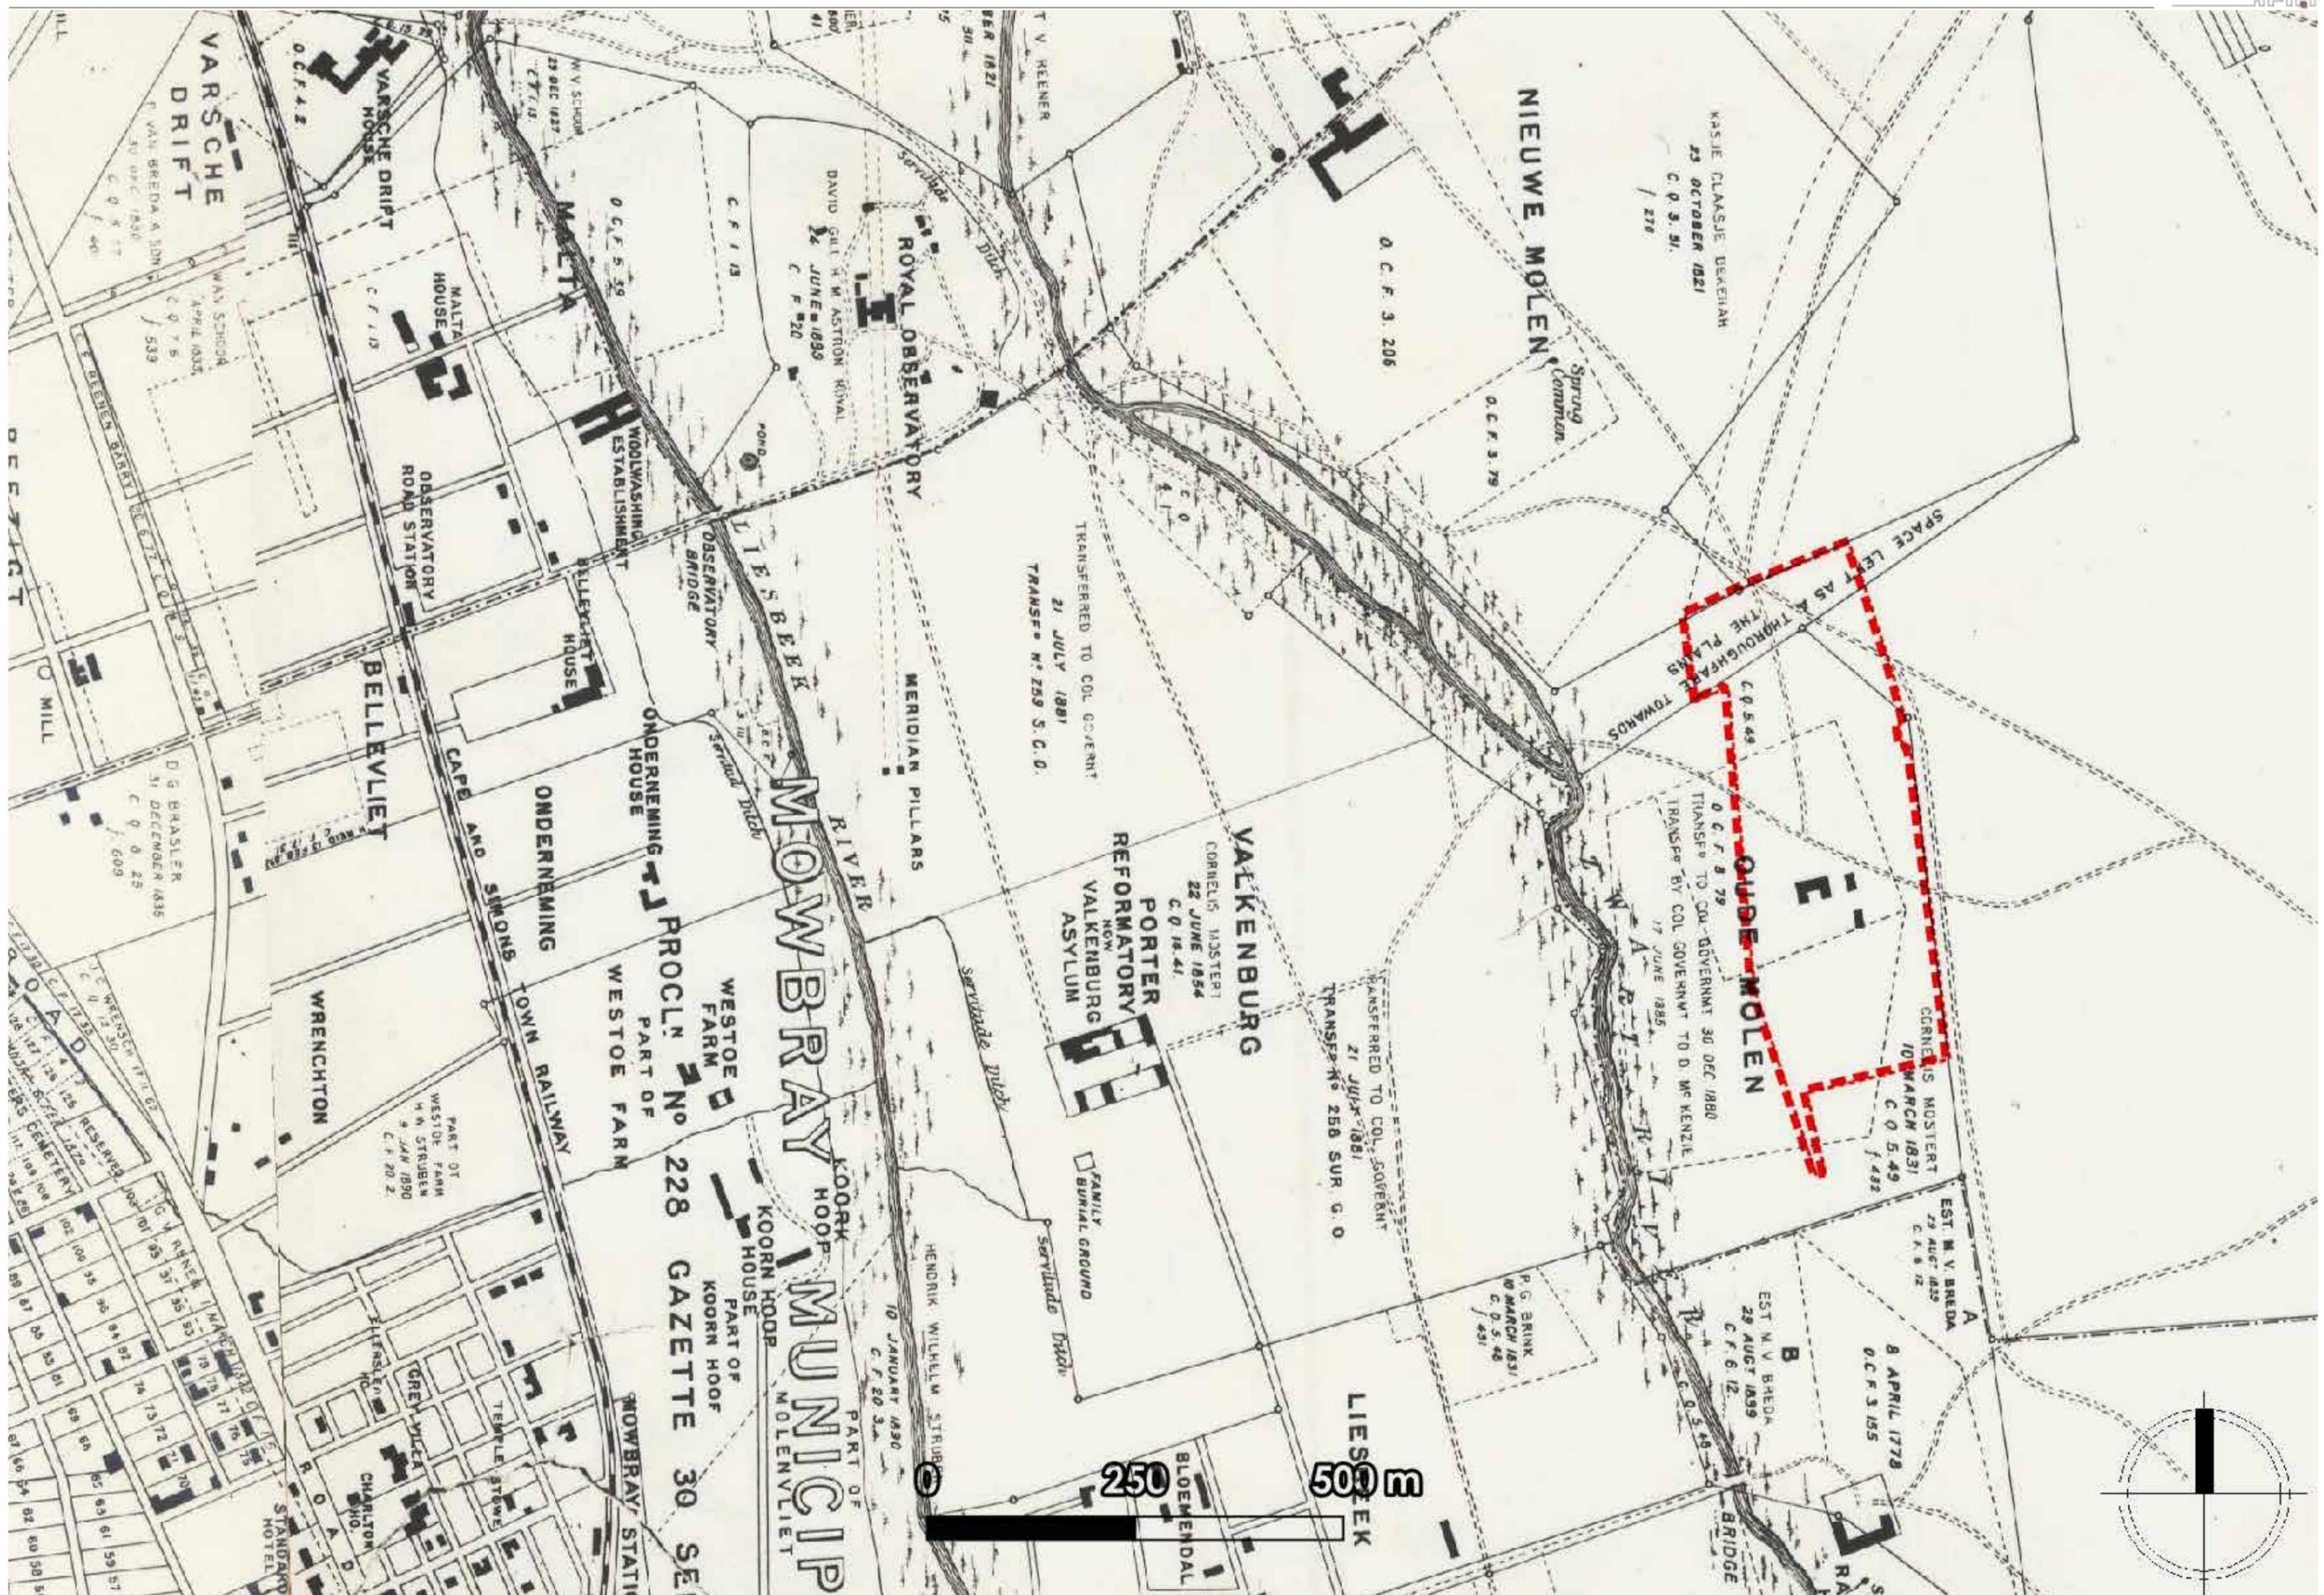
Figure 27. Topographical map of 1897, showing the extent of the Oude Molen property at the end of the C19th, and the location of farm buildings, but no mill; note also that the single structure located north of the mill house in Figure 23 is not depicted, but two structures to the east are (RSA, 2023)

The mill began to fall into decline by the early middle of the C19th - the first steam mill was operational in Cape Town by 1833, and by 1855 a further five had been built. Oude Molen likely continued its operations into the 1860s, and appears on a map of the Colony from 1863, but by 1885 it is no longer depicted, and appears to have been demolished after sustaining wind damage in a storm (see Figure 27).

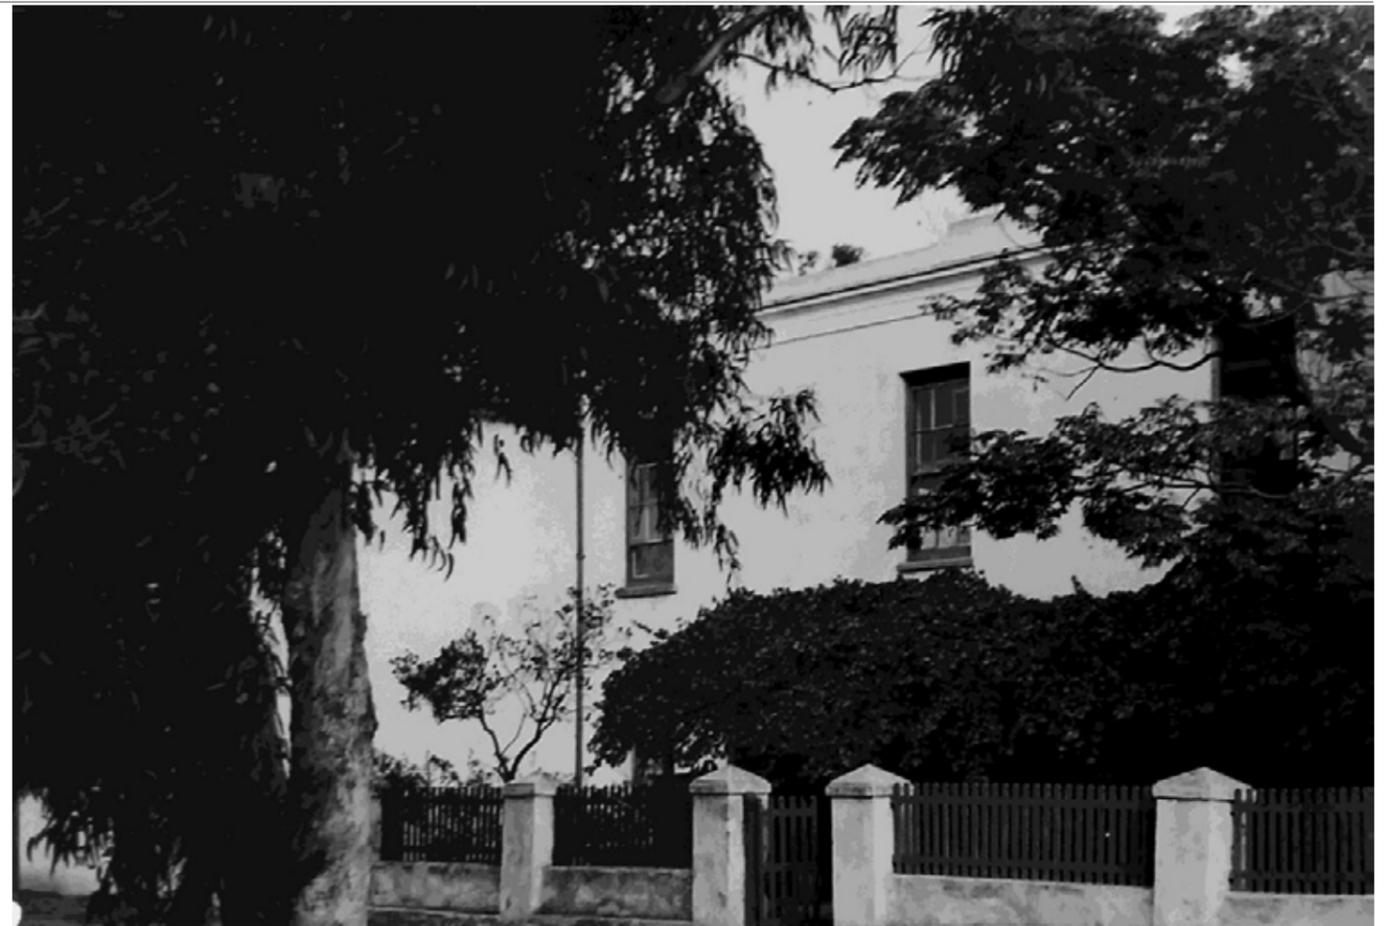
Figure 32. The mill house captured by Elliot in c. 1905-1910 (KAB E897)

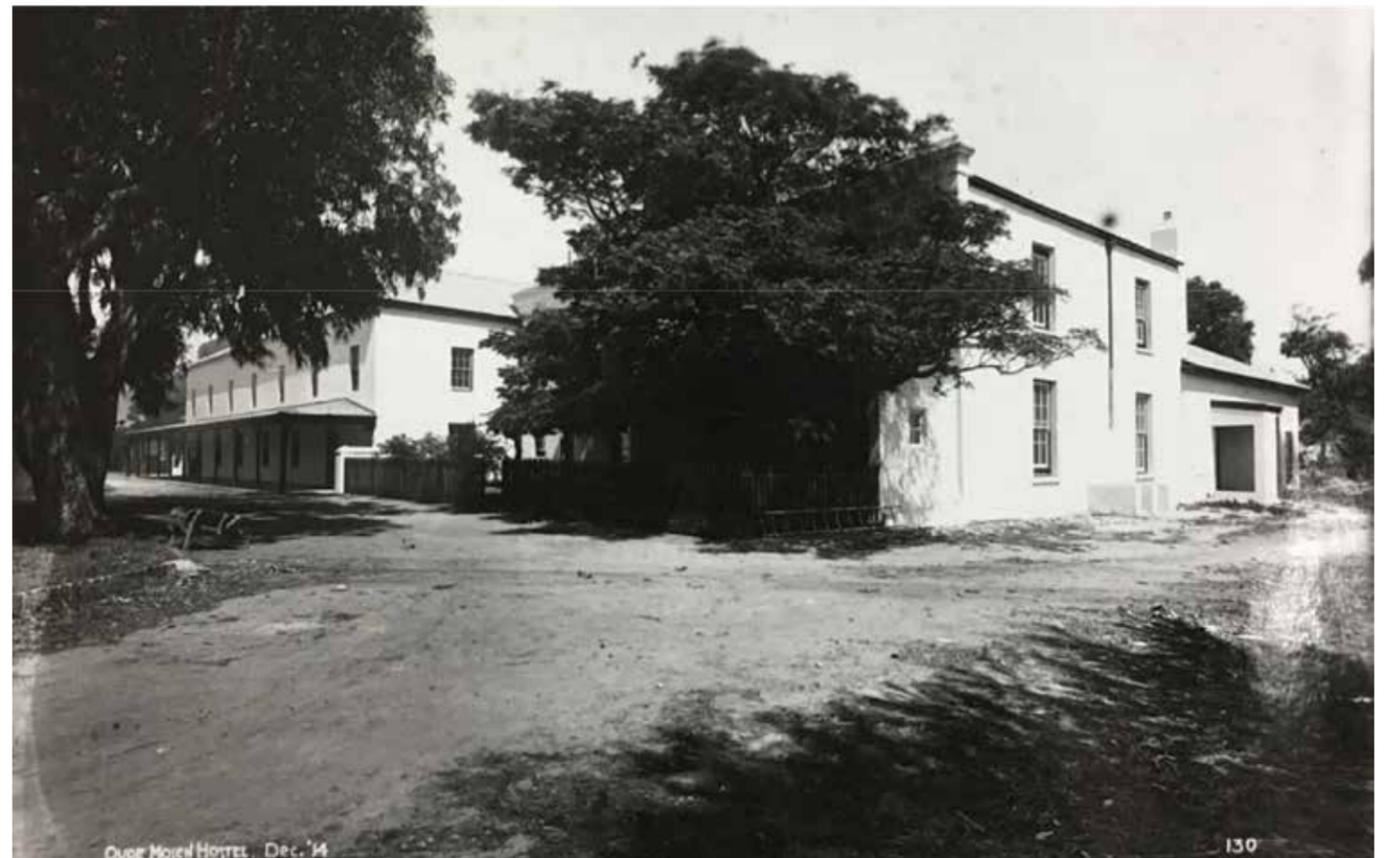
Figure 33. The mill house in December 1914, with the hostel extension completed (KAB AG12280)

Most significantly in terms of the homestead, the male patients' wing was added onto the eastern extent of the mill house, comprising the Uitvlugt Hostel Building; this was completed by late 1914 (Figure 32 and Figure 33); the New Military Hospital was completed in 1916 to house black military patients. A dairy and cow byre was constructed south of the complex by 1913; this was demolished in the 1950s (Figure 34). The bulk of construction, however, was undertaken to the north of the homestead, with the construction of a 'Coloured Mental Hospital' comprising four F-shaped wards, a dining hall, kitchen, superintendents house, married quarters and a mortuary, with a second one built by 1968.
