ARCHAEOLOGICAL IMPACT ASSESSMENT OUDE MOLEN VILLAGE, ERF 26439-RE, CAPE TOWN

HWC REF: 21022615SB0330E

submitted in terms of Section 38(4) of the NHRA (1999) for
OUDE MOLEN PRECINCT, ERF 26439-RE,
ALEXANDER ROAD, PINELANDS, CAPE TOWN

FINAL AIA

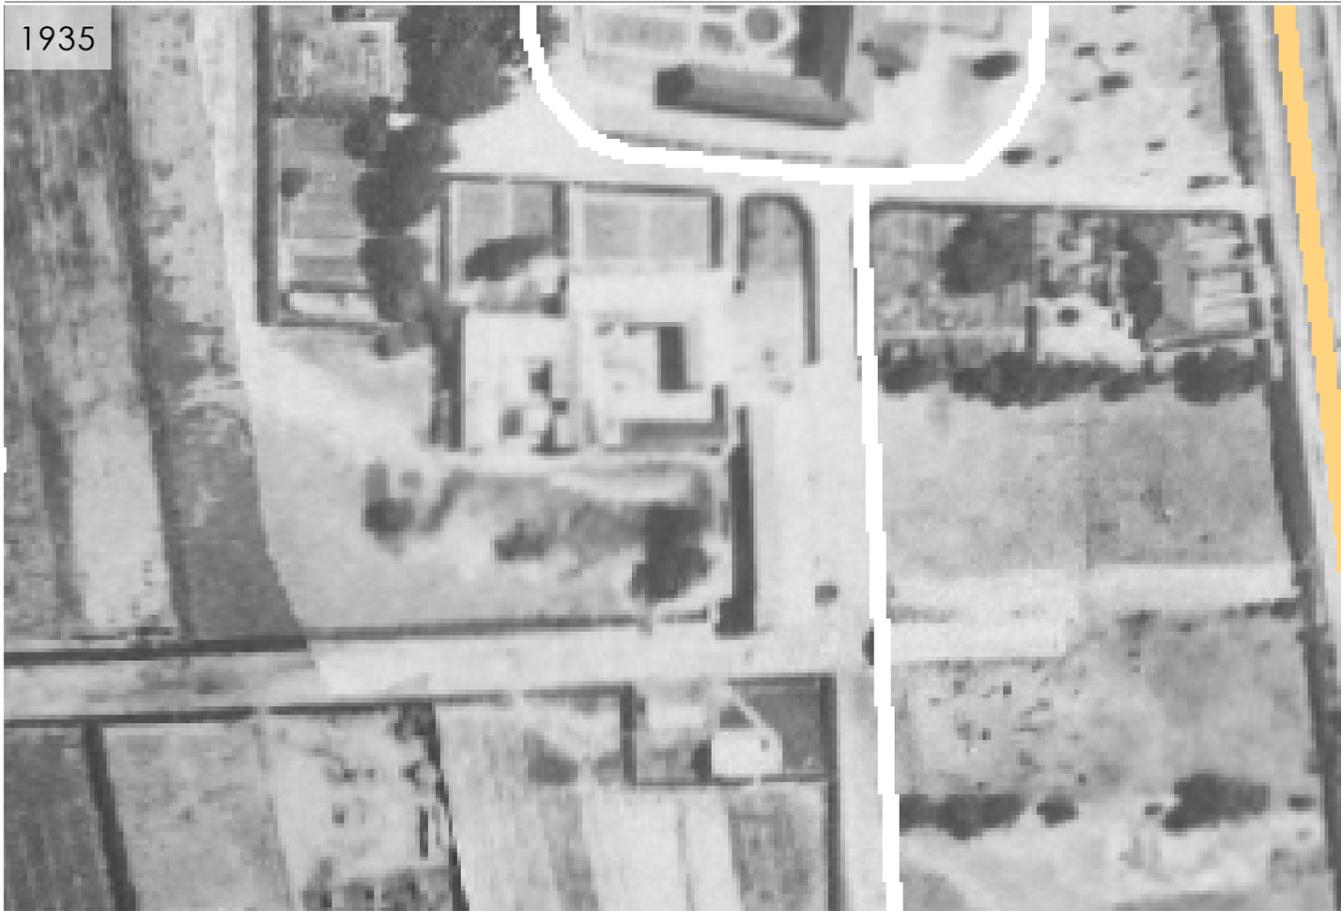
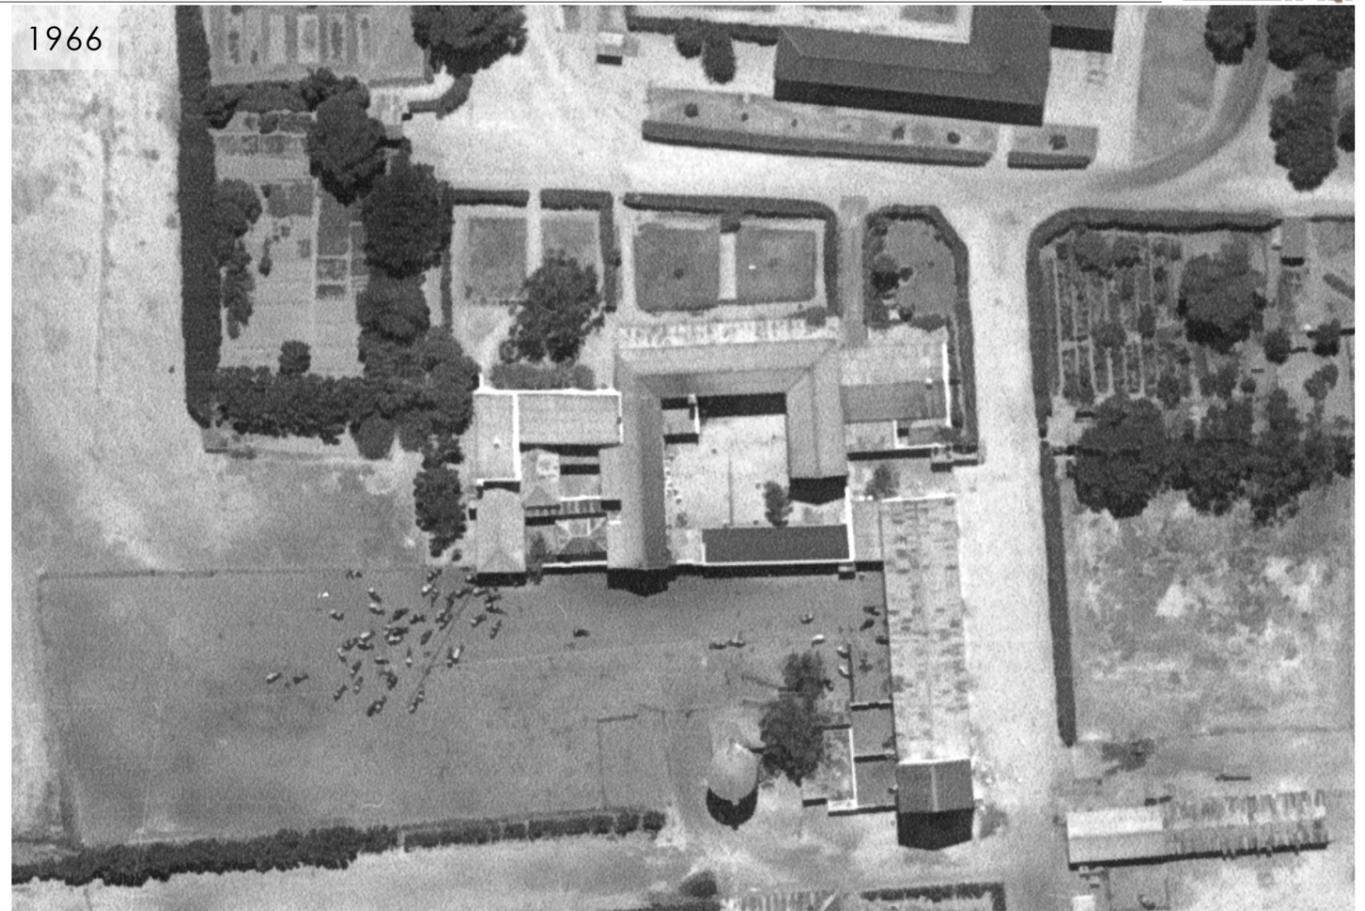
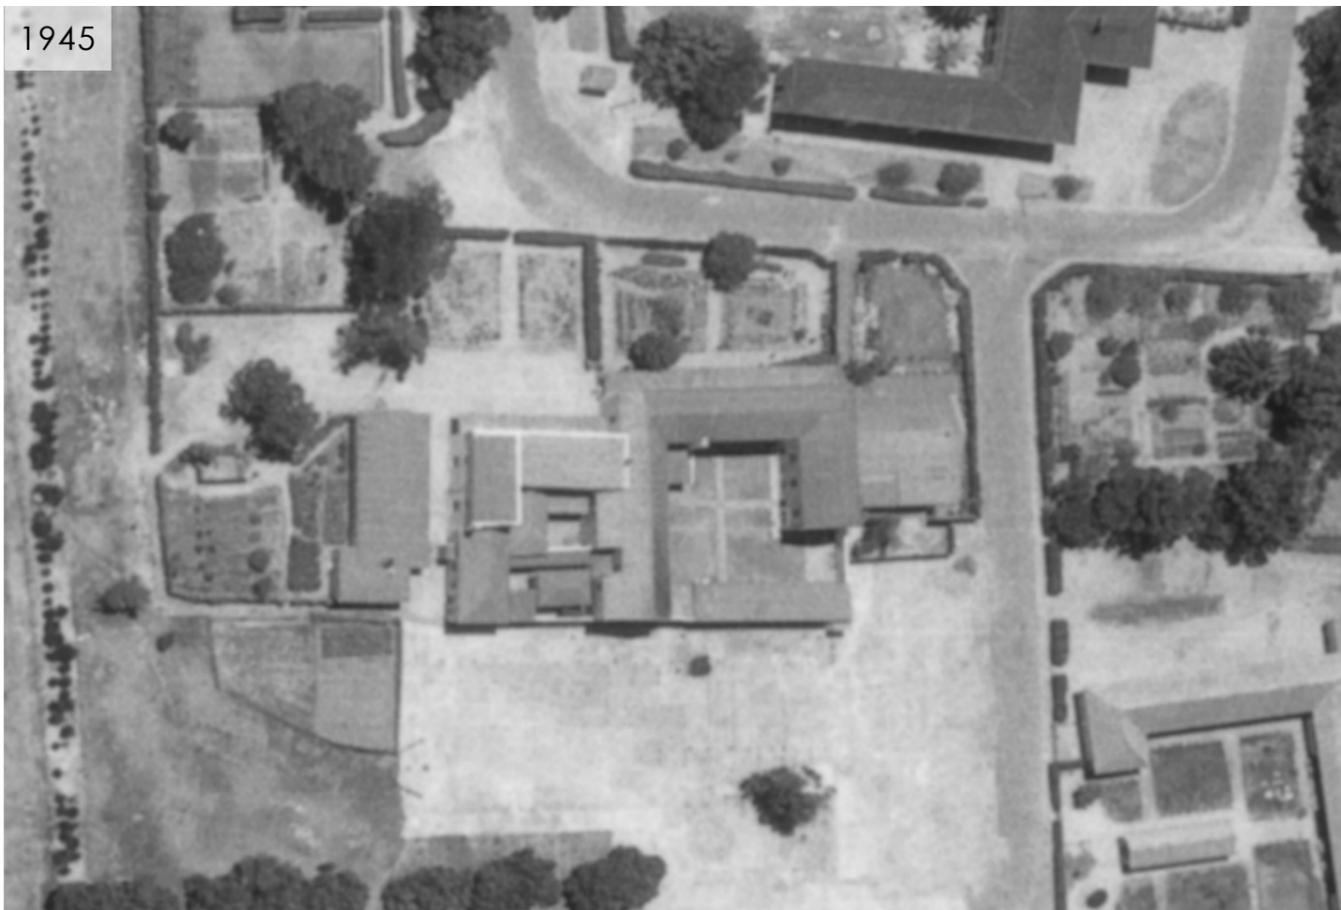
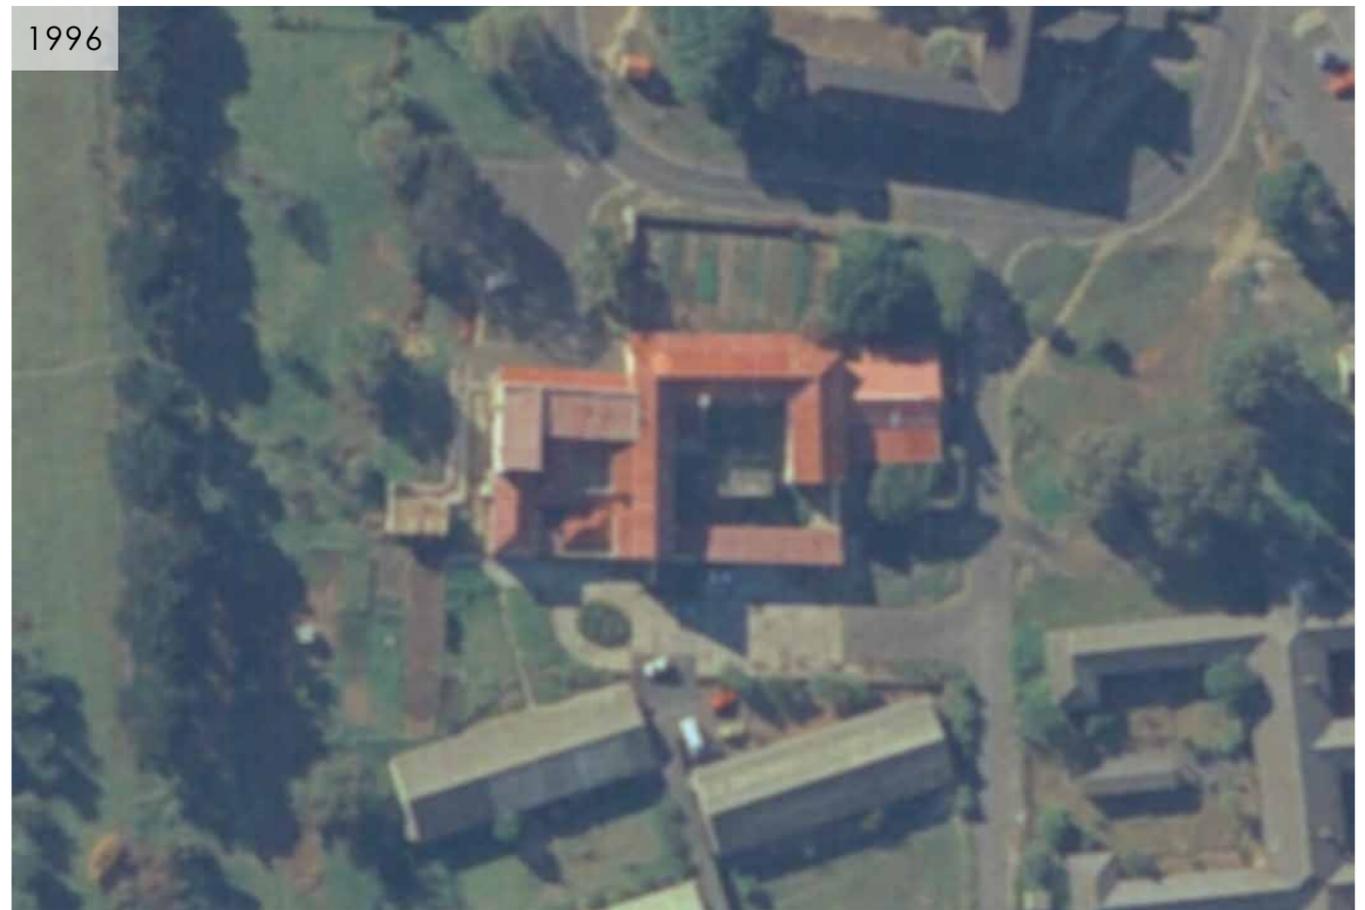
Figure 34. The evolution of the farmstead during the C20th (NGI, 2023)

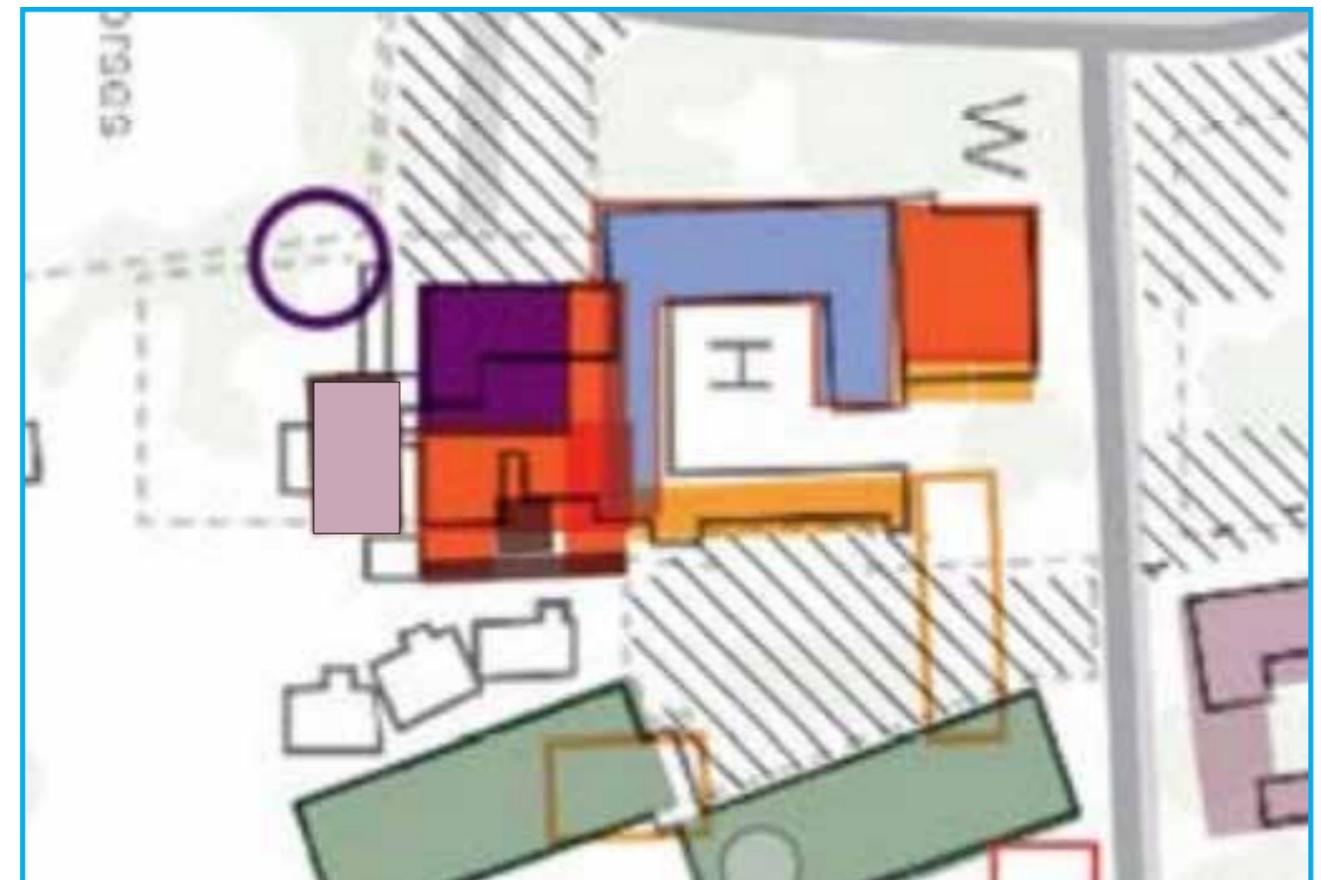
Figure 35. Chronology of Built Form inset showing the detail of the mill house complex above (Winter, Baumann and Wilson, 2022: 18)

- Figure 34. The evolution of the farmstead during the C20th (NGI, 2023)
- Figure 35. Chronology of Built Form inset showing the detail of the mill house complex above (Winter, Baumann and Wilson, 2022: 18)

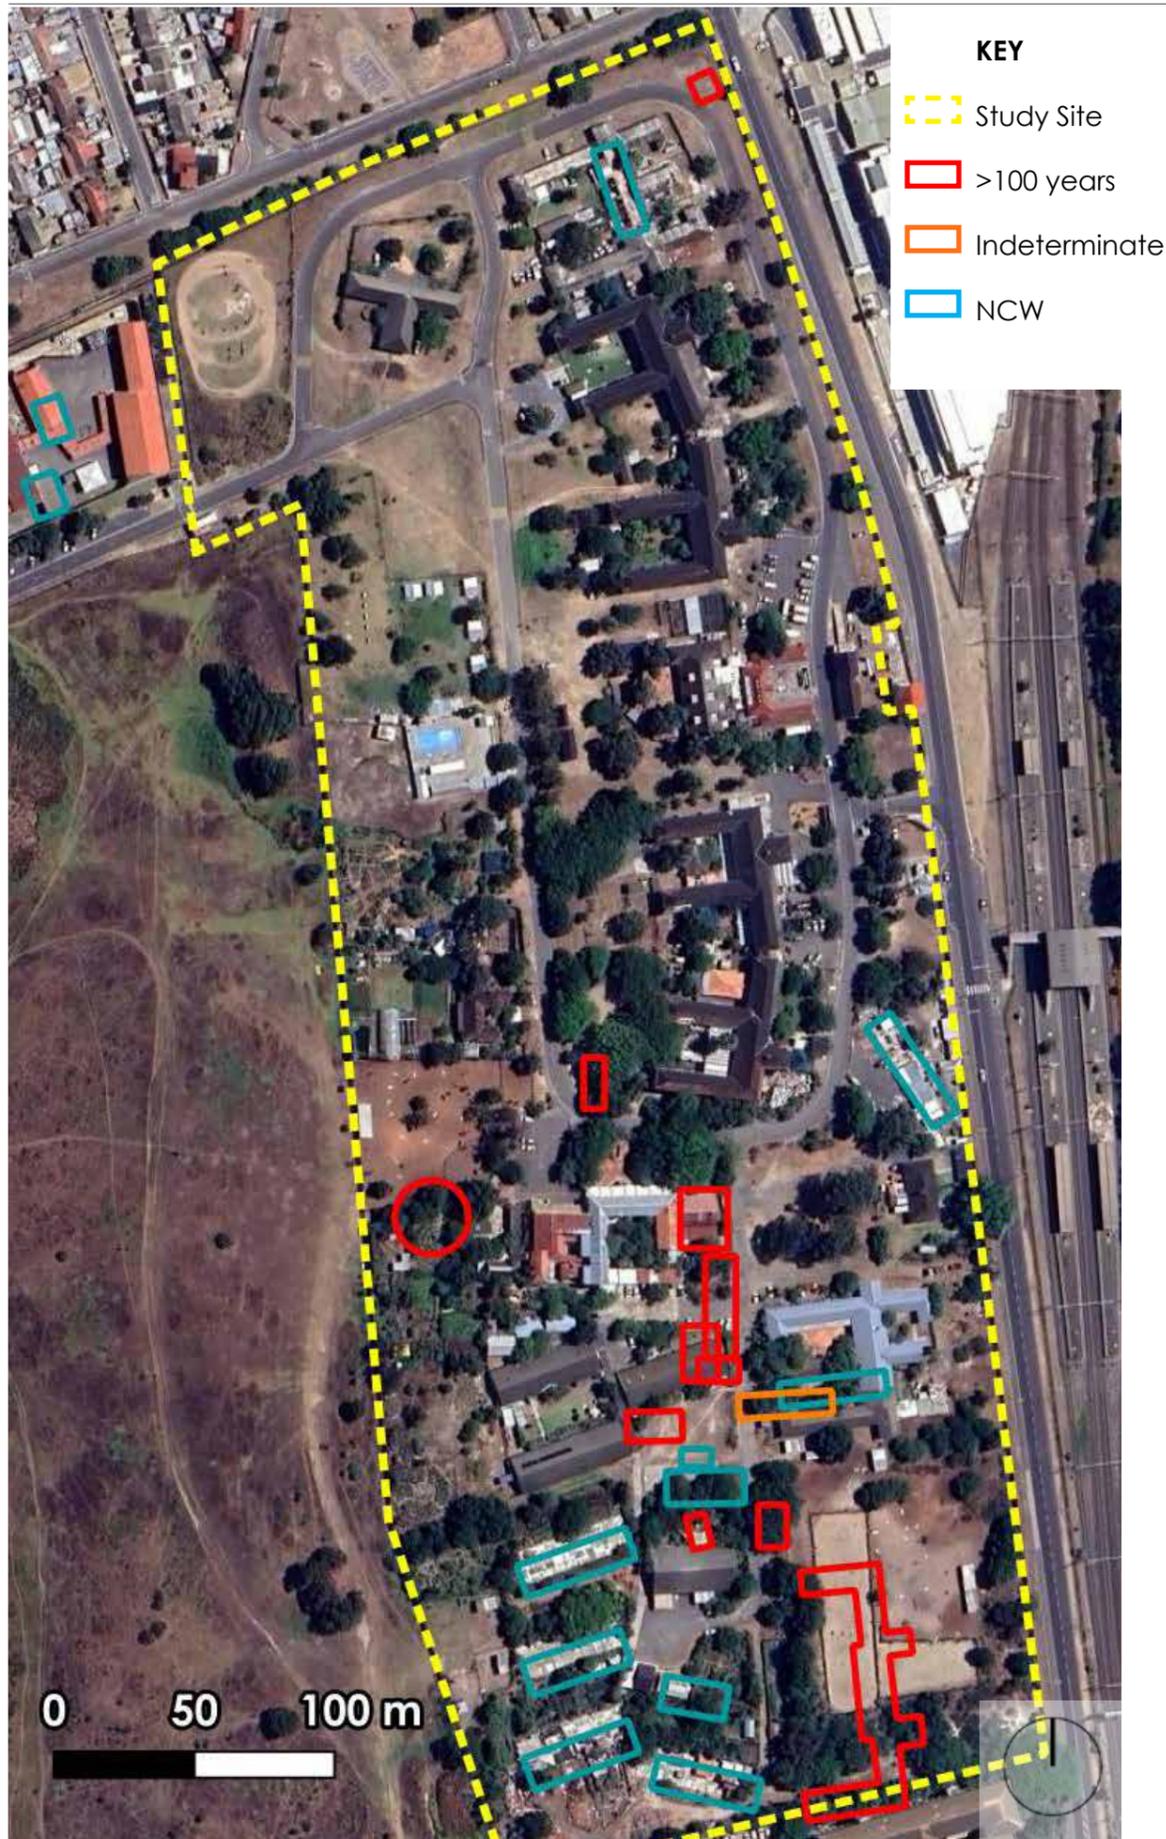
Figure 36. Map of demolitions indicating which constitute archaeological ruins, i.e. are older than 100 years (RSA, 2023; after Winter, Baumann and Wilson, 2022)

The site survey noted the standing structures, including the homestead and its component structures as well as the hospital buildings across site. Only those hospital buildings older than 100 years, and in ruins, would be considered archaeological in terms of the National Heritage Resources Act (No. 25 of 1999). The most significant of these are the demolished portions of earlier configurations of the homestead, and the early C20th Military Hospital (Figure 35 to Figure 41). The area of the two mortuaries could have been of some significance, as it is possible, although unlikely, that human skeletal material might have been accidentally discarded or lost during operations of those facilities, and thus have entered the archaeological record. However, this part of the facility is outside of the project area, and was redeveloped in the 1990s and is thus likely to be devoid of any such traces.

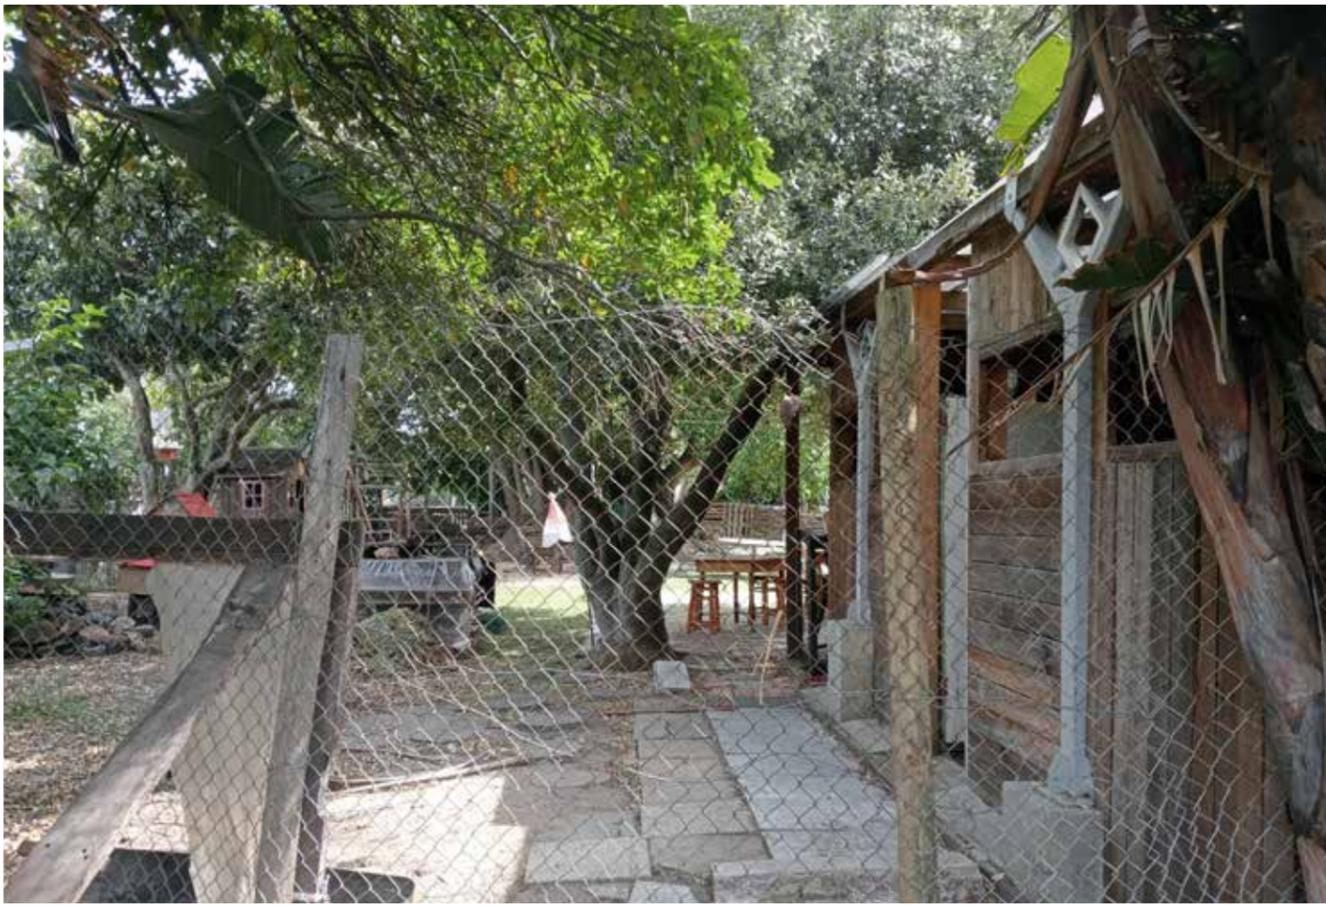
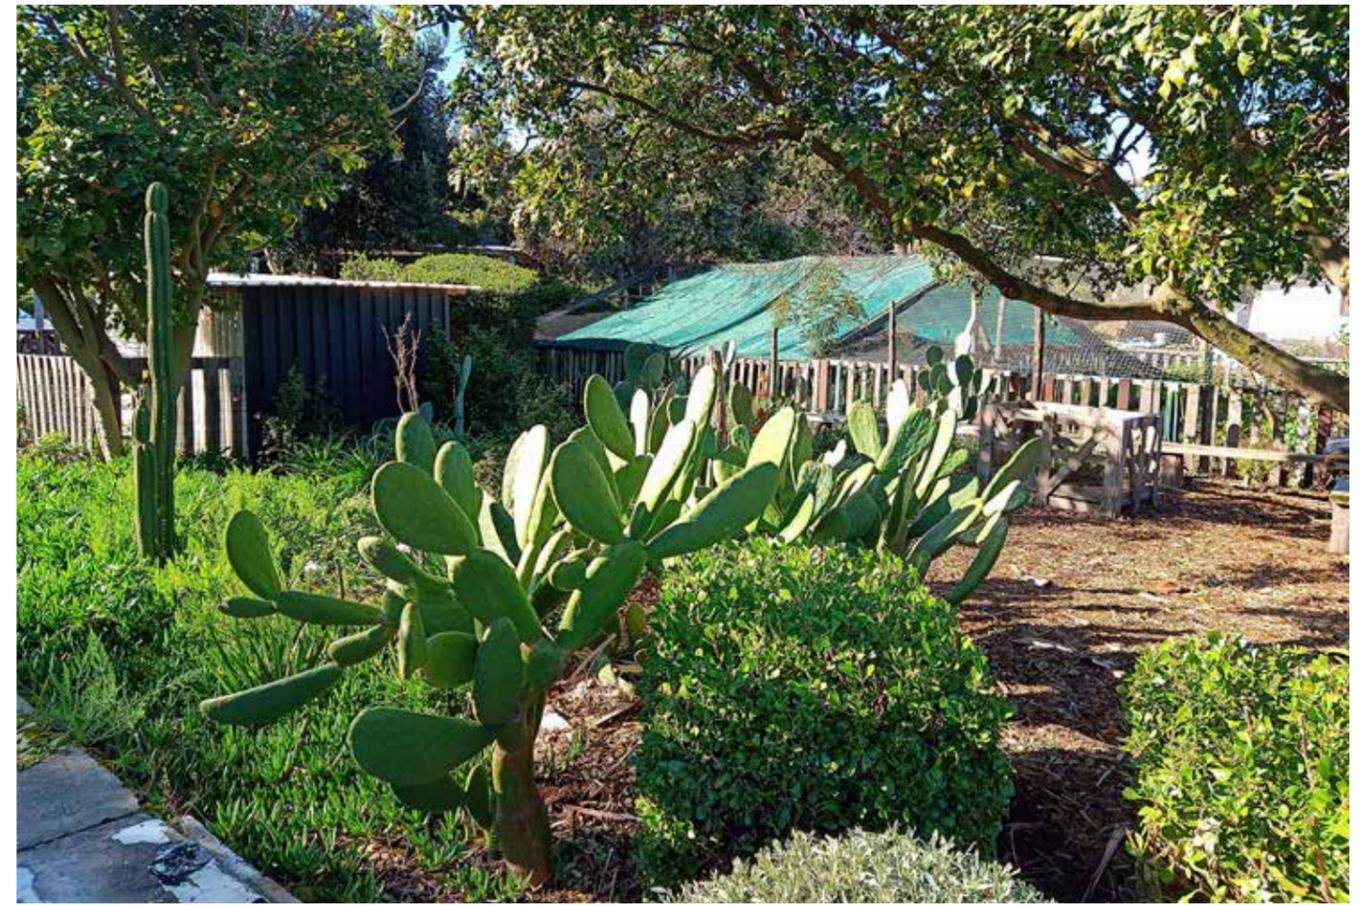
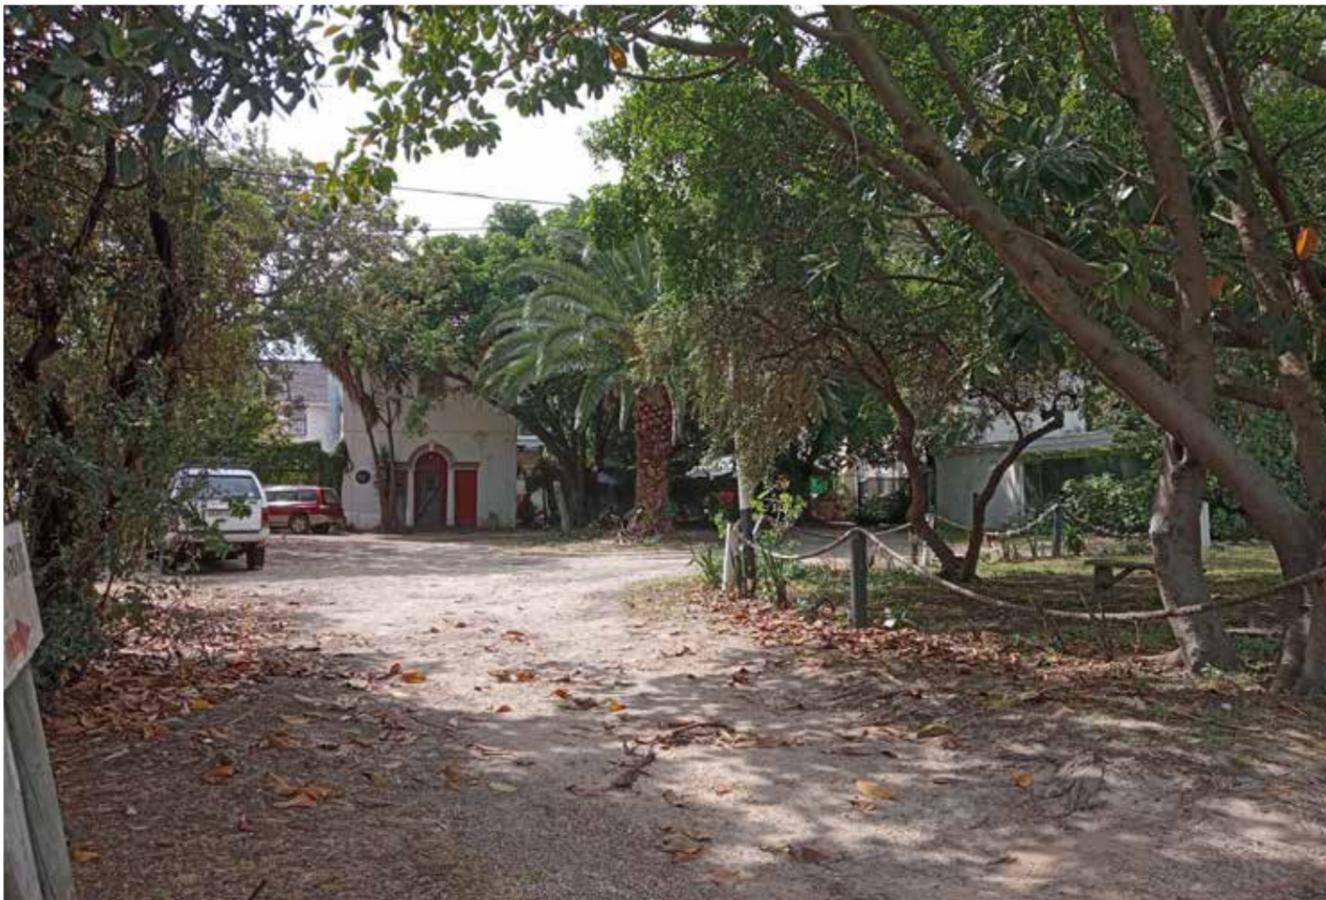
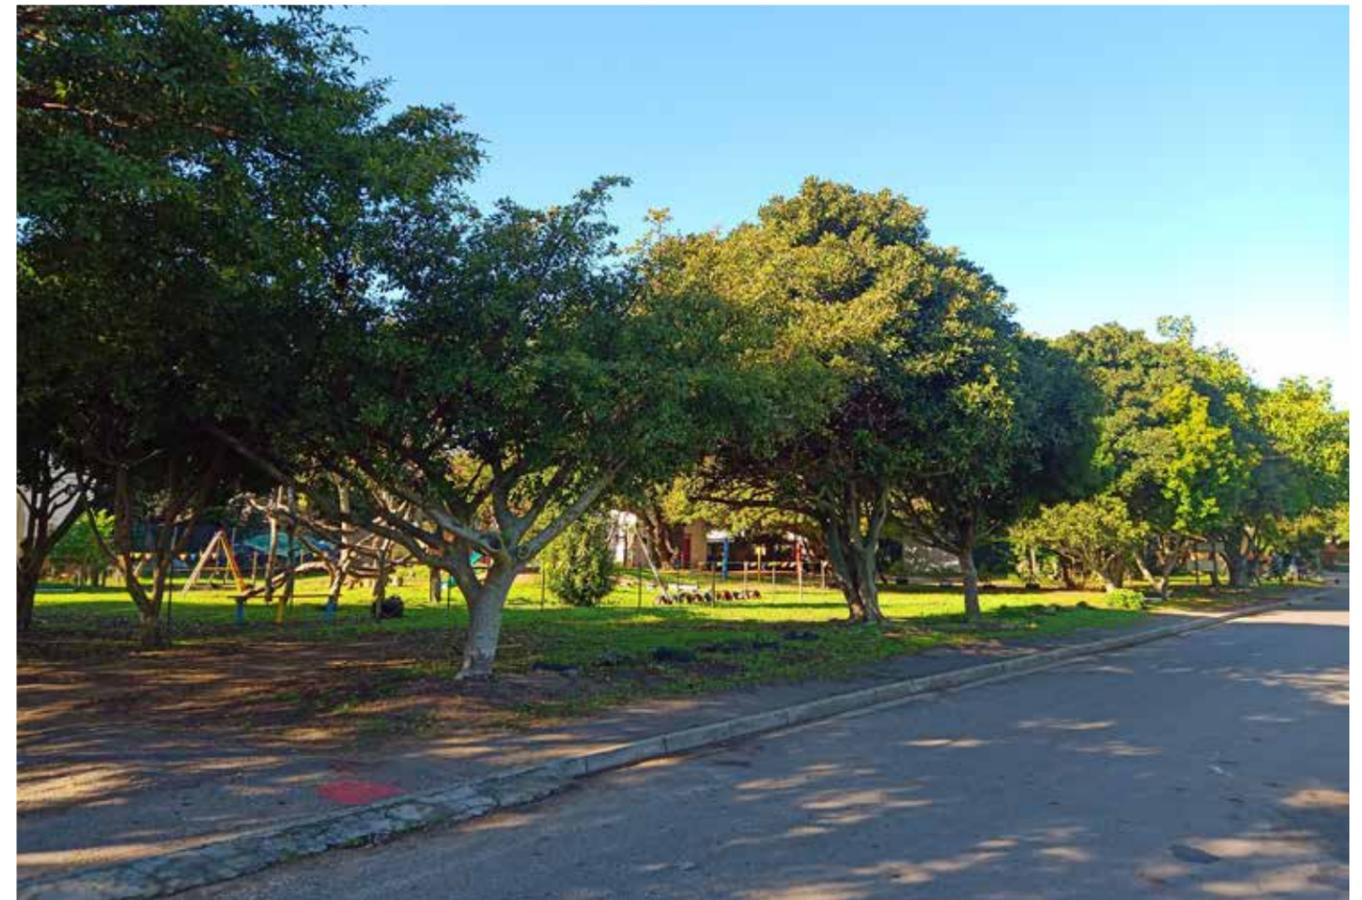
Figure 38. General site conditions - note degree of transformation of the landscape (left: RSA, 2023; right: Gibbs, 2023)

Site surveys on 1 and 28 November 2023 yielded no evidence for archaeological material on the site (see Figure 38 to Figure 42). This is in keeping with outcomes of other archaeological survey work on the site which has widely noted that, despite the long and significant history associated with the wider area that now comprises Two Rivers Urban Park, little to no archaeological evidence of this past is evident (Attwell and Associates and ARCON, 2016, 2017; Hart and Townsend, 2019; Orton, 2022; Schietecatte and Hart, 2014). Hart and Townsend (2019) note that the "Liesbeek valley has no sequences of human occupation such as described above. In fact, to date no San or Khoikhoi archaeological sites have been identified. This does not mean that people were not living here as stock-keeping people were very mobile following available grazing. It does, however, mean that there was no focus in the project area that attracted repeated visits or long-term occupation of any kind, as would be the case with sacred places and capital settlements."

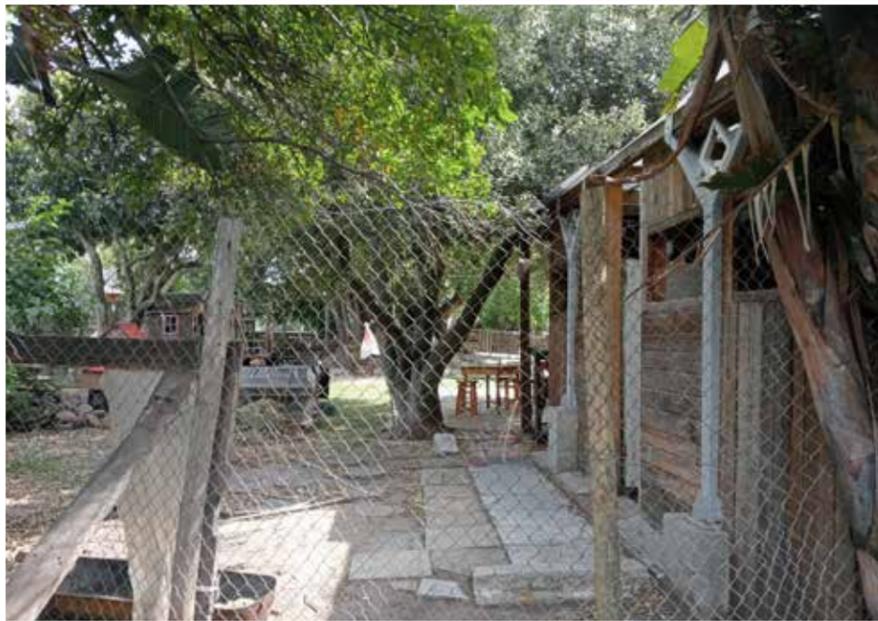
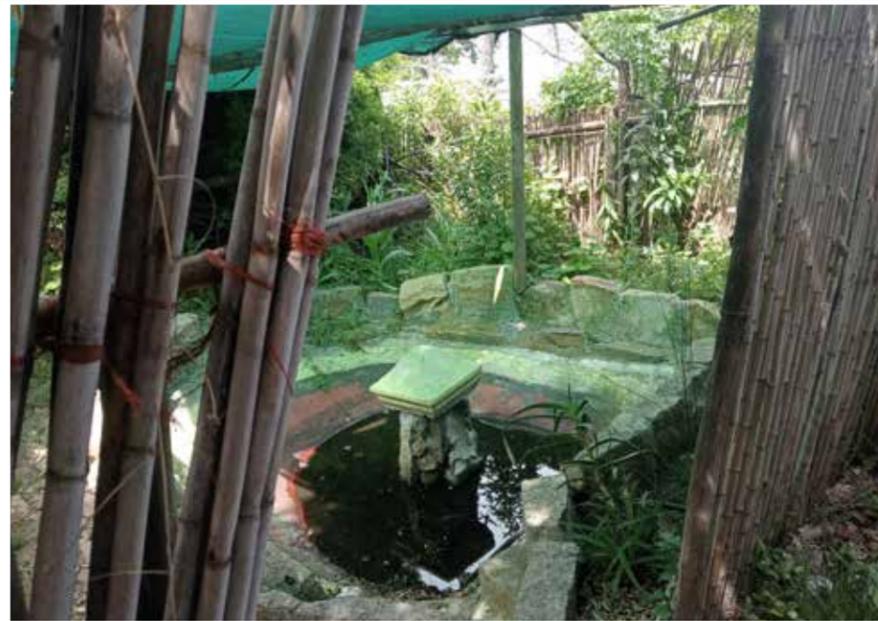
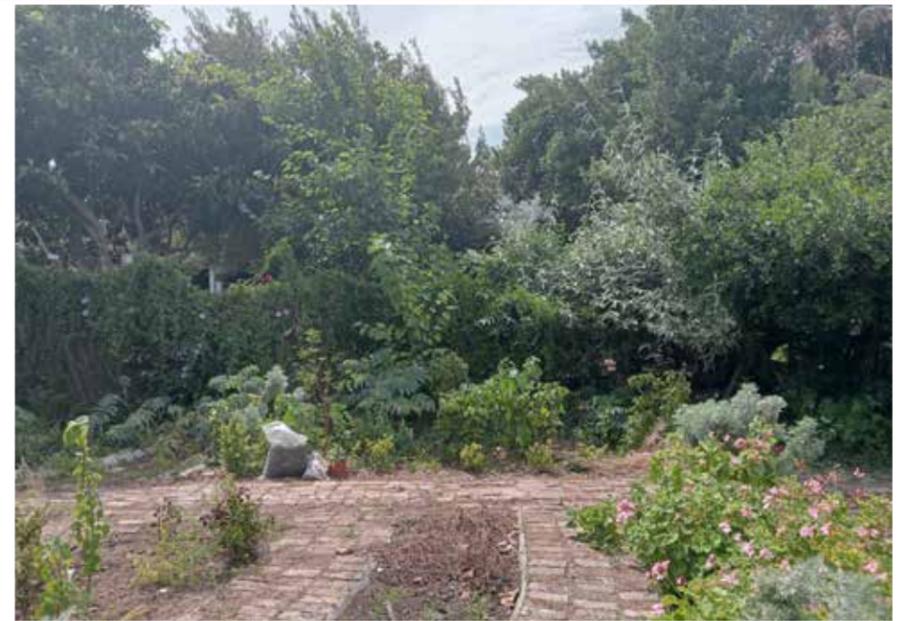
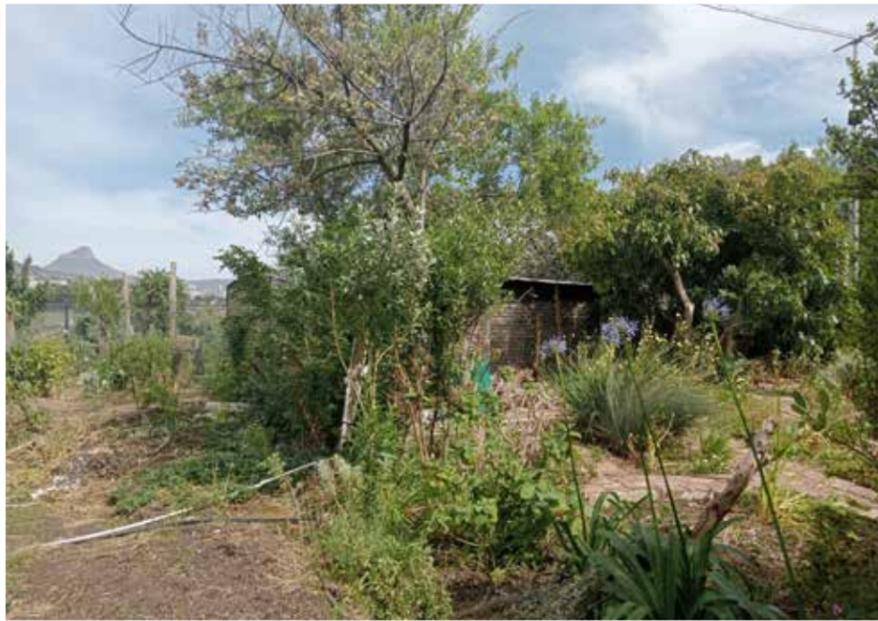
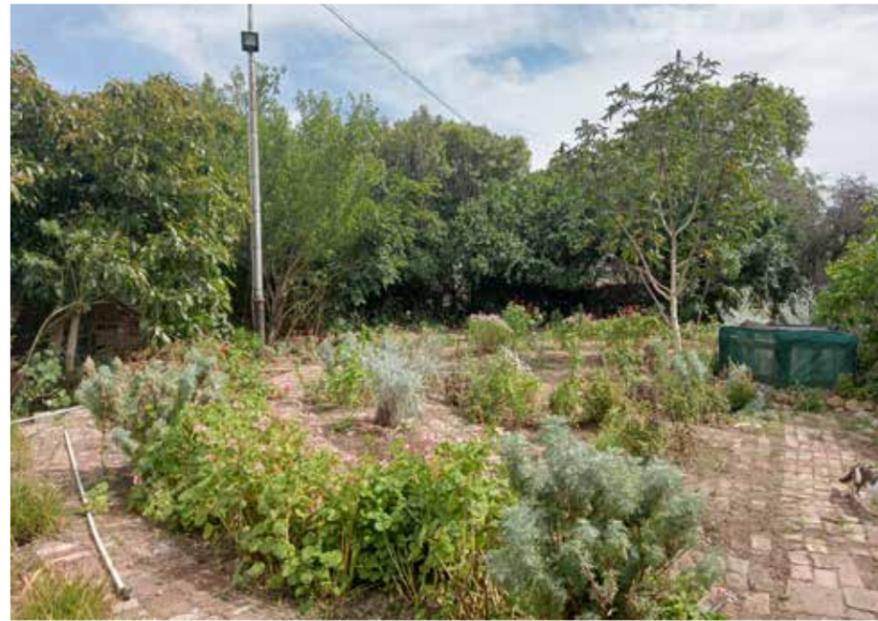
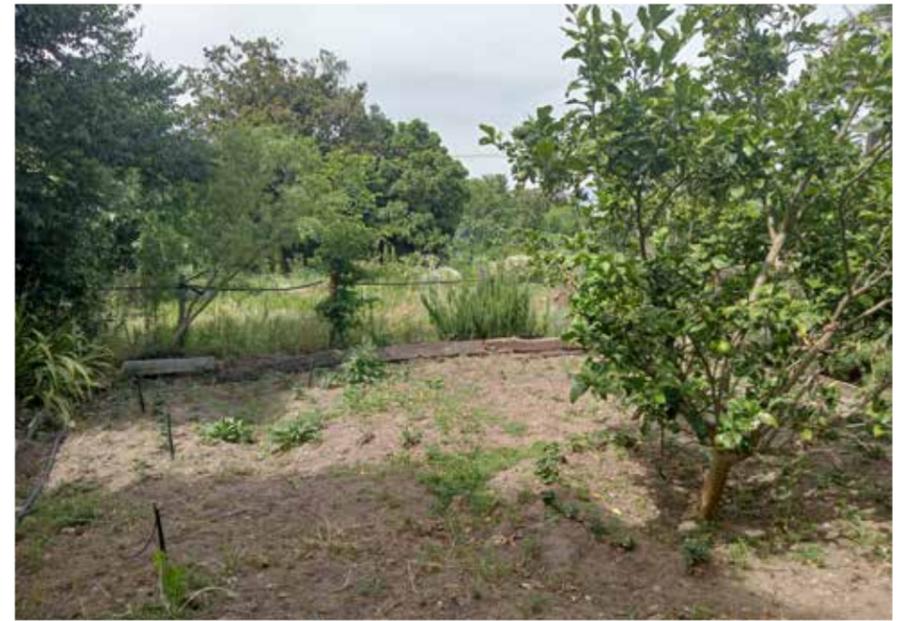
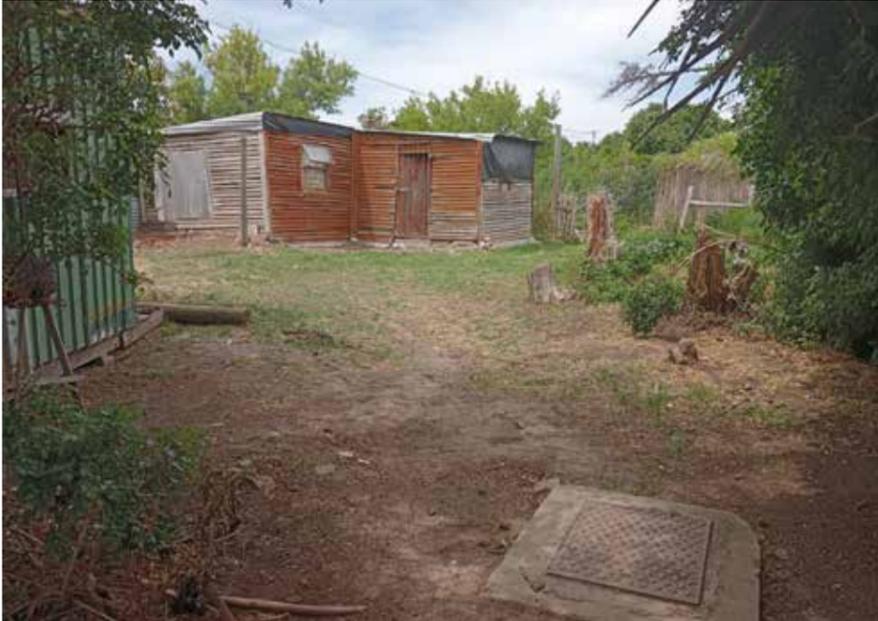
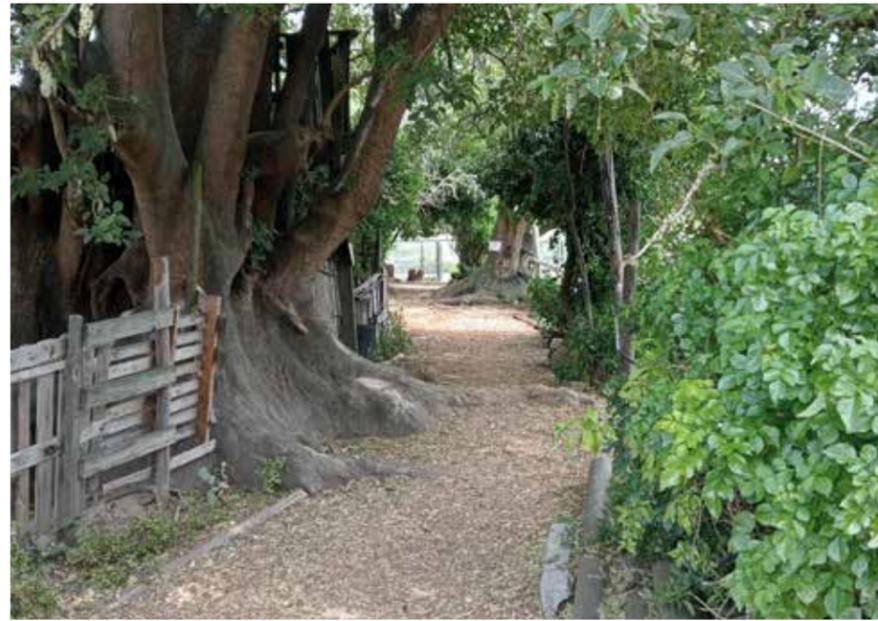
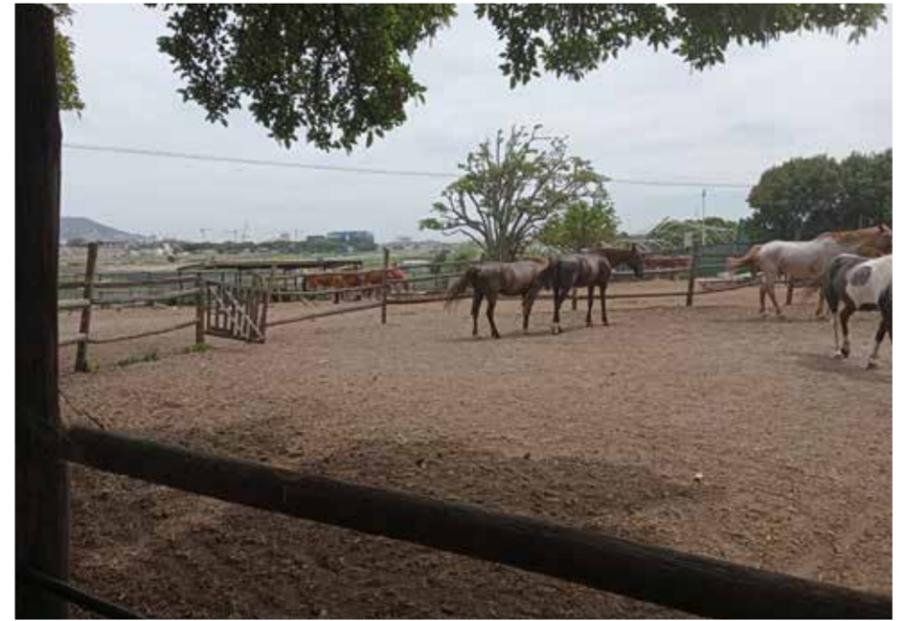
Figure 39. Site conditions -in likely area of mill (RSA, 2023)

The precise location of any remnant of the mill therefore remains open to a degree of speculation, but would certainly be located in the area to the west of the homestead, as identified by previous studies. Further to this, a substantial structure like the mill, built specifically to withstand high Cape winds, with a base of some 8-10m in diameter, would have had extensive foundations, and thus we can expect stone foundations, brickwork and/or foundation cut and fill deposits to remain below current ground level.

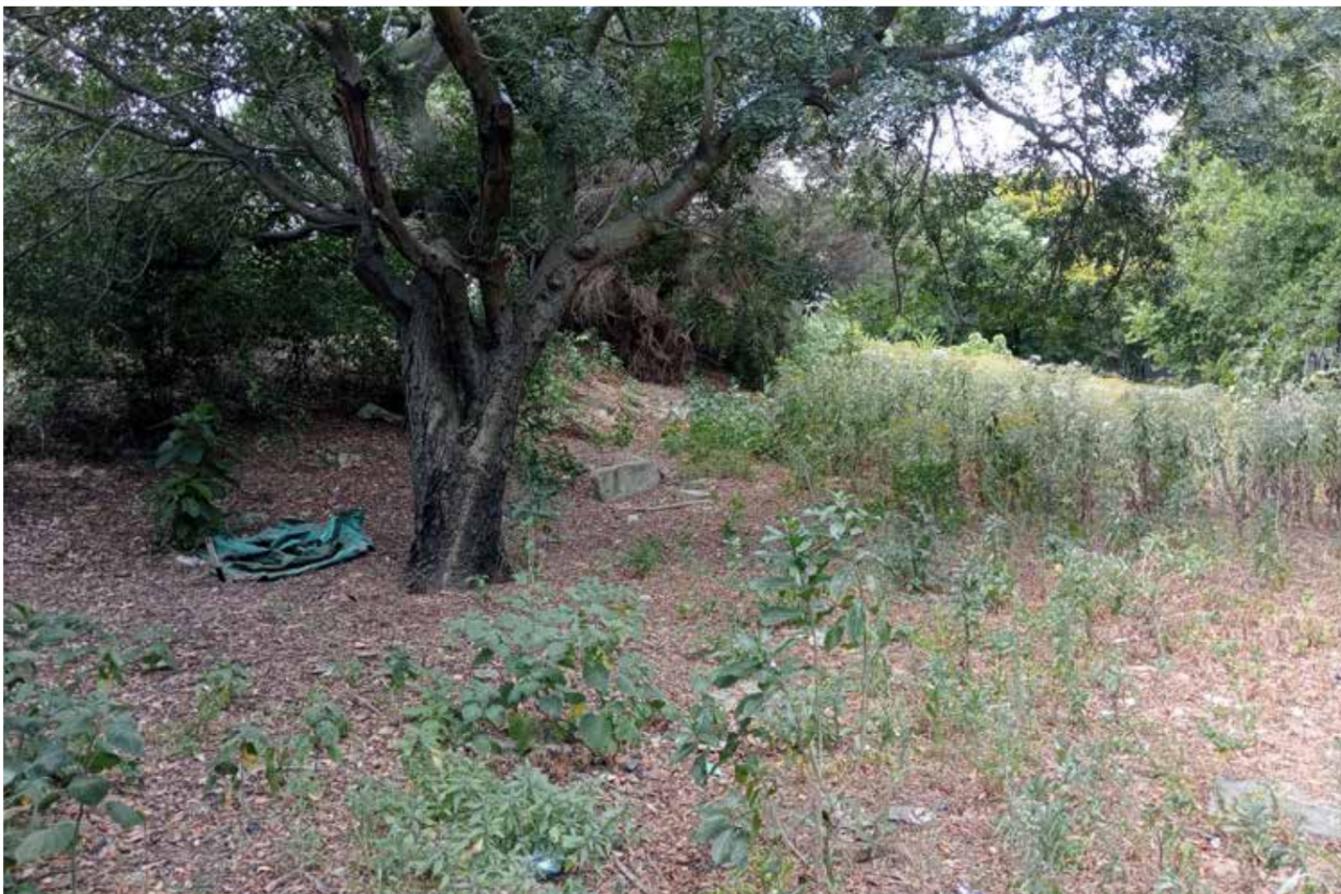
Figure 40. Military Hospital site; the embankment and building rubble would indicate the demolition rubble remain in situ (RSA, 2023)

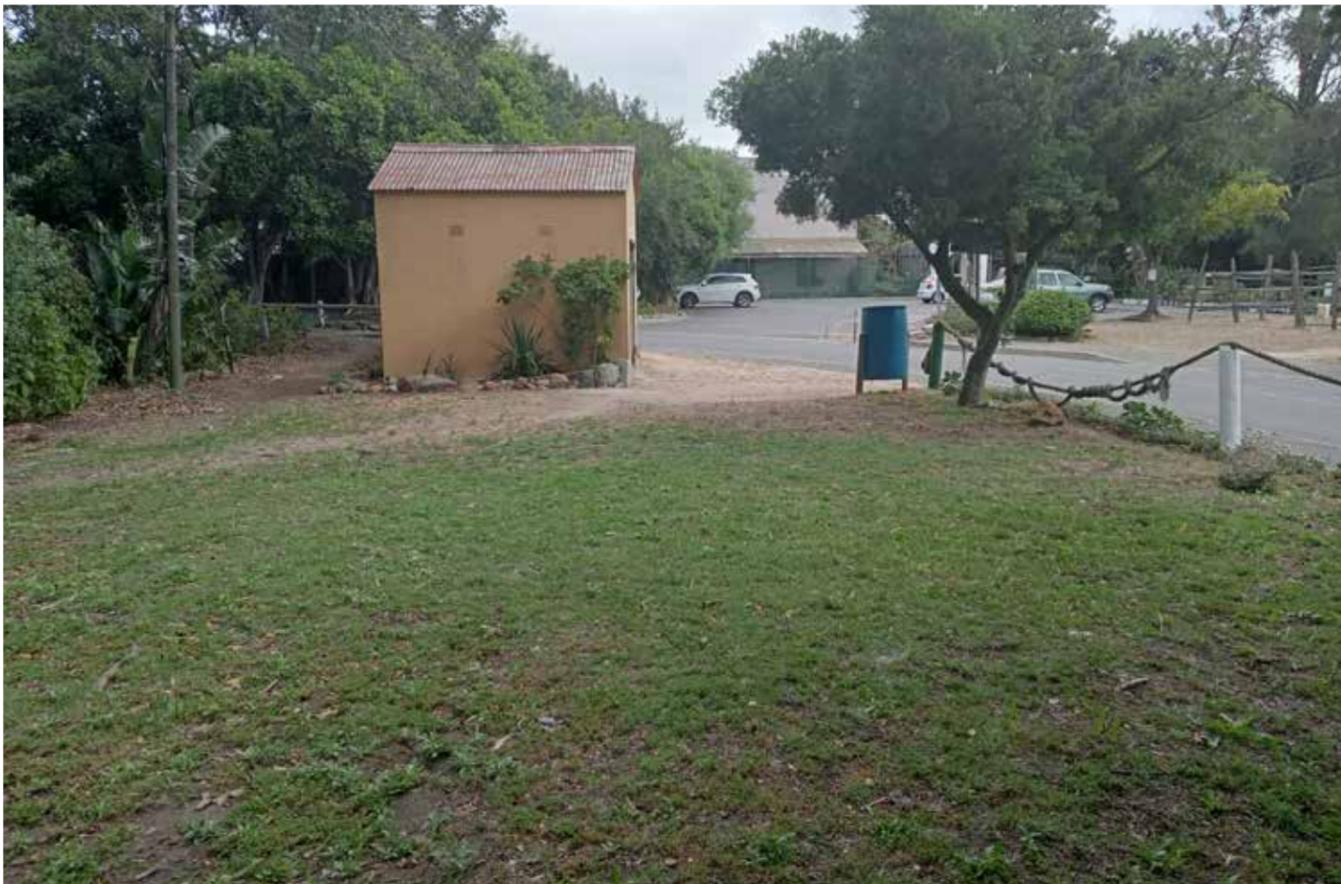
Figure 41. The area north of the mill house where a structure is indicated in the Smyth plan of 1806; cf. Figure 21 (RSA, 2023)

- Figure 40. Military Hospital site; the embankment and building rubble would indicate the demolition rubble remain in situ (RSA, 2023)
- Figure 41. The area north of the mill house where a structure is indicated in the Smyth plan of 1806; cf. Figure 21 (RSA, 2023)
