ARCHAEOLOGICAL IMPACT ASSESSMENT OUDE MOLEN VILLAGE, ERF 26439-RE, CAPE TOWN

HWC REF: 21022615SB0330E

submitted in terms of Section 38(4) of the NHRA (1999) for
OUDE MOLEN PRECINCT, ERF 26439-RE,
ALEXANDER ROAD, PINELANDS, CAPE TOWN

FINAL AIA

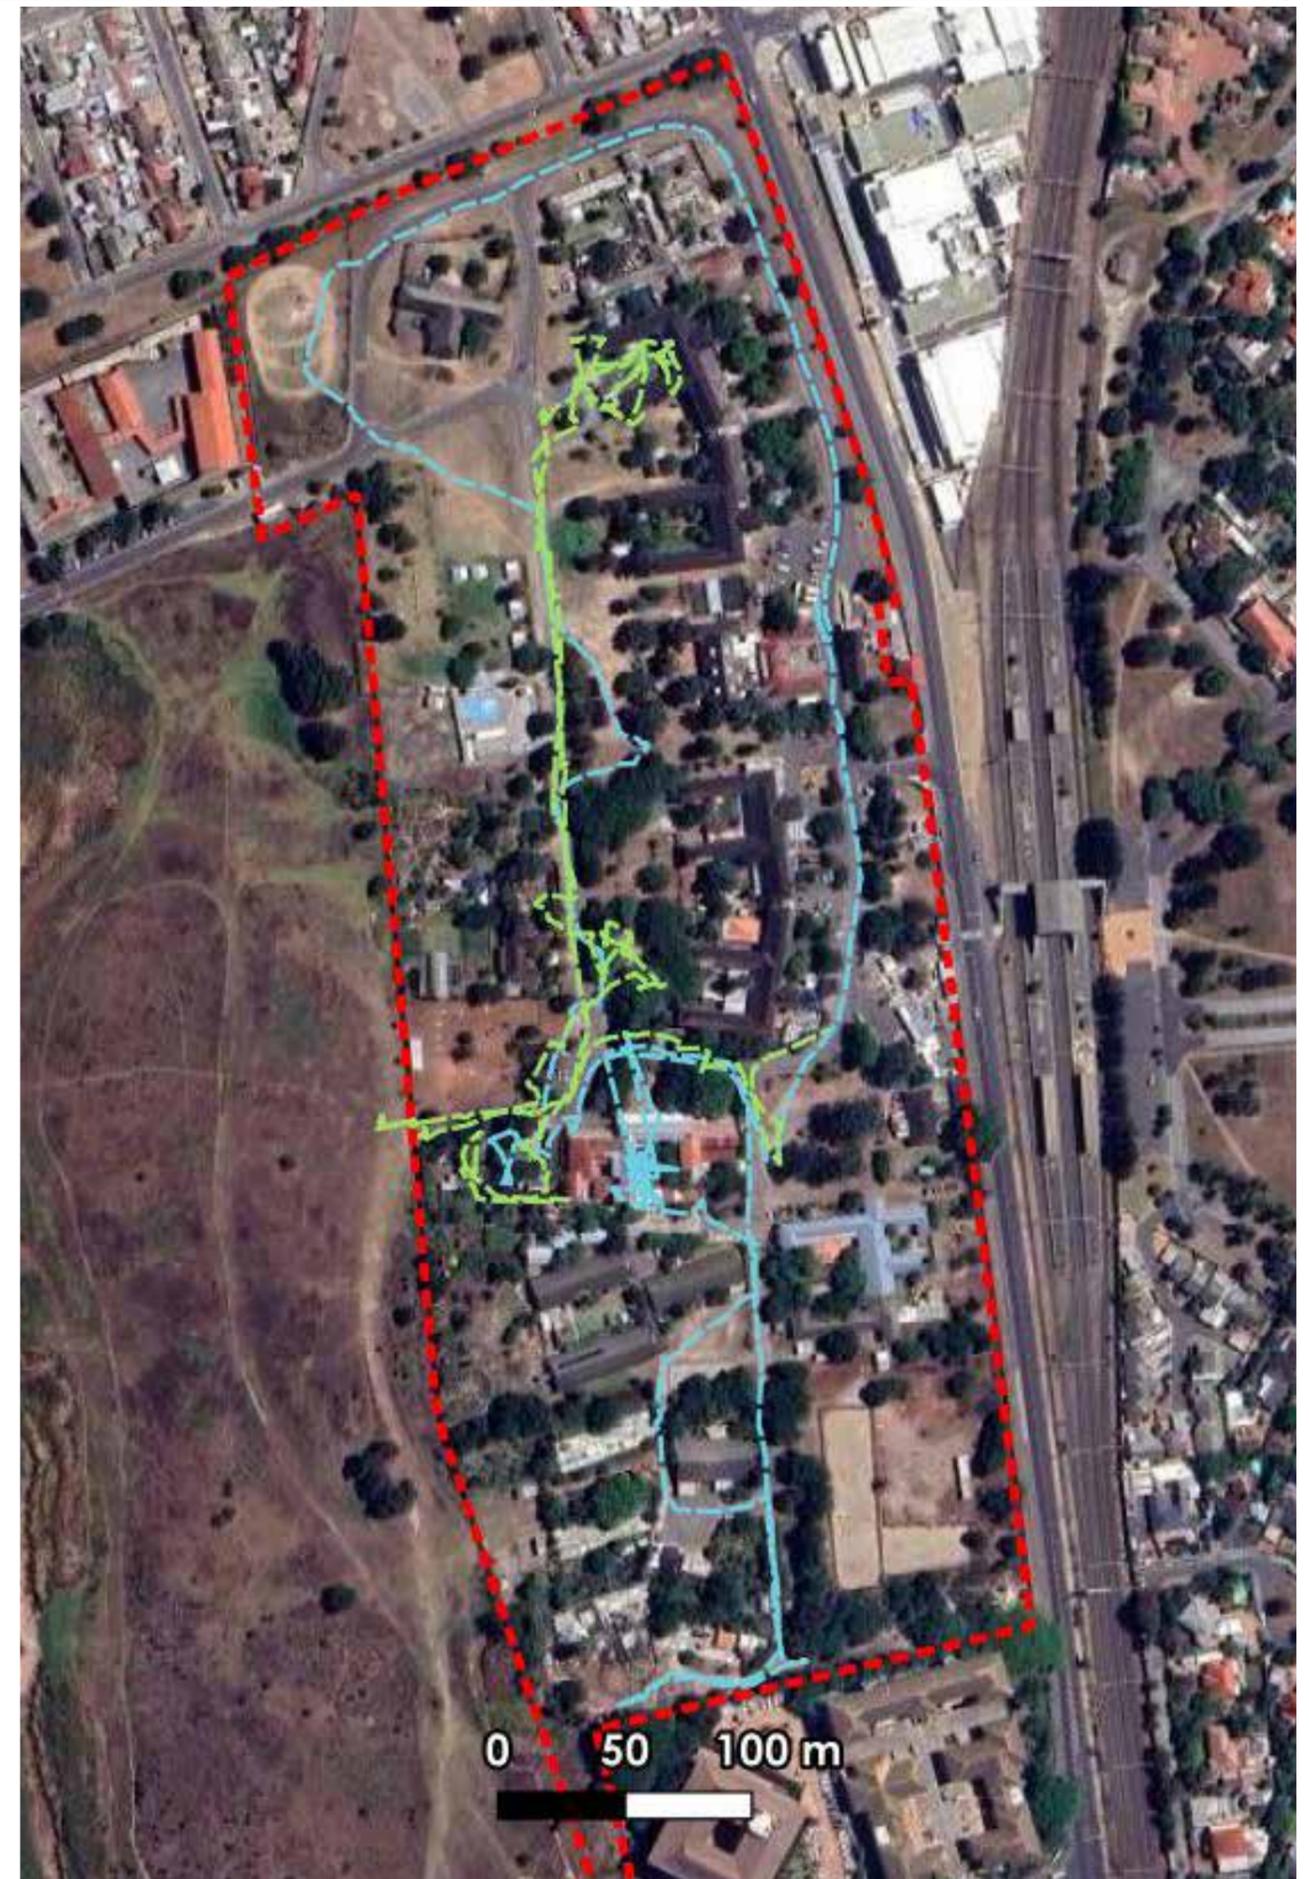
Figure 42. Trackways recorded on 1 Nov (green) and 28 Nov (blue) (RSA, 2023)

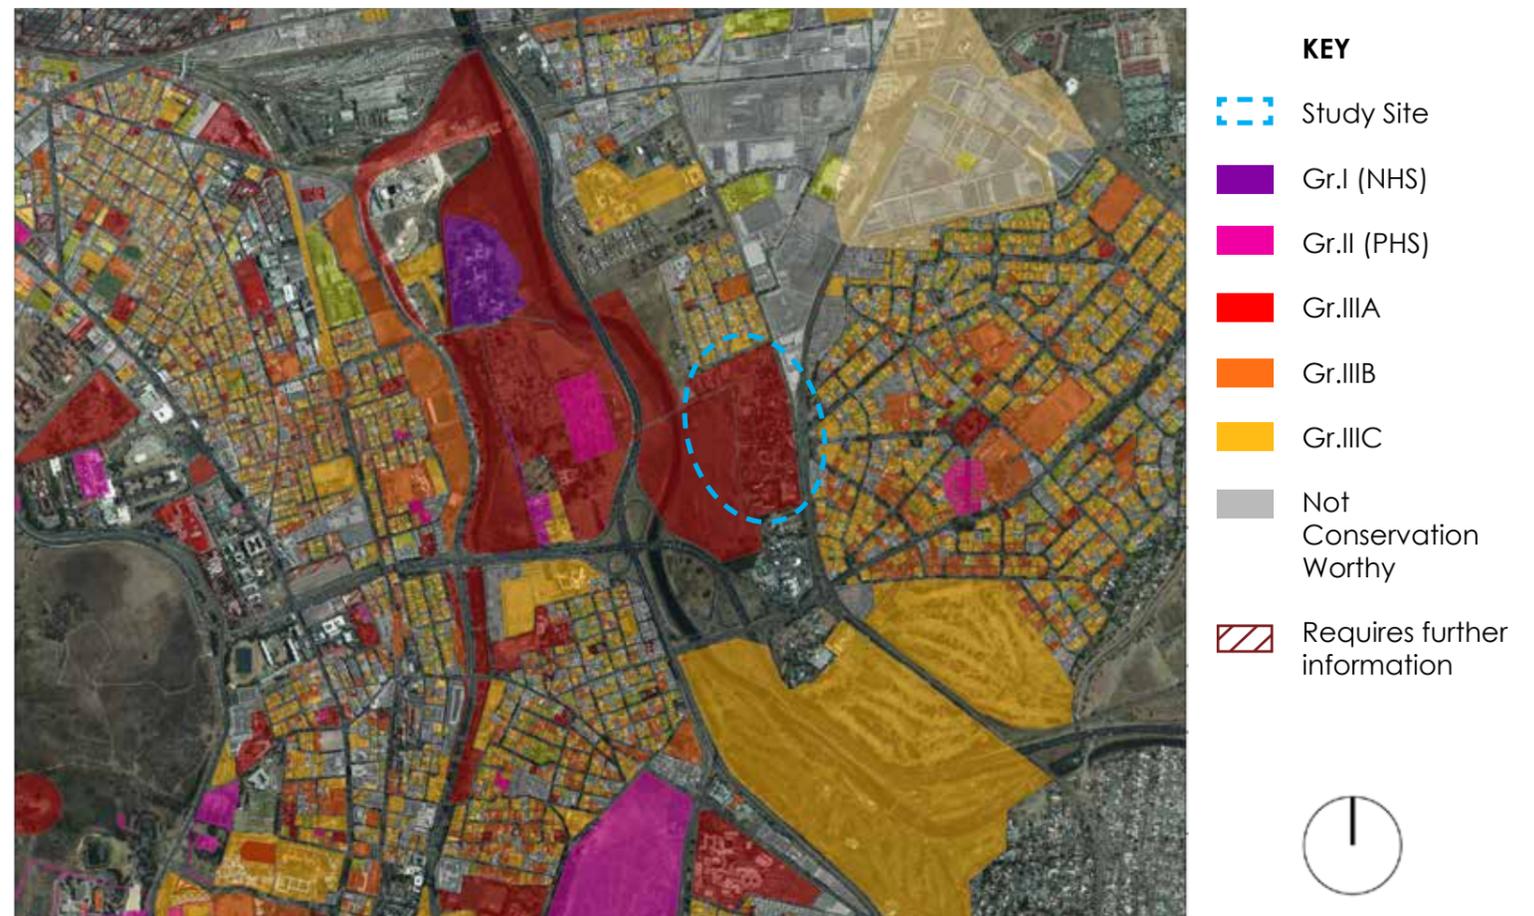
Figure 44. City of Cape Town Grading Map (top) and HPOZ map (below) (City EGSViewer, 2023).

The entire property is graded Grade IIIA, with the mill site and mill house/homestead, and the hospital precinct considered and graded separately (Figure 44). These gradings relate to the significance of the built fabric and cultural landscape, rather than archaeological grading. The exception to this is the mill structure as a component of the mill and farmhouse complex, which is necessarily an archaeological feature.

- Figure 42. Trackways recorded on 1 Nov (green) and 28 Nov (blue) (RSA, 2023)
- Figure 43. City of Cape Town HPOZ map (City EGSViewer, 2023).
- Figure 44. City of Cape Town Grading Map (top) and HPOZ map (below) (City EGSViewer, 2023).

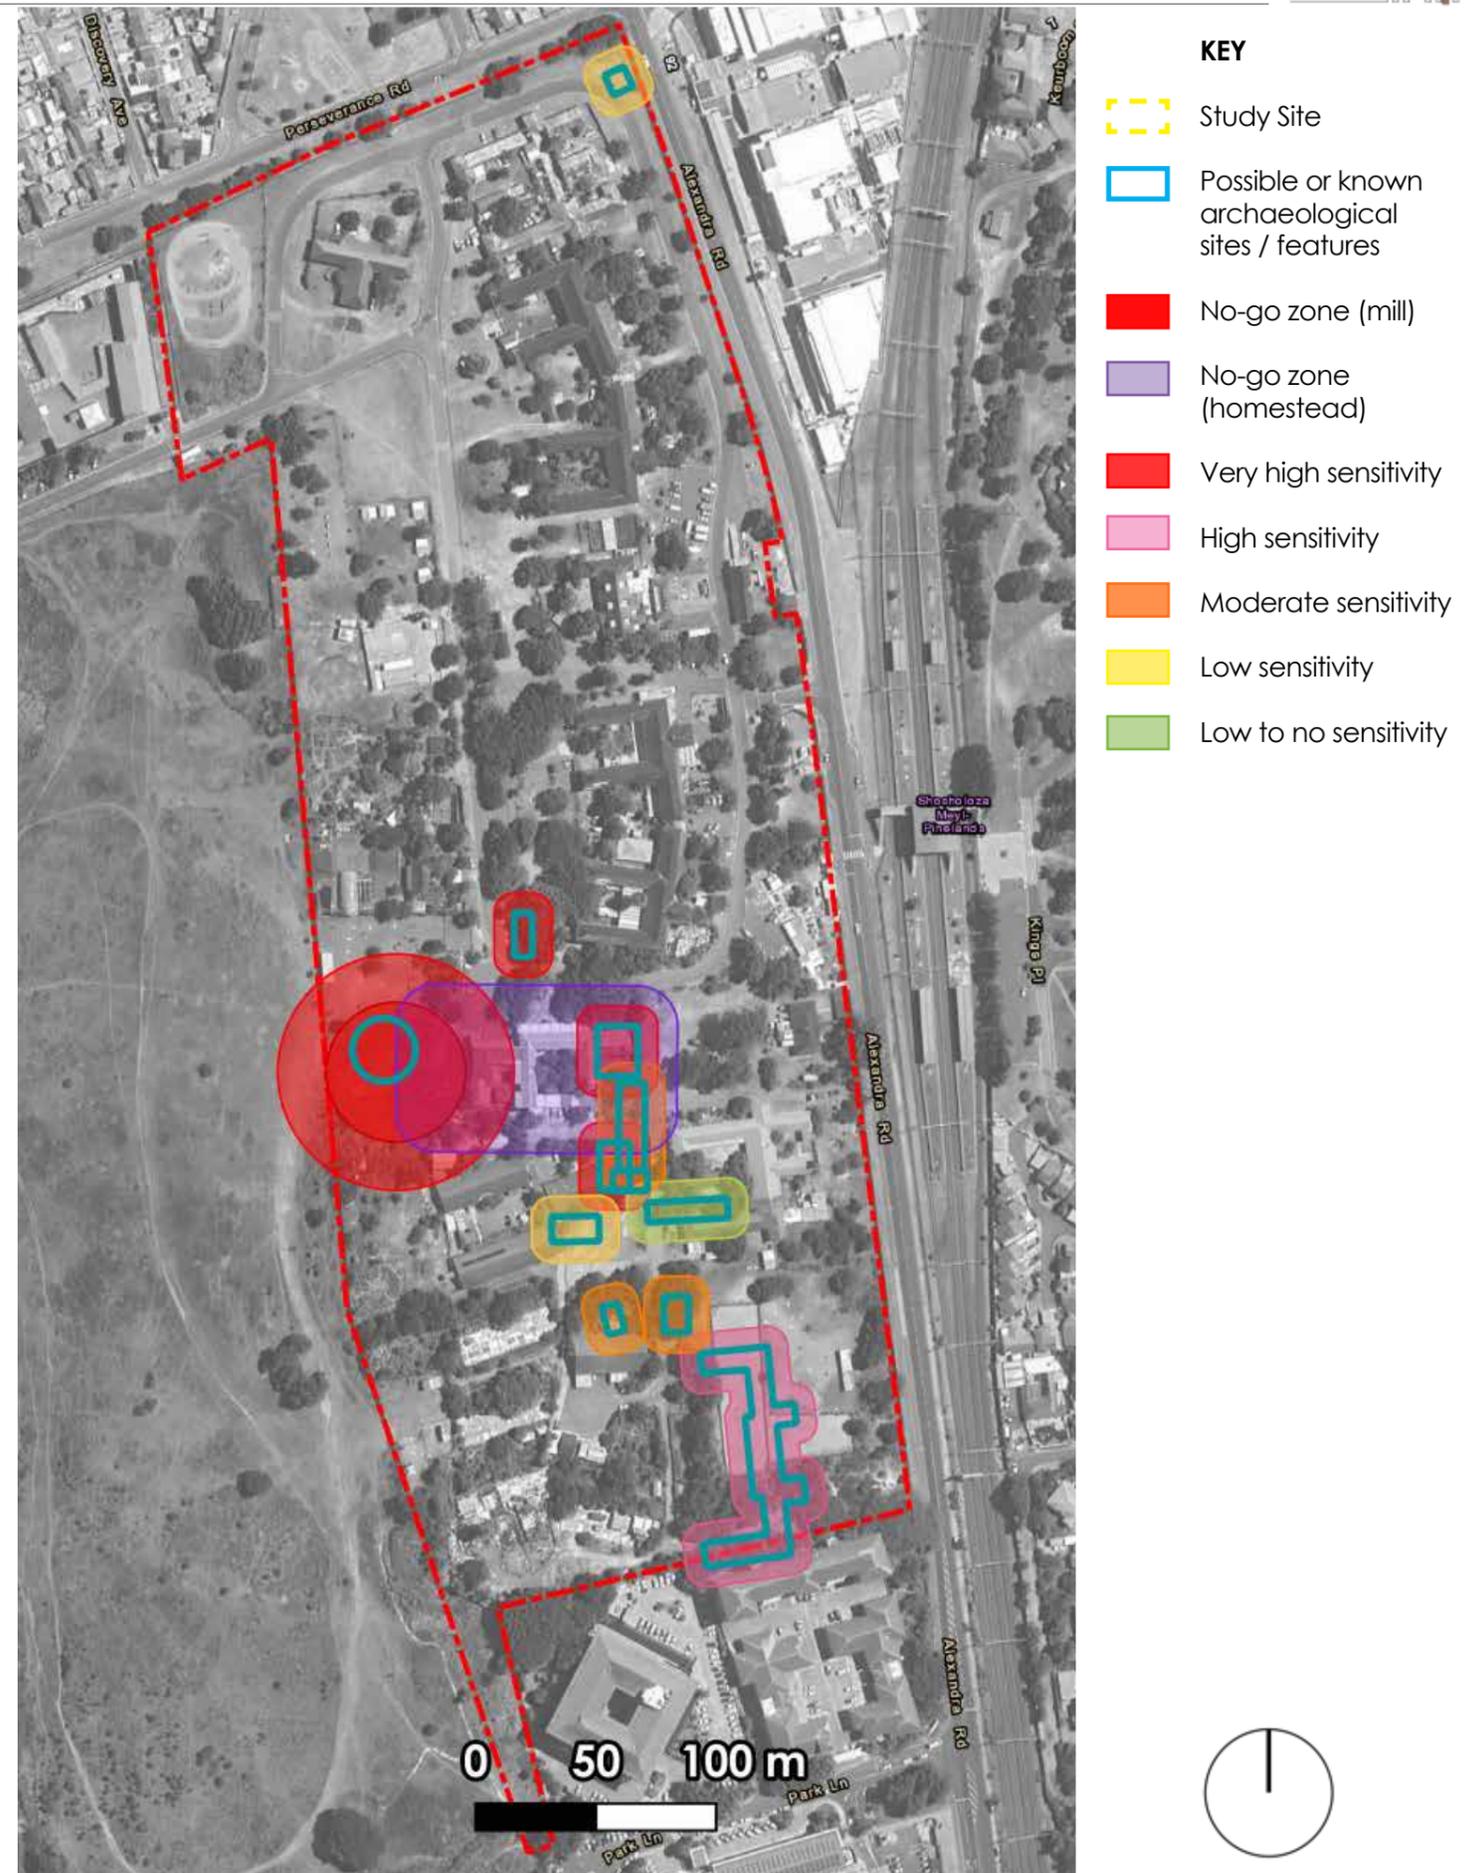
Figure 45. Overview of archaeological sensitivity of known or anticipated archaeological sites or features (RSA, 2023)

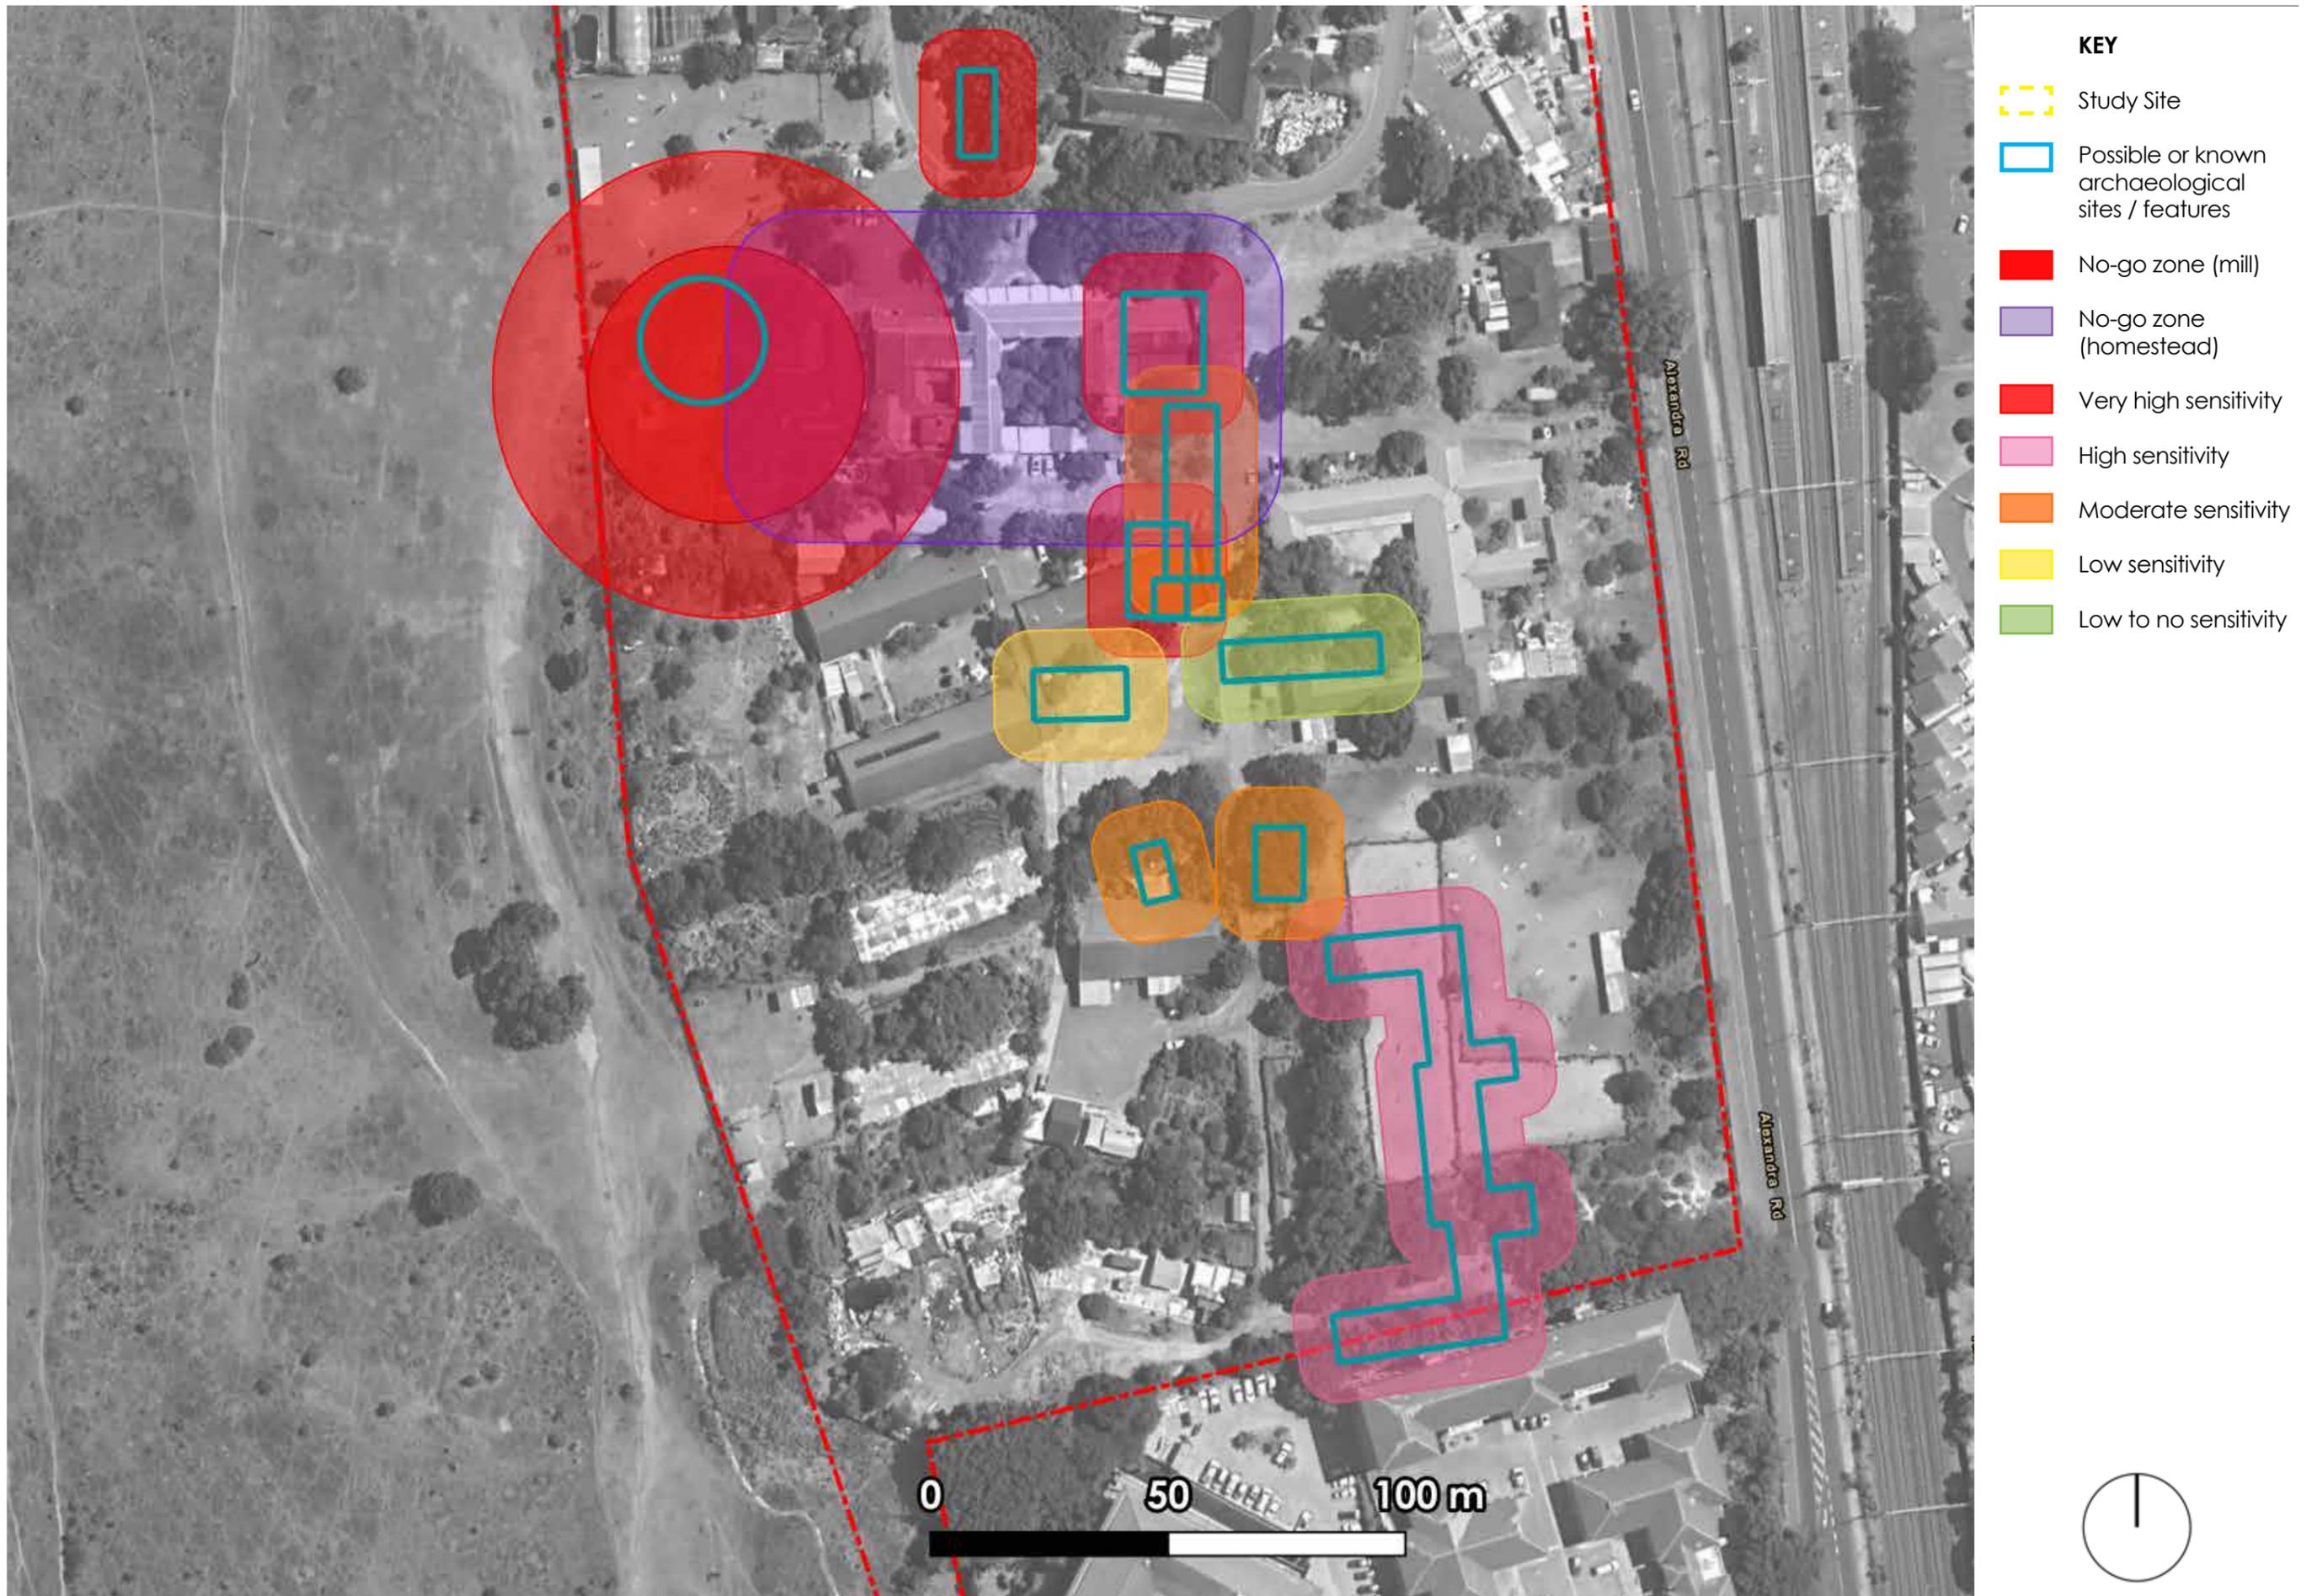
Figure 46. Detail of archaeological sensitivity mapping in the core historic precinct (RSA, 2023)

A general no-go buffer is advised for 20m in all directions from the homestead which should not be subject to redevelopment, or any construction activity in proximity to it until a plan for its repair, rebuilding and preservation has been fully explored, permitted and implemented.

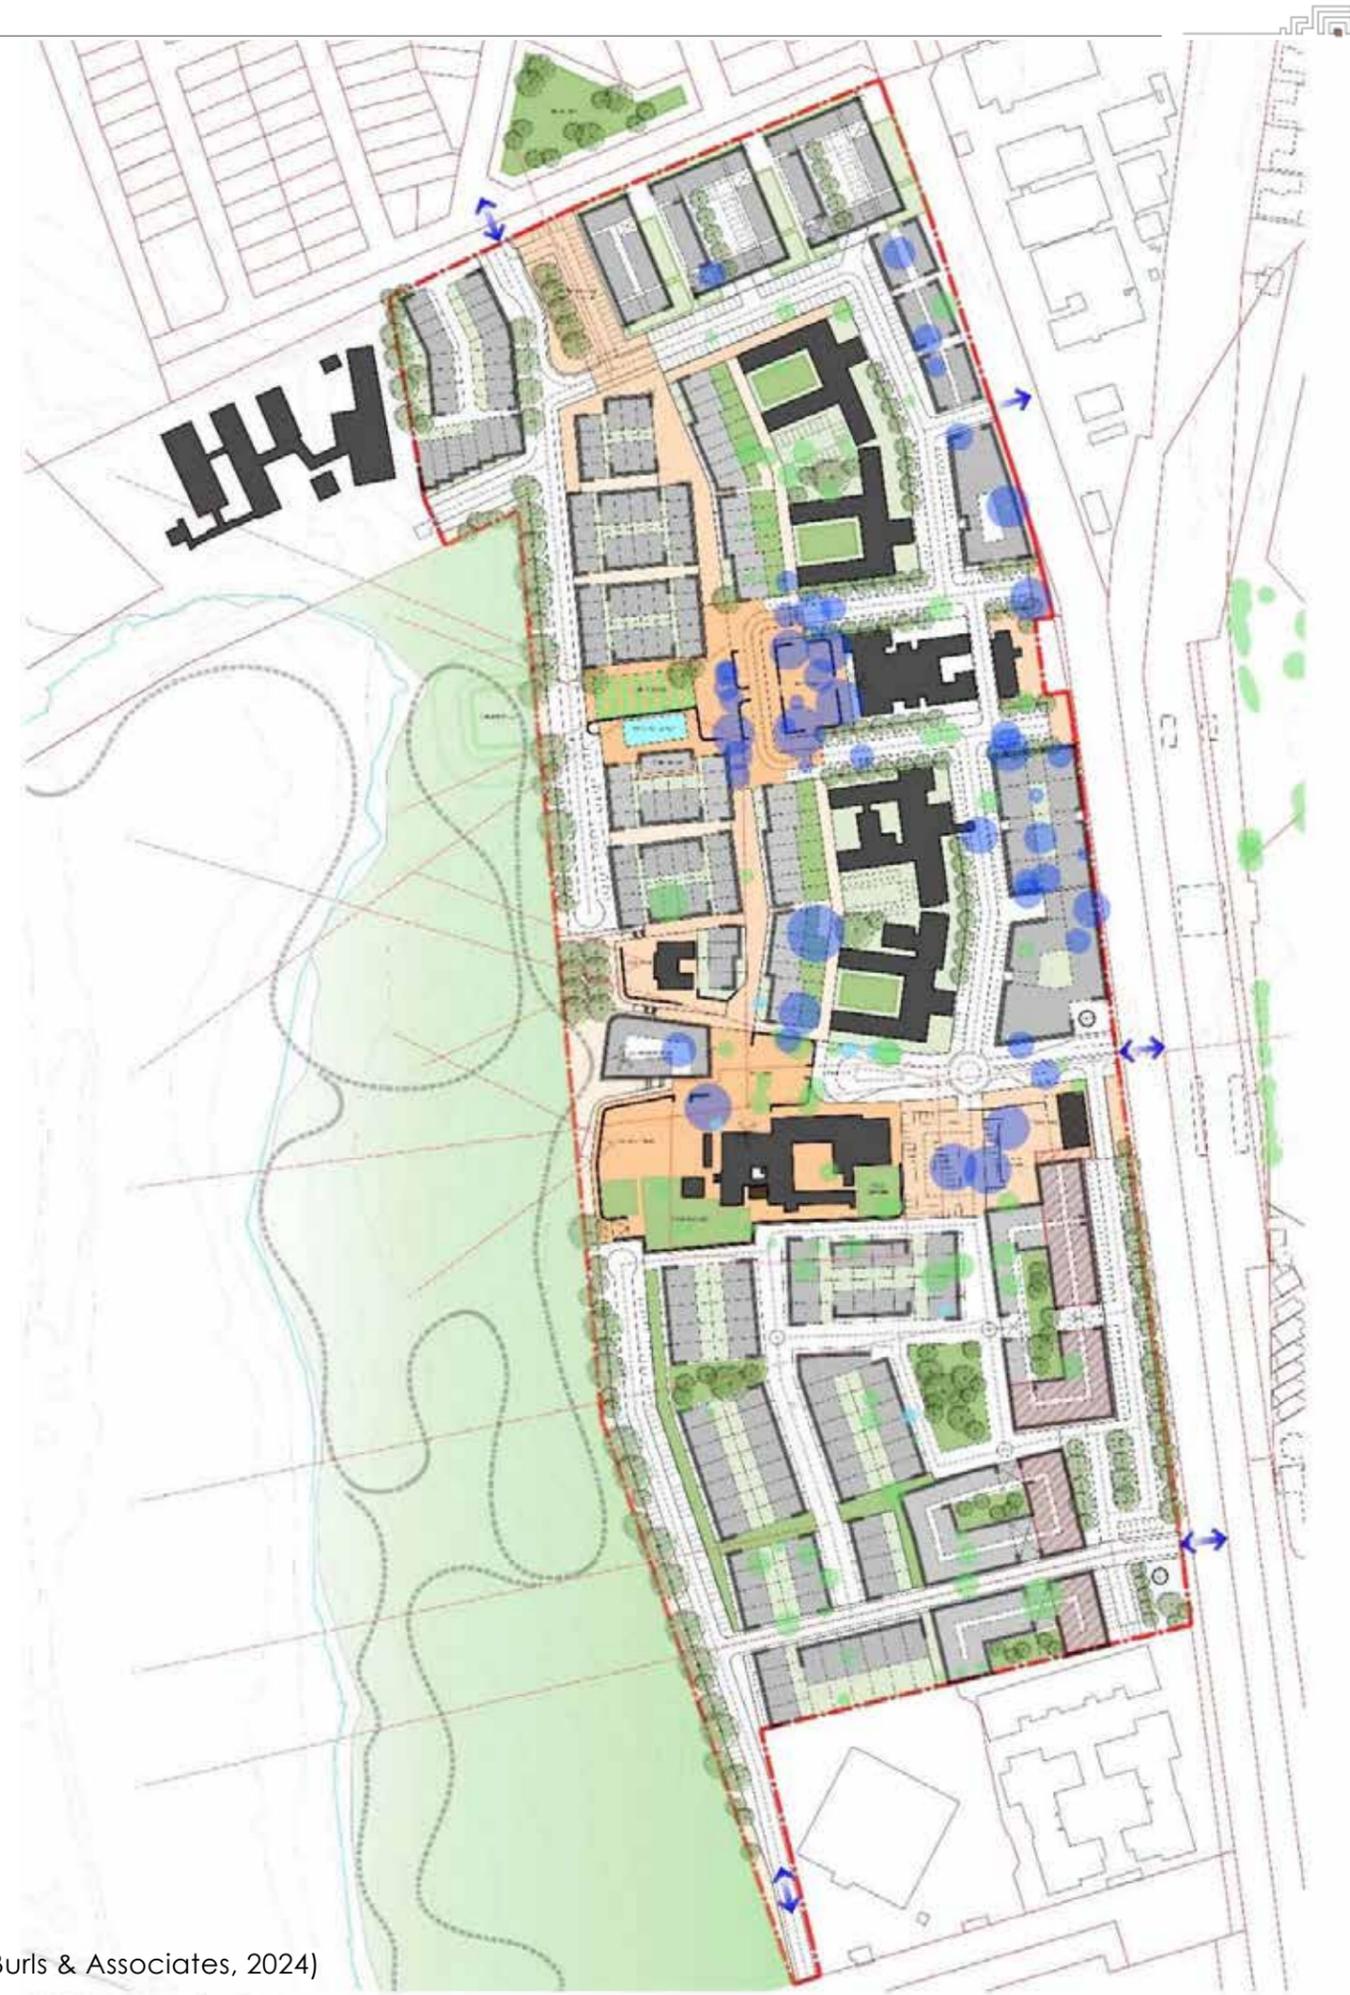
Figure 47. Concept Precinct Plan (Nigel Burls & Associates, 2024)

This submission pertains to a high level Precinct Plan for further detailing at SDP and later stages; as such, no finalised plans are under consideration. The concept precinct plan as put forward, however, can be evaluated against the archaeological heritage indicators provided above.

- Figure 47. Concept Precinct Plan (Nigel Burls & Associates, 2024)
- Figure 48. Consolidated Plan (left) and Landscape Plan (right) (SVA International, 2024)

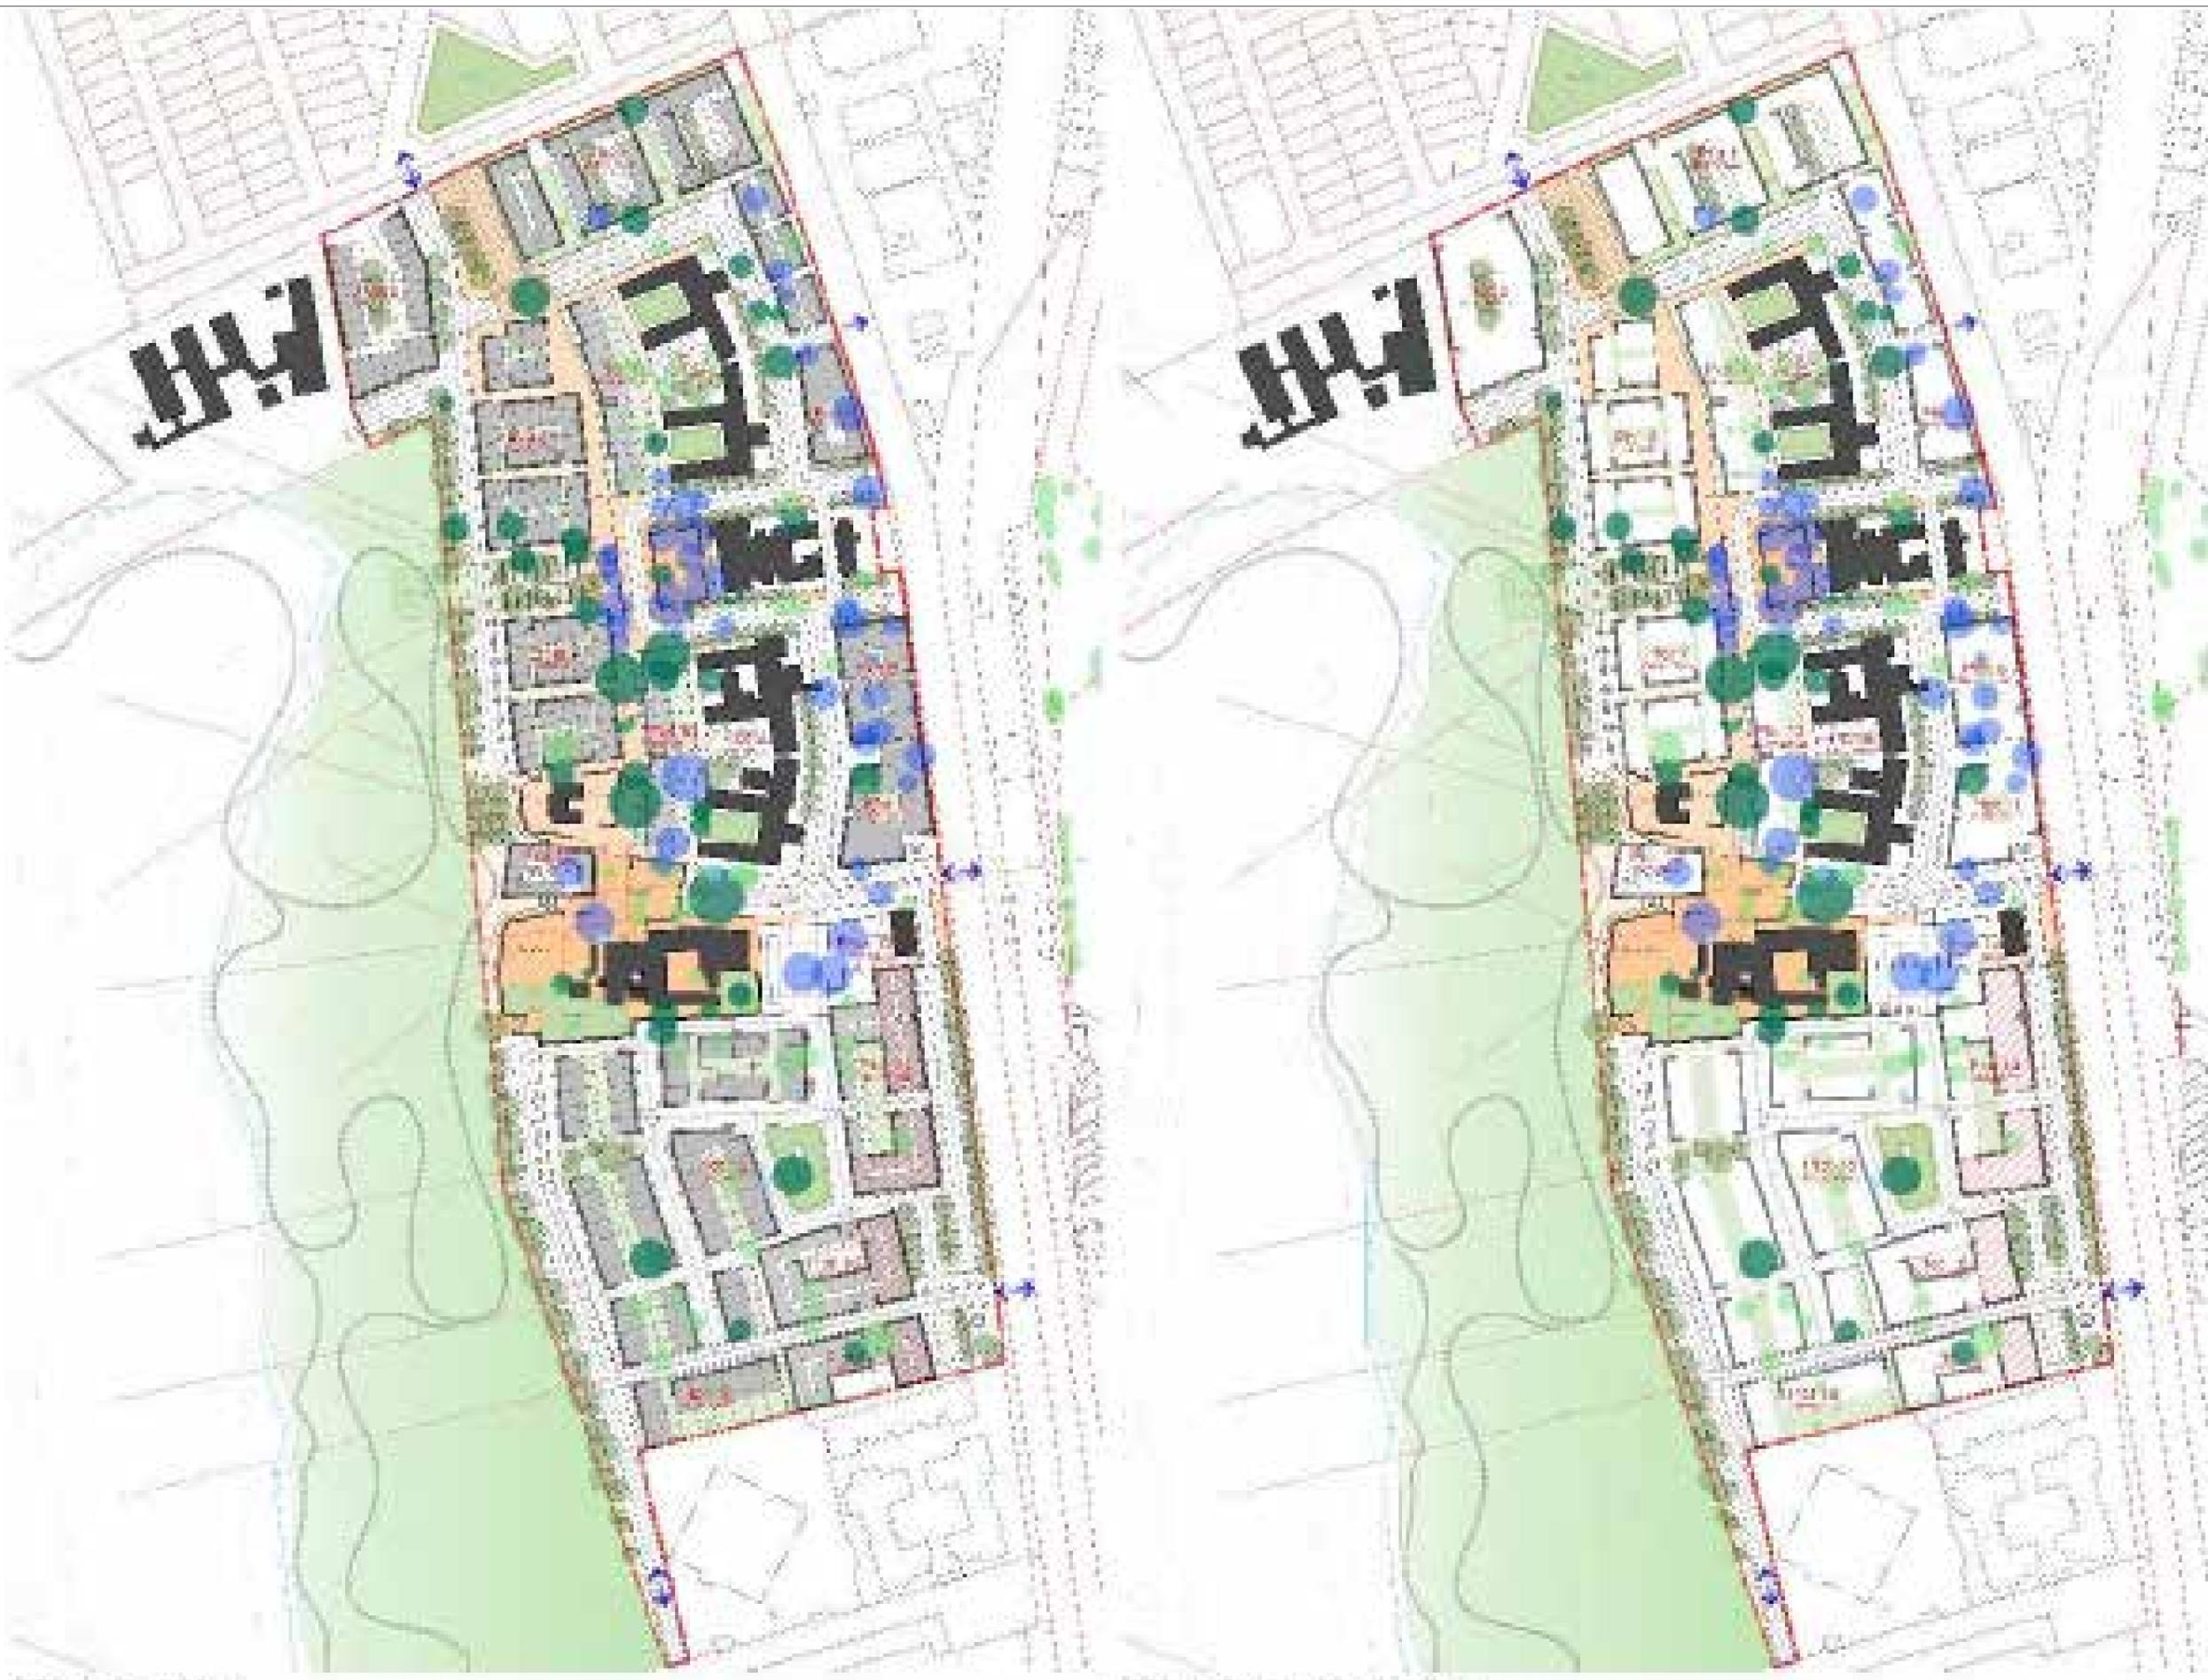
Figure 48. Consolidated Plan (left) and Landscape Plan (right) (SVA International, 2024)

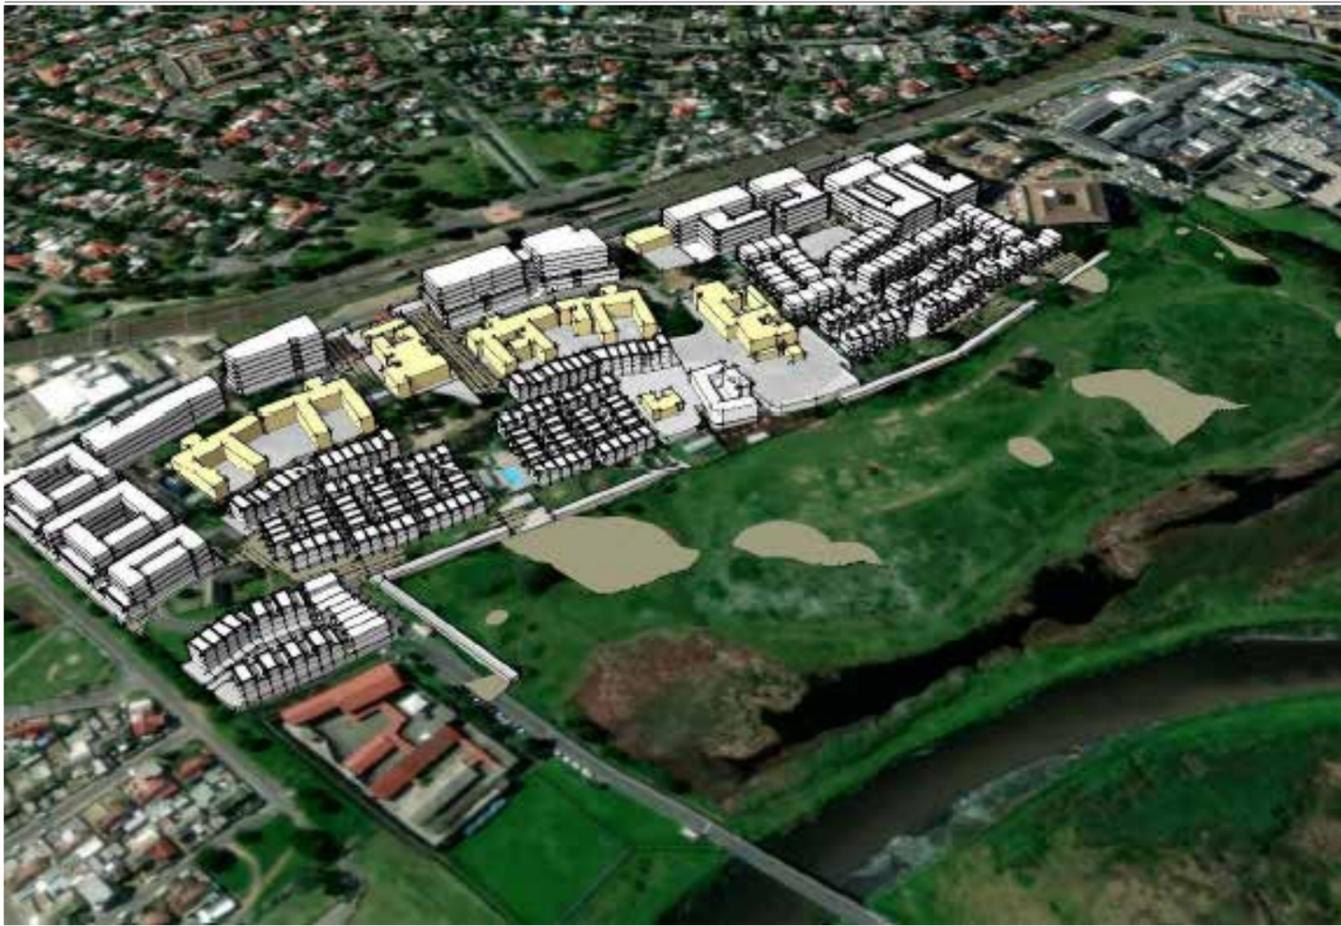
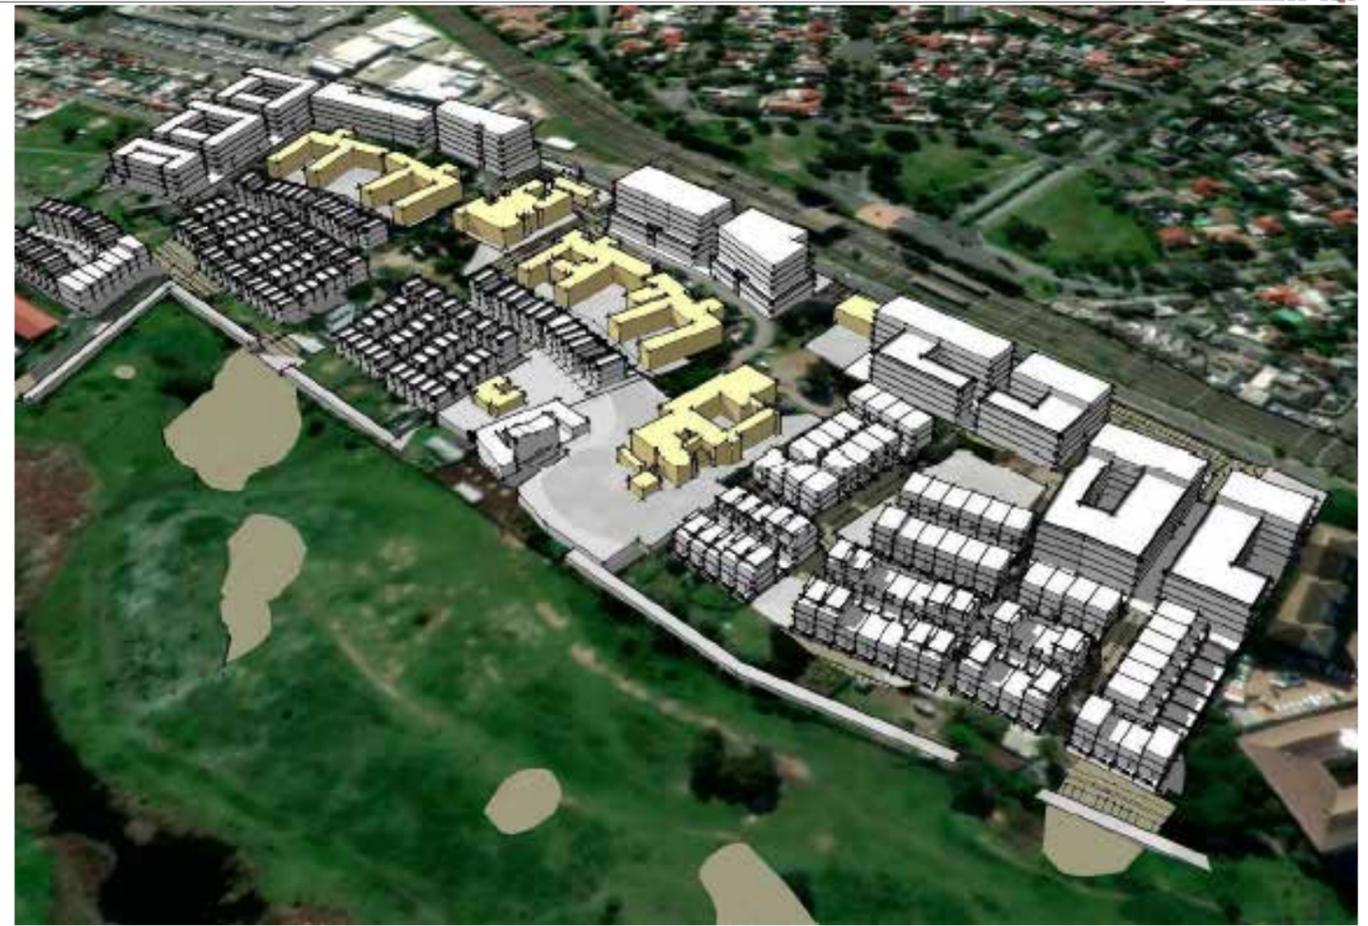
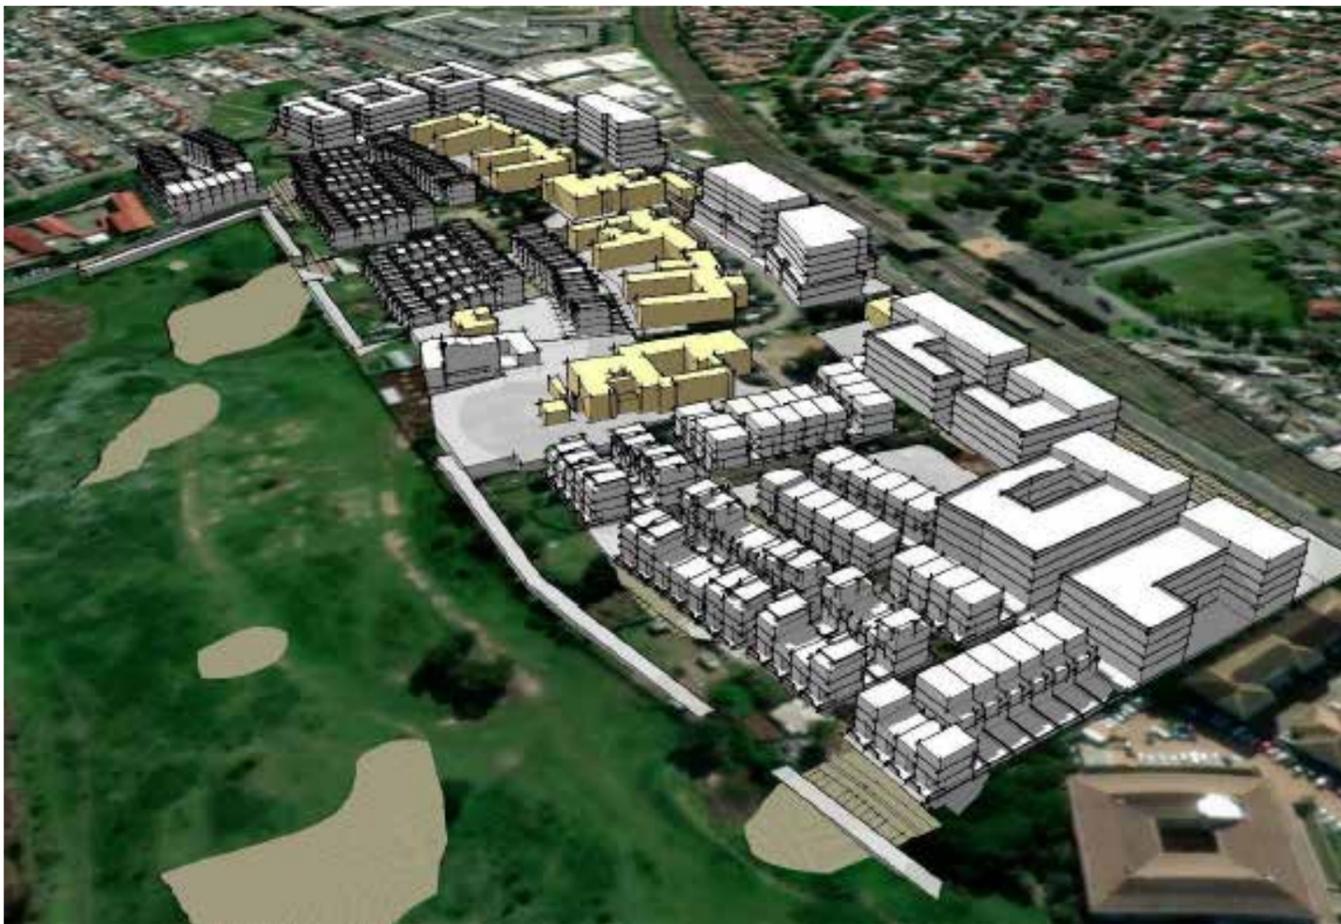
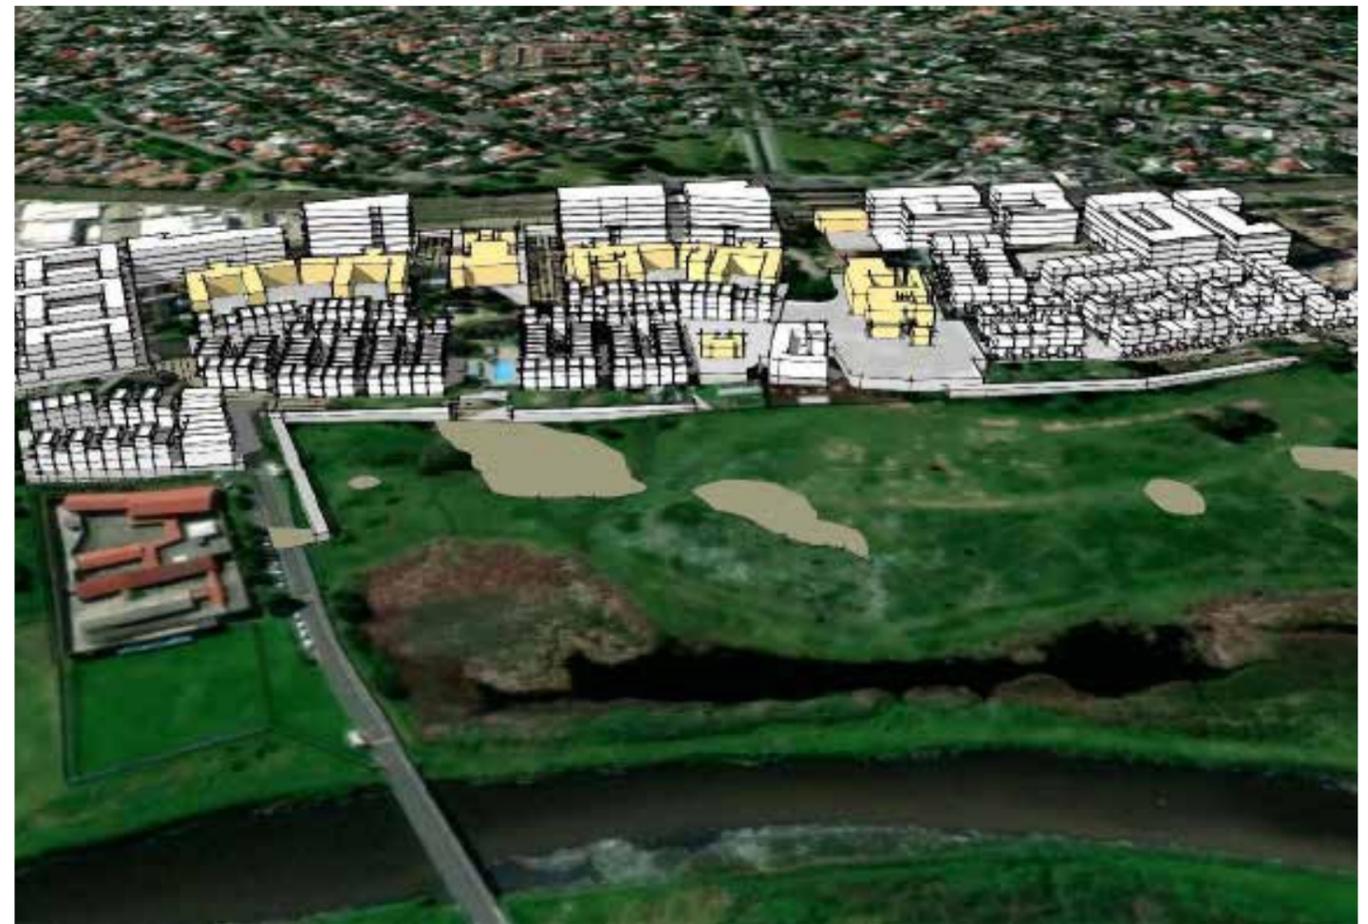
Figure 49. Concept Precinct Plan 3D massing views (Nigel Burls & Associates, 2024)

- Figure 49. Concept Precinct Plan 3D massing views (Nigel Burls & Associates, 2024)
- Figure 50. First Nation Heritage Nodes & Preferred OMP Alternative with FN Spatial Response (Nigel Burls & Associates, 2024)
