ARCHAEOLOGICAL IMPACT ASSESSMENT OUDE MOLEN VILLAGE, ERF 26439-RE, CAPE TOWN

HWC REF: 21022615SB0330E

submitted in terms of Section 38(4) of the NHRA (1999) for
OUDE MOLEN PRECINCT, ERF 26439-RE,
ALEXANDER ROAD, PINELANDS, CAPE TOWN

FINAL AIA

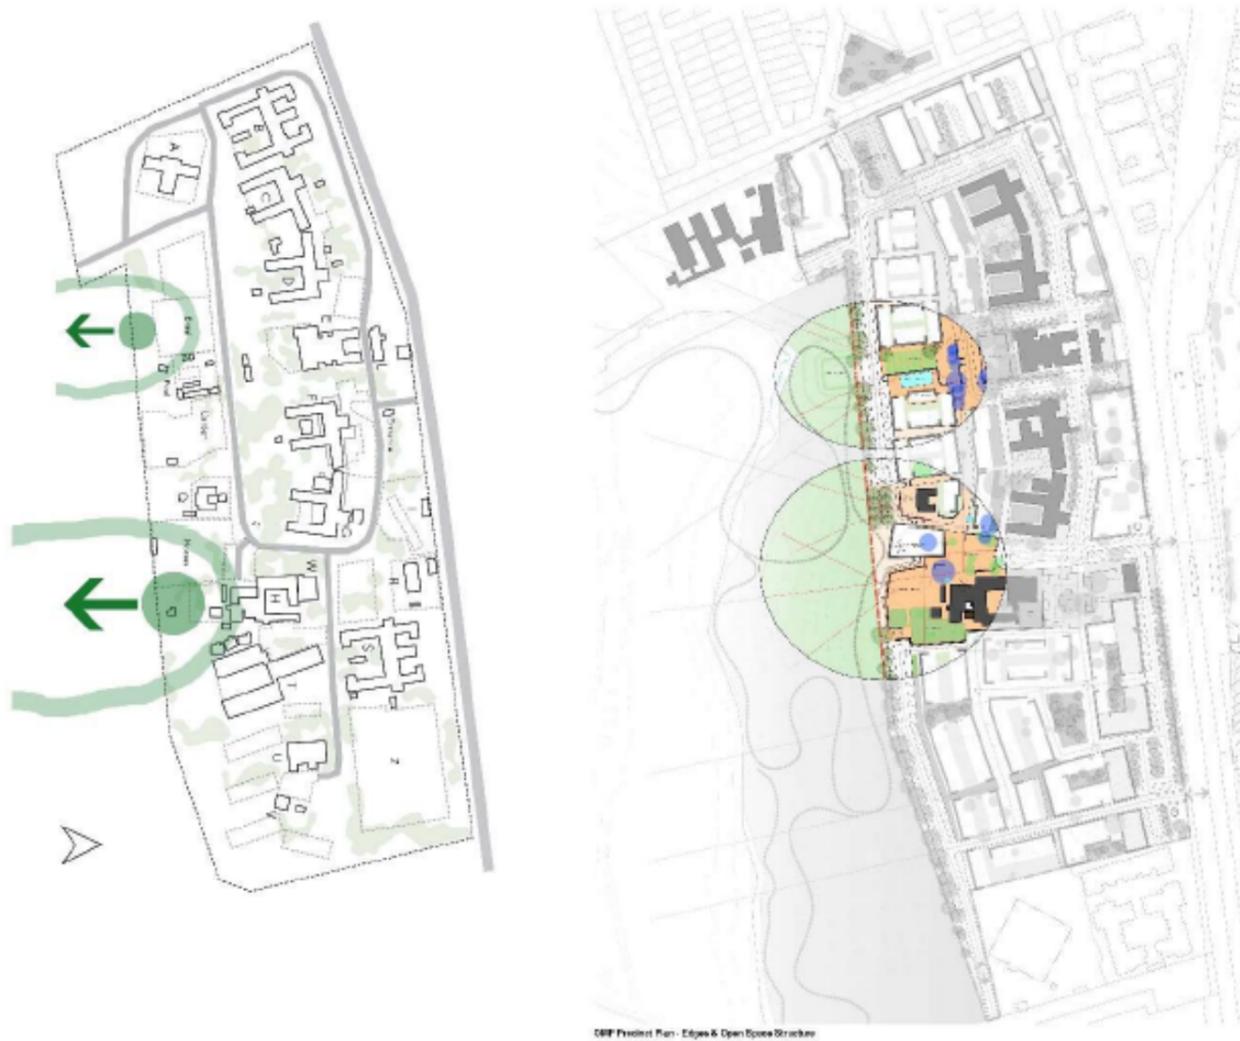
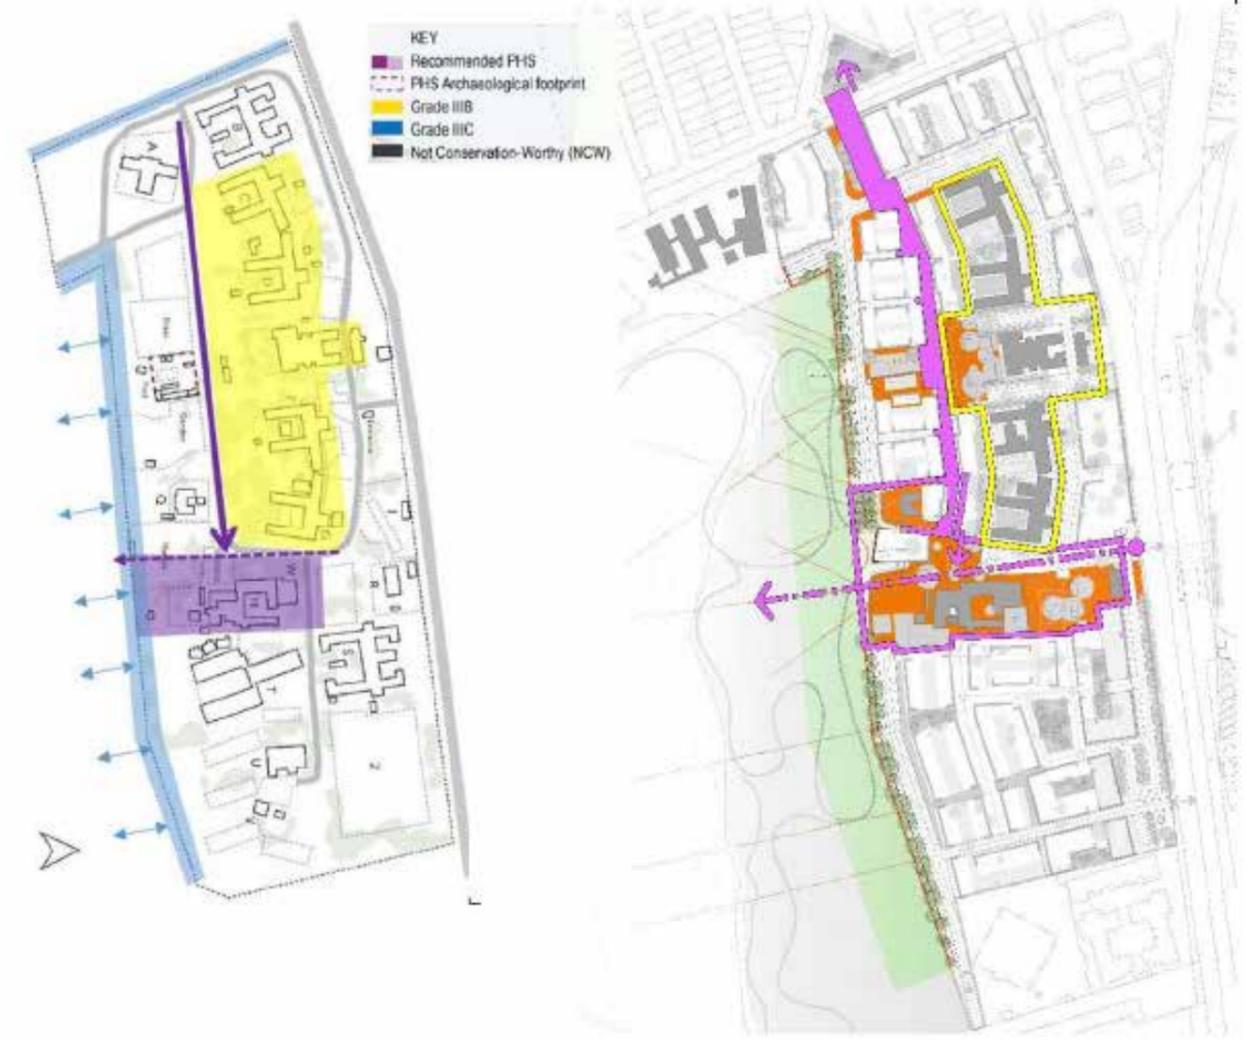
Using the same colour palette, the preferred alternative indicates how the design responds to the proposed heritage gradings in the OMP. The elements highlighted includes:

- The Homestead Complex and Surrounds
- The North-South Route
- The F-Ward Precinct

Figure 50. First Nation Heritage Nodes & Preferred OMP Alternative with FN Spatial Response (Nigel Burls & Associates, 2024)

Figure 51. Grading Map & Preferred OMP Alternative with Response Elements (Nigel Burls & Associates, 2024)

- Figure 49. Concept Precinct Plan 3D massing views (Nigel Burls & Associates, 2024)
- Figure 50. First Nation Heritage Nodes & Preferred OMP Alternative with FN Spatial Response (Nigel Burls & Associates, 2024)

- Figure 51. Grading Map & Preferred OMP Alternative with Response Elements (Nigel Burls & Associates, 2024)
- Figure 52. 'Tussen die Riviere" Resistance and Liberation Heritage Route (Nigel Burls & Associates, 2024)

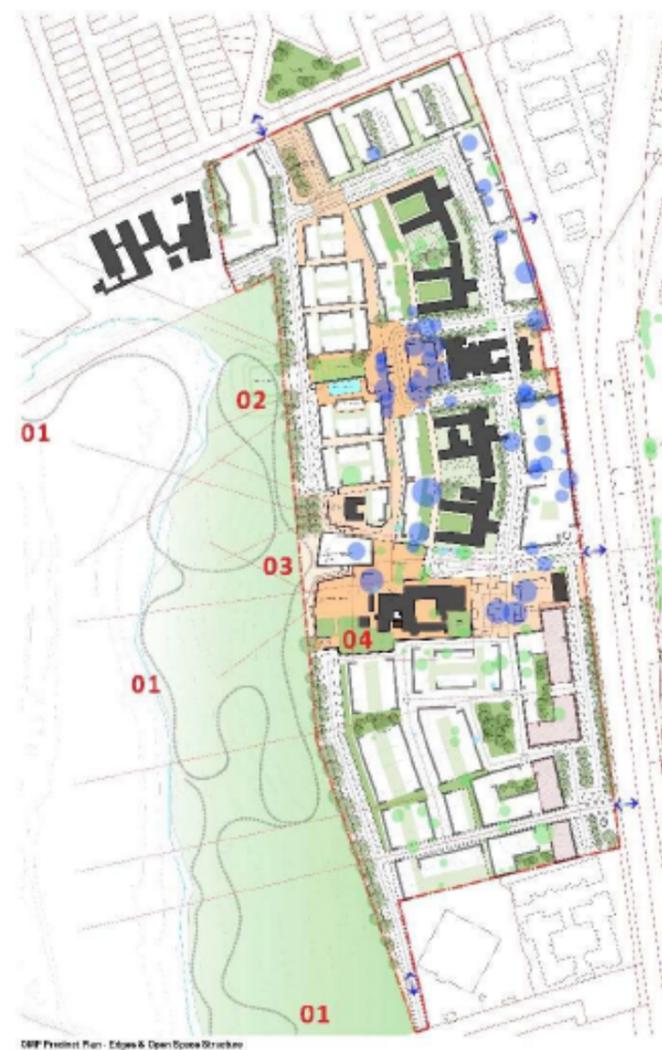
Legend - Tussen die Riviere RLHR

- 01 - Resistance and Liberation Heritage Route (RLHR)
- 02 - First Nation Event Area & Garden Amphitheatre
- 03 - Cultural Heritage & Media Centre
- 04 - Indigenous Garden / Food Garden

Figure 52. 'Tussen die Riviere' Resistance and Liberation Heritage Route (Nigel Burls & Associates, 2024)

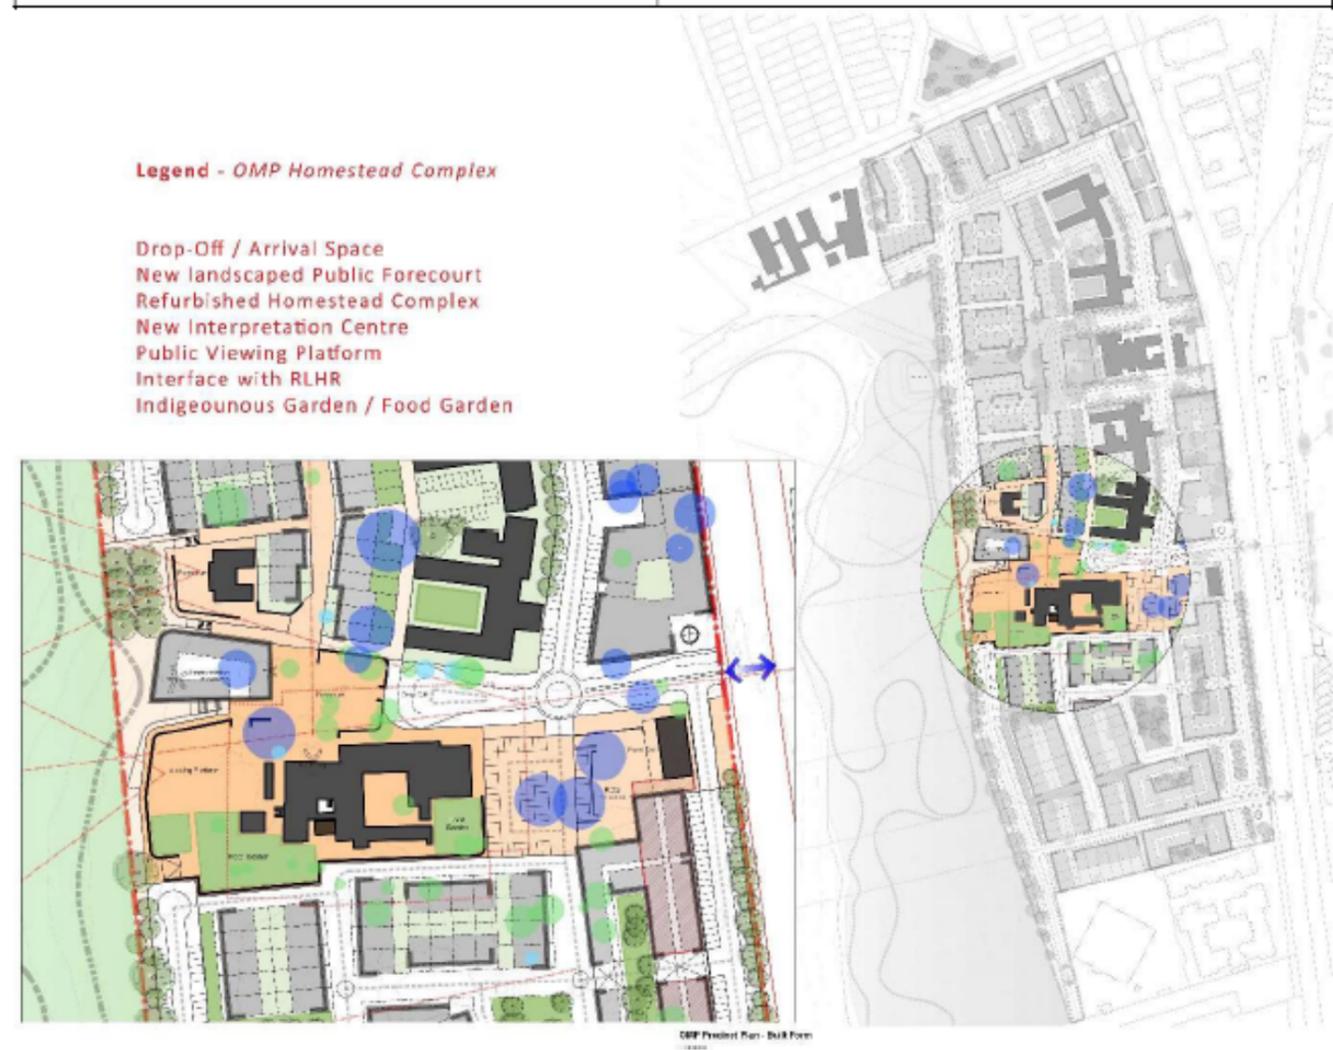
Legend - OMP Homestead Complex

- Drop-Off / Arrival Space
- New landscaped Public Forecourt
- Refurbished Homestead Complex
- New Interpretation Centre
- Public Viewing Platform
- Interface with RLHR
- Indigenous Garden / Food Garden

Figure 53. Homestead Complex and surrounds (Nigel Burls & Associates, 2024)

- Figure 53. Homestead Complex and surrounds (Nigel Burls & Associates, 2024)
- Figure 54. Sensitivity zones rendered as mitigatory strategies (RSA, 2023)

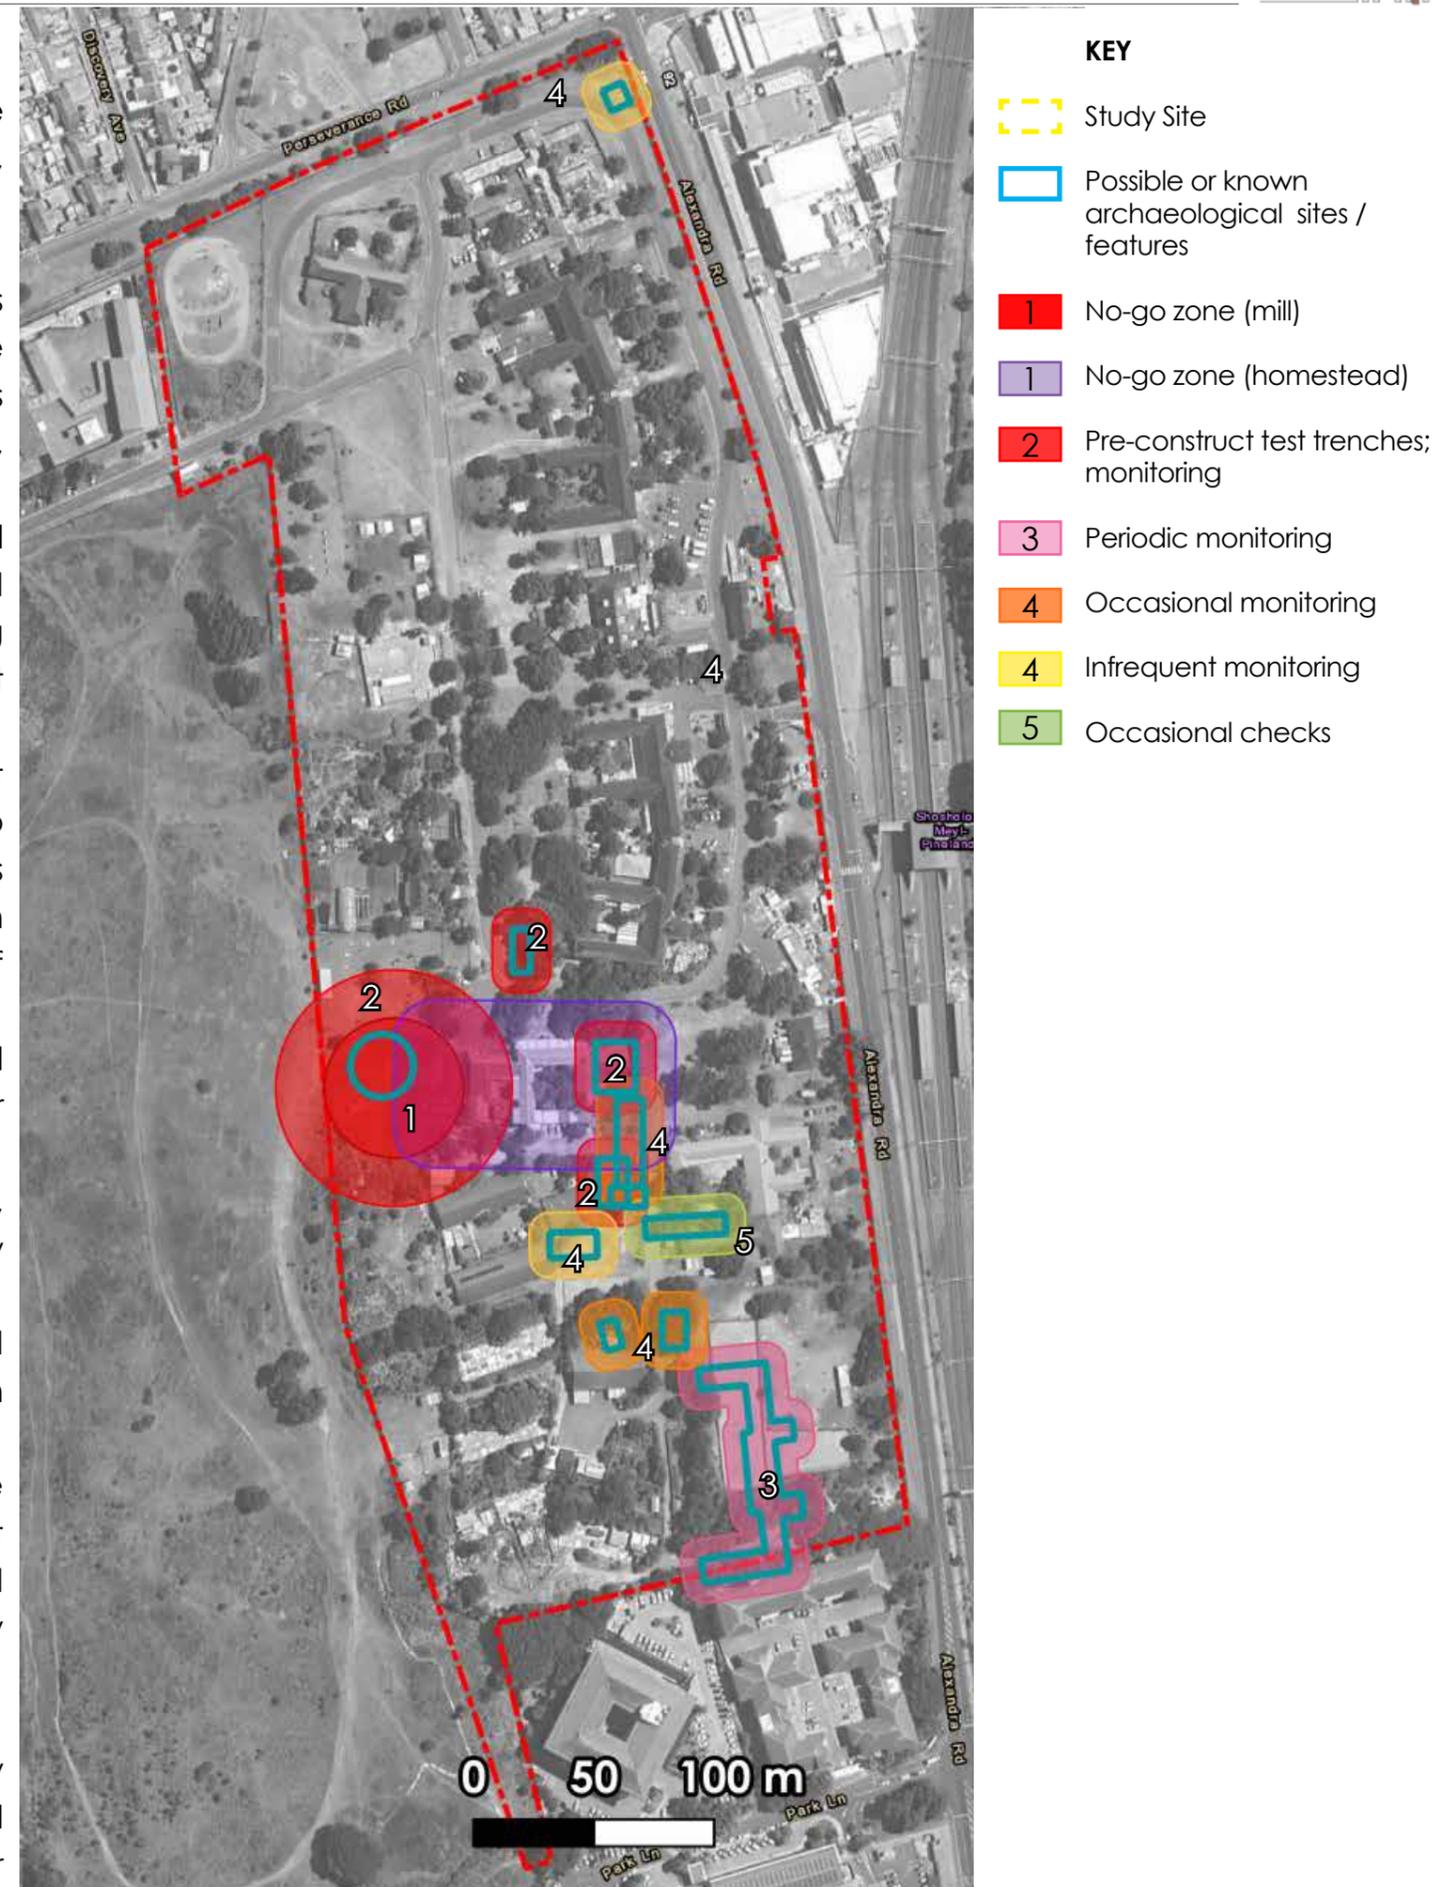
Figure 54. Sensitivity zones rendered as mitigatory strategies (RSA, 2023)

6. The NCW areas, together with all other areas of site can be considered for development, subject only to occasional inspection of foundation trenches and other earthworks.

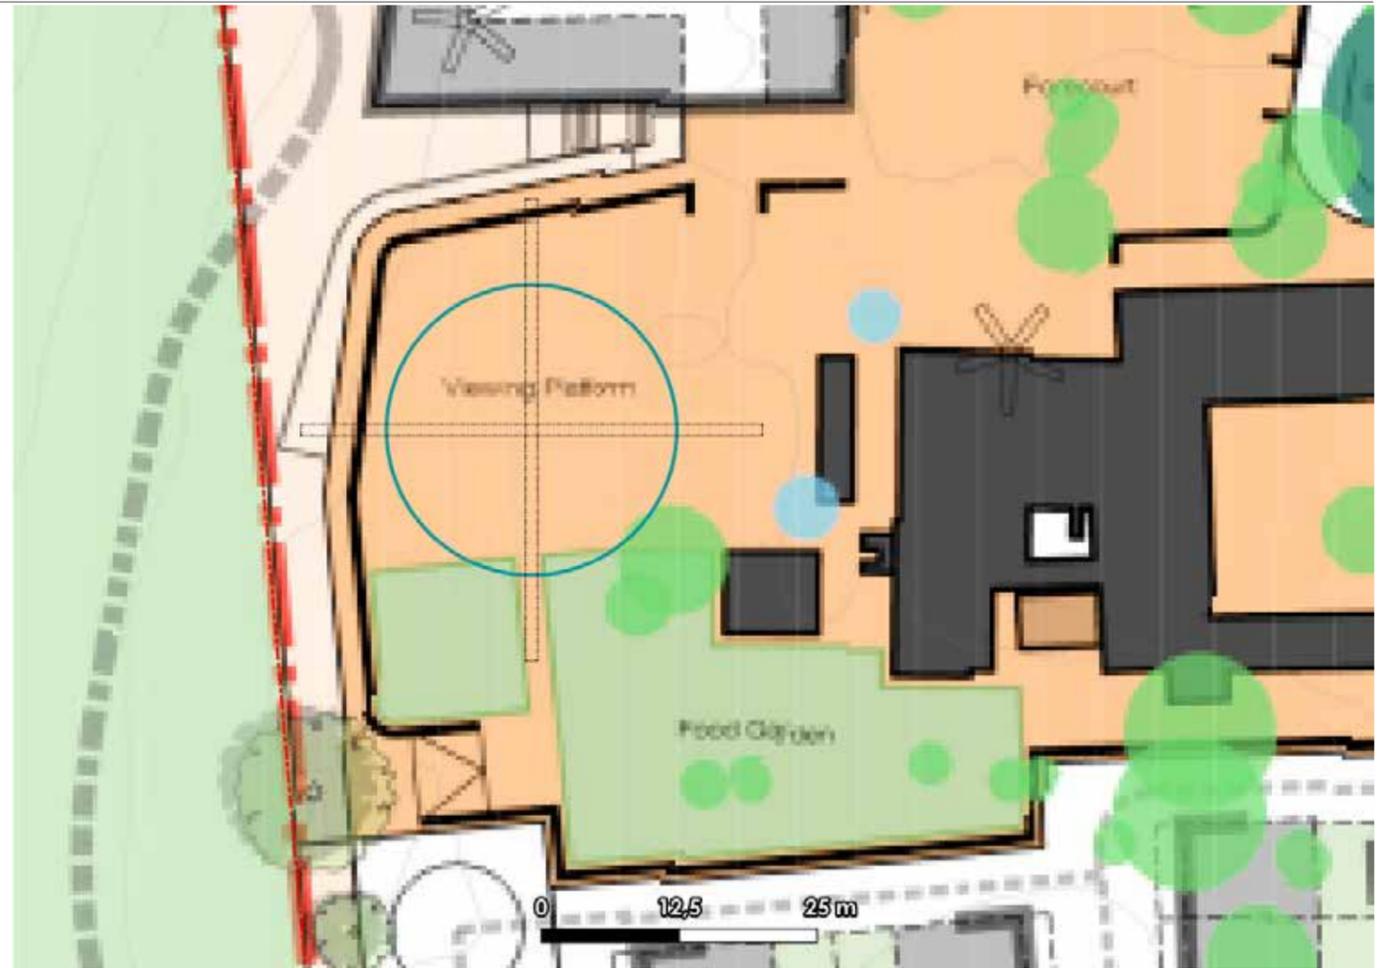
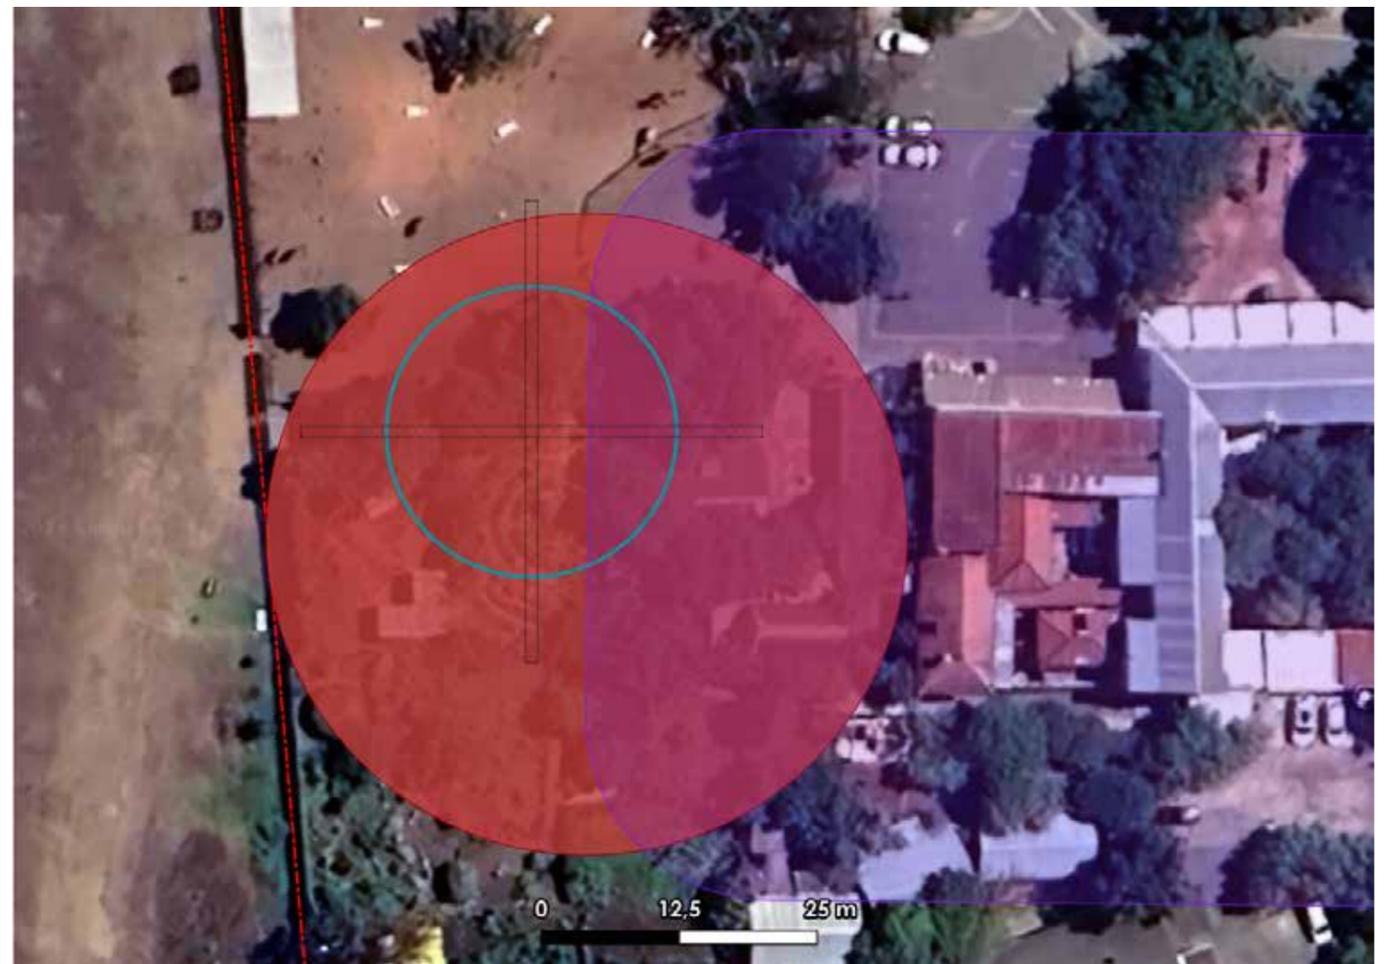
Figure 55. Proposed location and extent of intersecting test trenches within the mill area development no-go zone, overlaid on the Precinct Plan (top) and an aerial image of site (right) (RSA, 2024)

2. Preliminary test trenching is recommended within the area of the mill to ascertain whether structural remains, features and/or associated deposits persist, and to determine their location and extent. This testing should be done prior to the next phase of design development so that the results can inform the proposals for future use of that area of site;

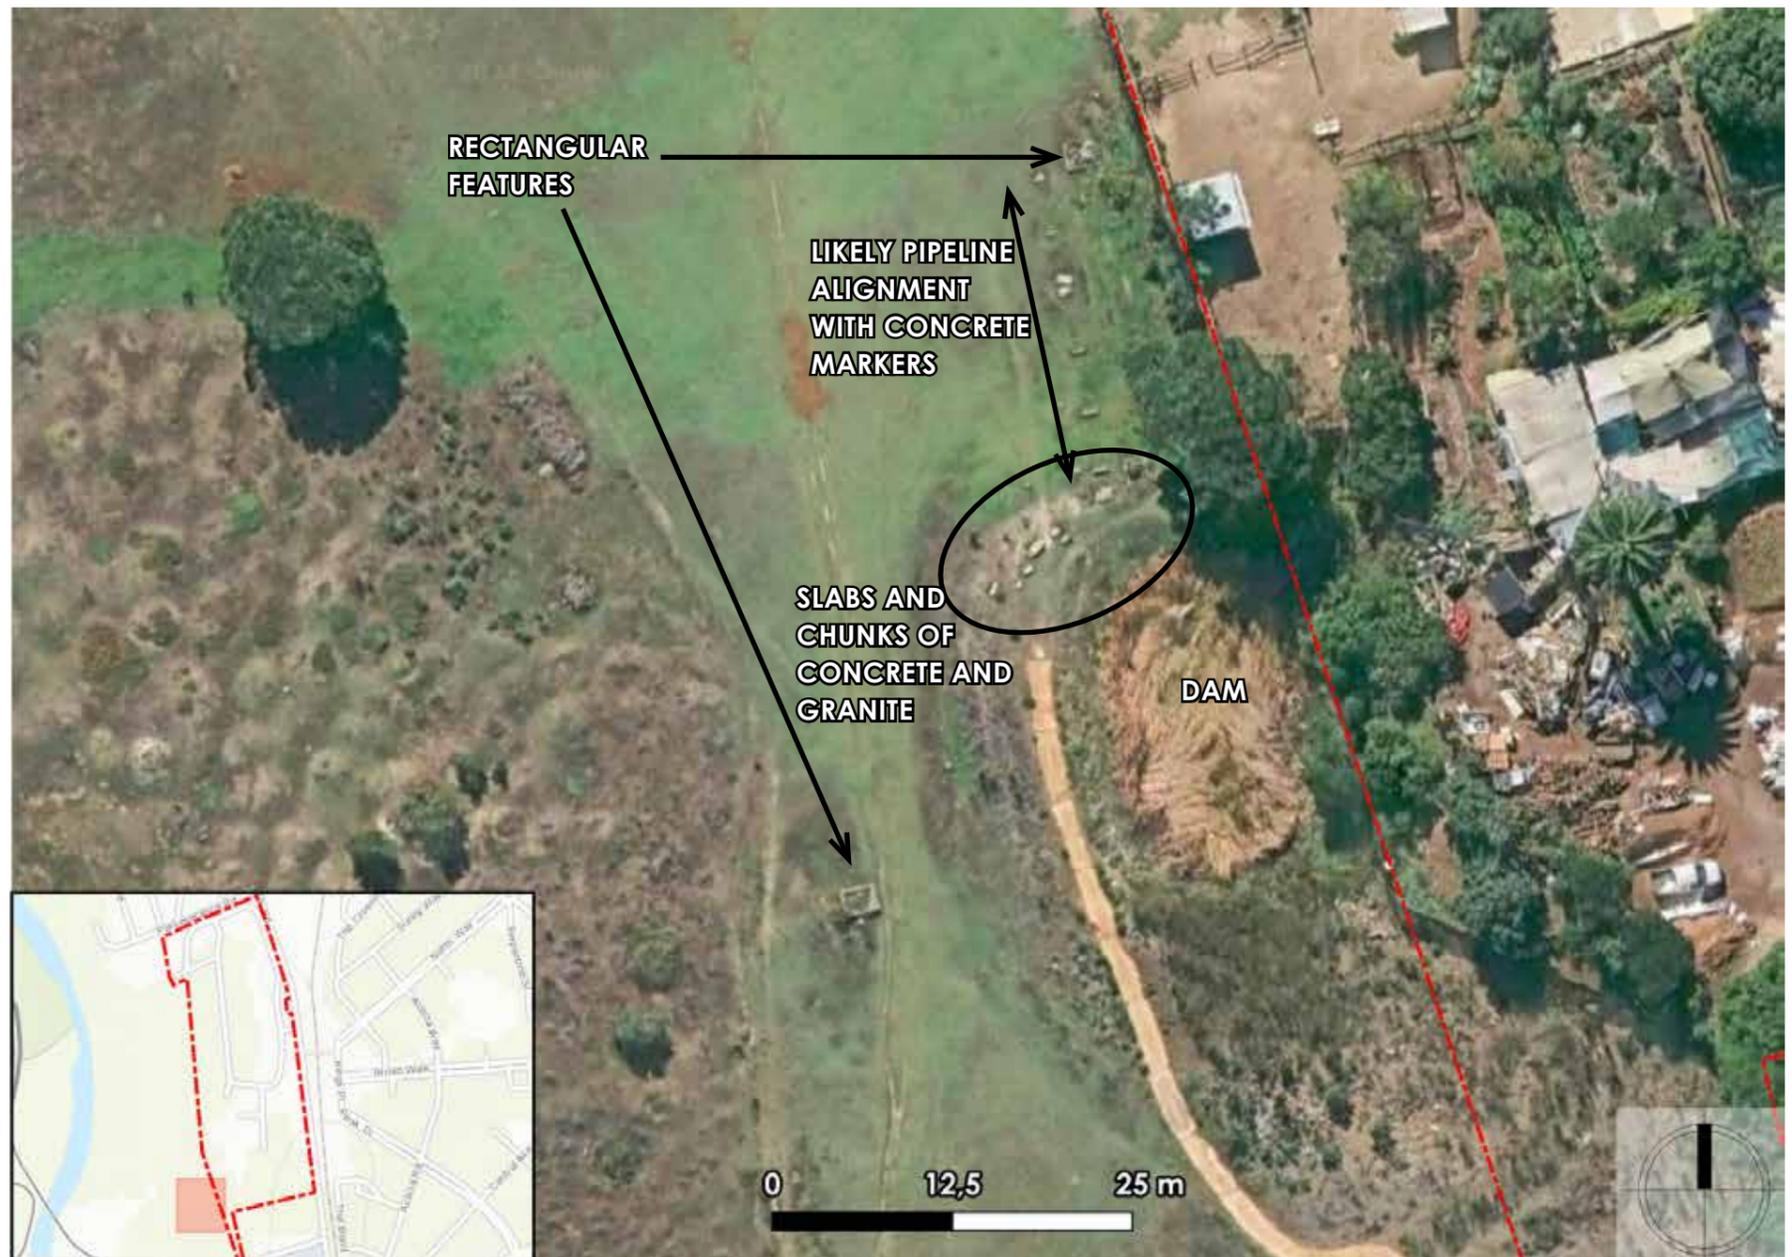
Figure 56. Map showing the location of the features identified as graves (RSA, 2024)

Further to these two features, numerous sections of copconcrete pipe were visible, as well as a few rectangular granite blocks. While it cannot be proven that the granite blocks are not disturbed headstones, it should be noted that several of them occur adjacent to a track around a dam, and they may well merely be displaced seating from here. The cement blocks and pipes appear to mark a pipeline between the upper concrete walled feature and the dam.

These findings are not conclusive, as no excavation or intrusive investigation of any kind was undertaken. Further, the positive identification of these features as anything other than graves does not negate the possibility of other unmarked graves existing nearby, nor does it negate the oral histories around graves existing in the area.

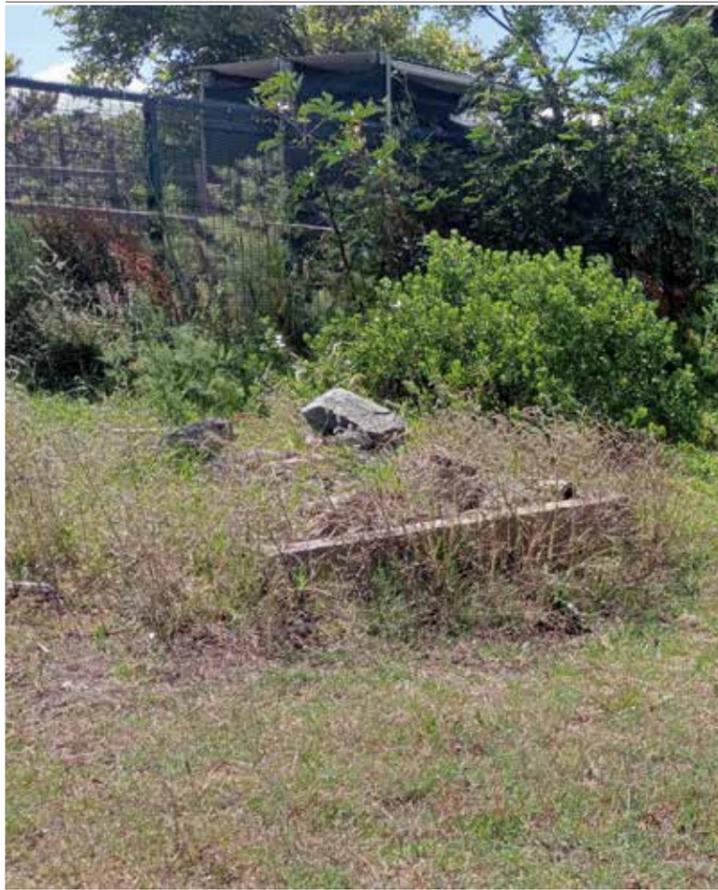
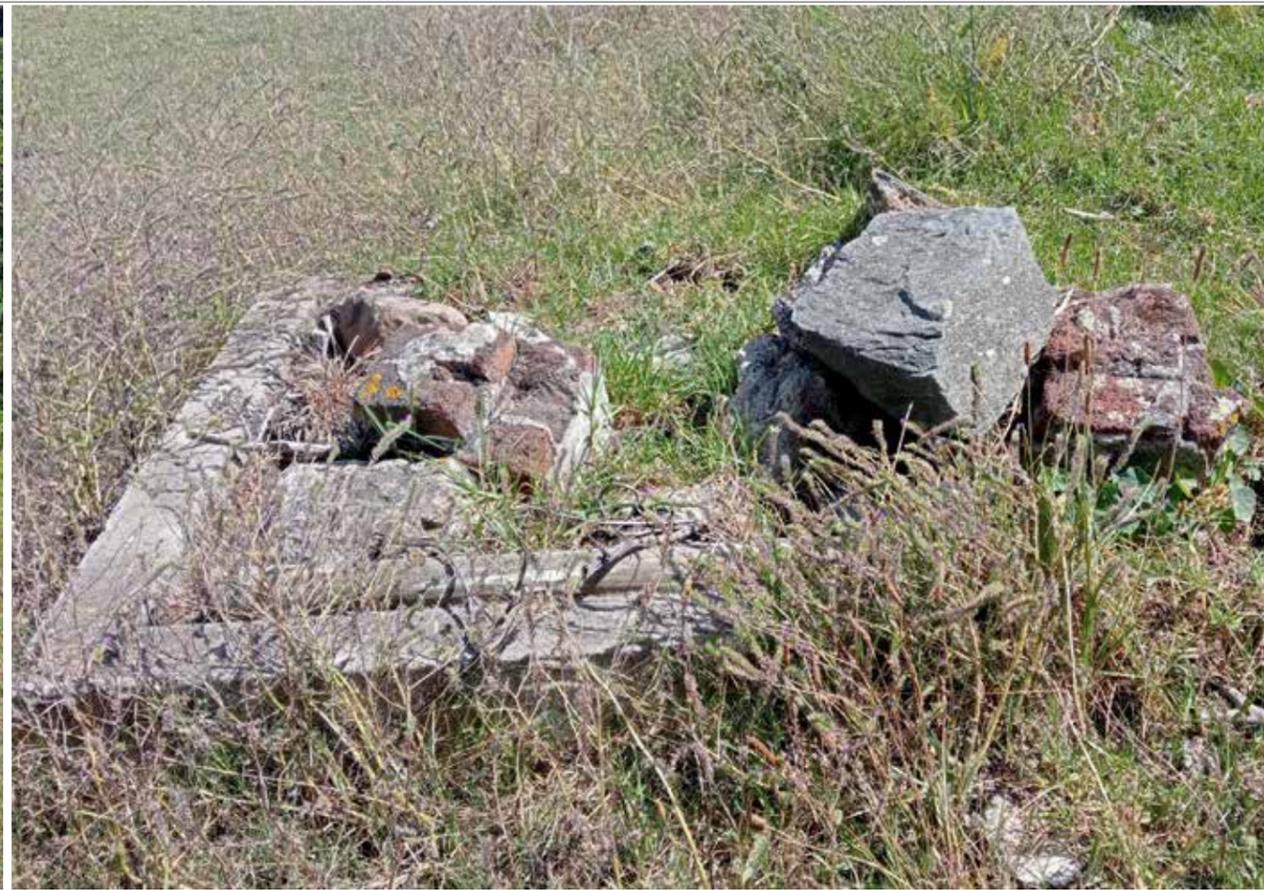
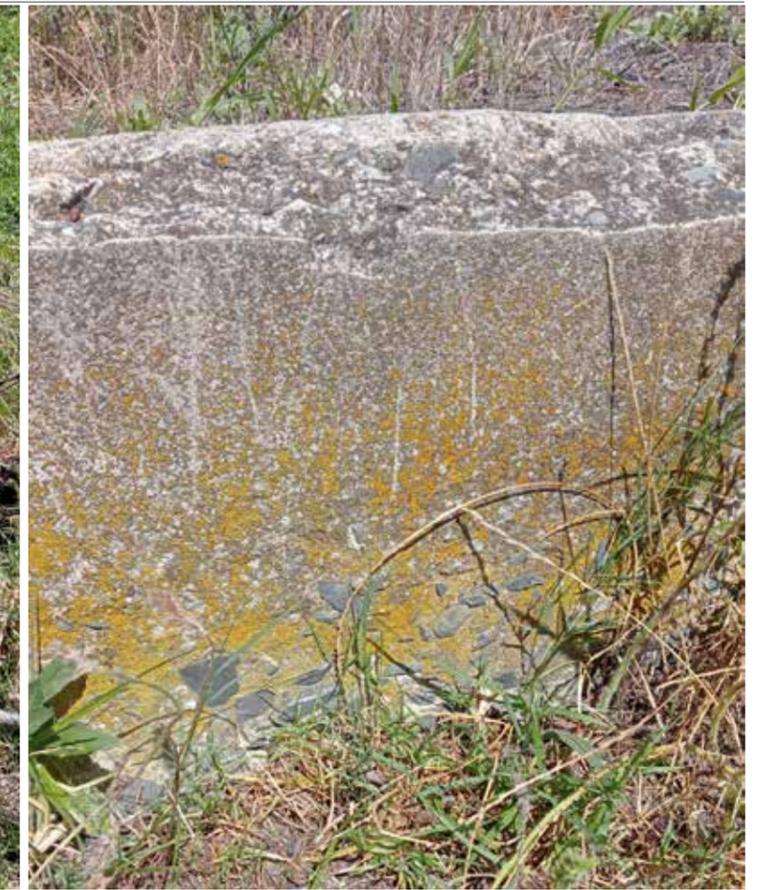
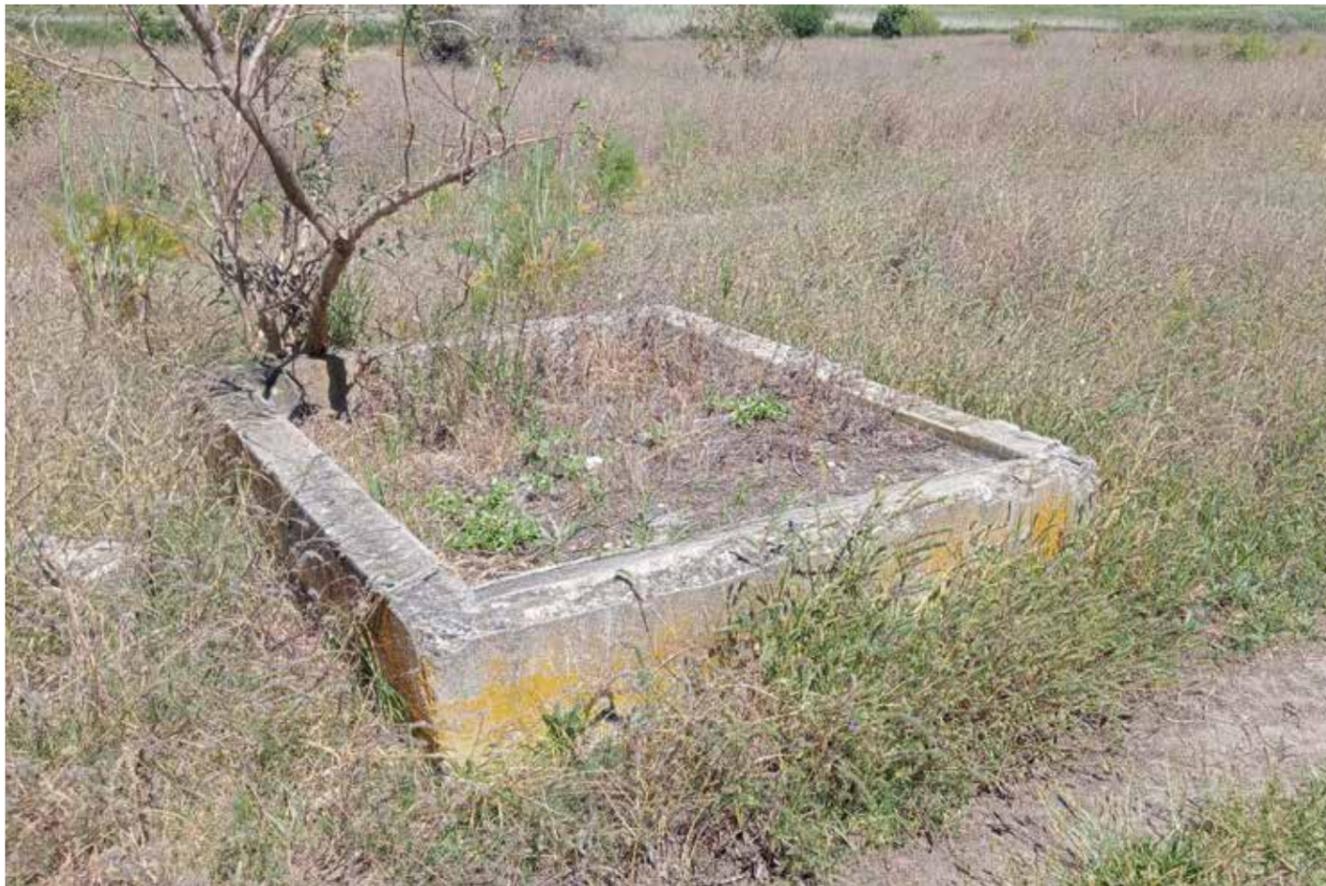
Figure 57. Images of the rectangular features pointed out to the archaeologist. The upper/eastermost of the two is shown top left and top centre, the lower/more westerly one is shown bottom left and right; note the slanted concrete top (bottom right) and the fabric comprising road metal aggregate (top right) (RSA, 2024)

- Figure 56. Map showing the location of the features identified as graves (RSA, 2024)
- Figure 57. Images of the rectangular features pointed out to the archaeologist. The upper/easternmost of the two is shown top left and top centre, the lower/more westerly one is shown bottom left and right; note the slanted concrete top (bottom right) and the fabric comprising road metal aggregate (top right) (RSA, 2024)

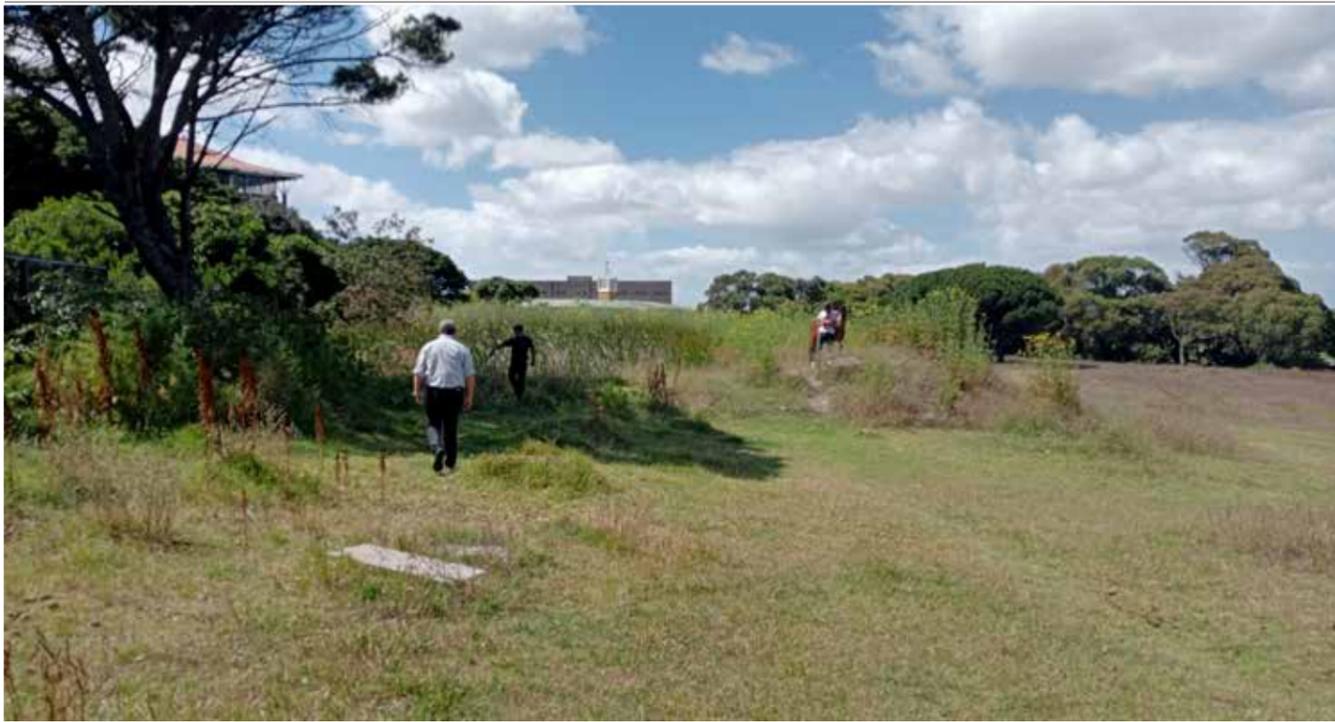
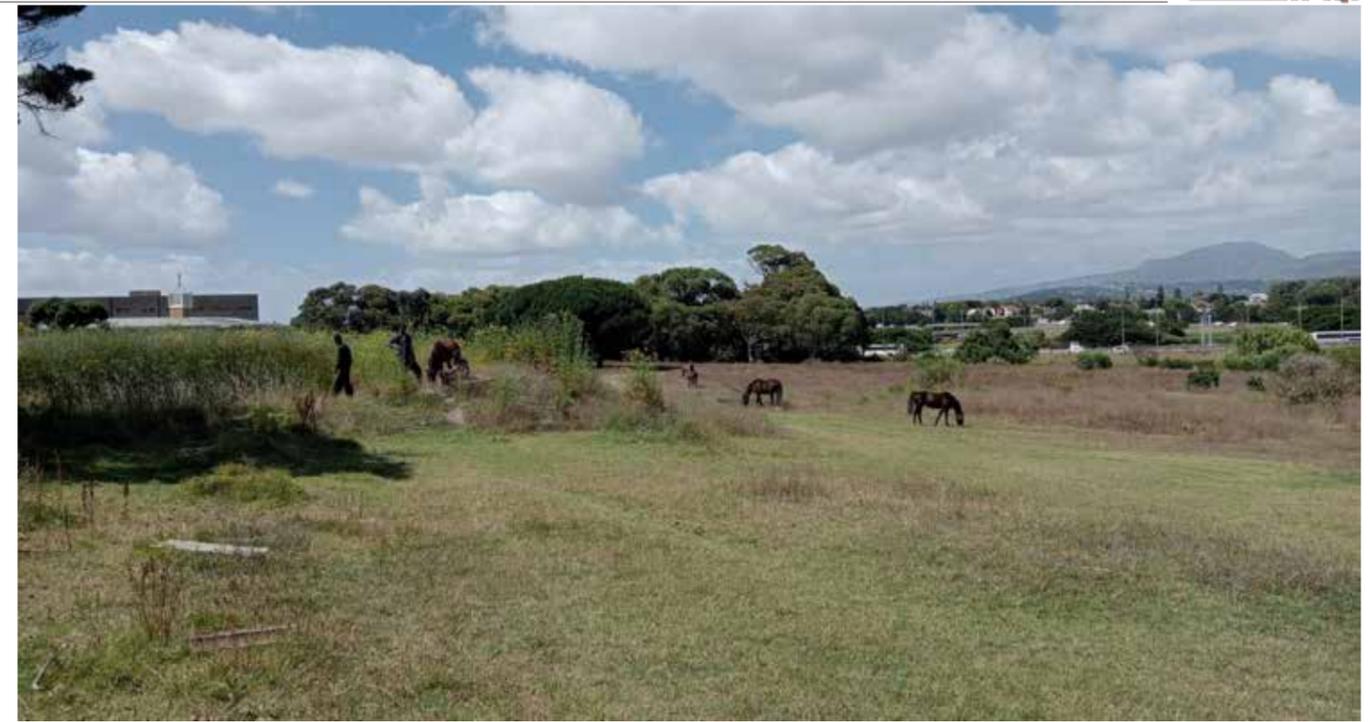
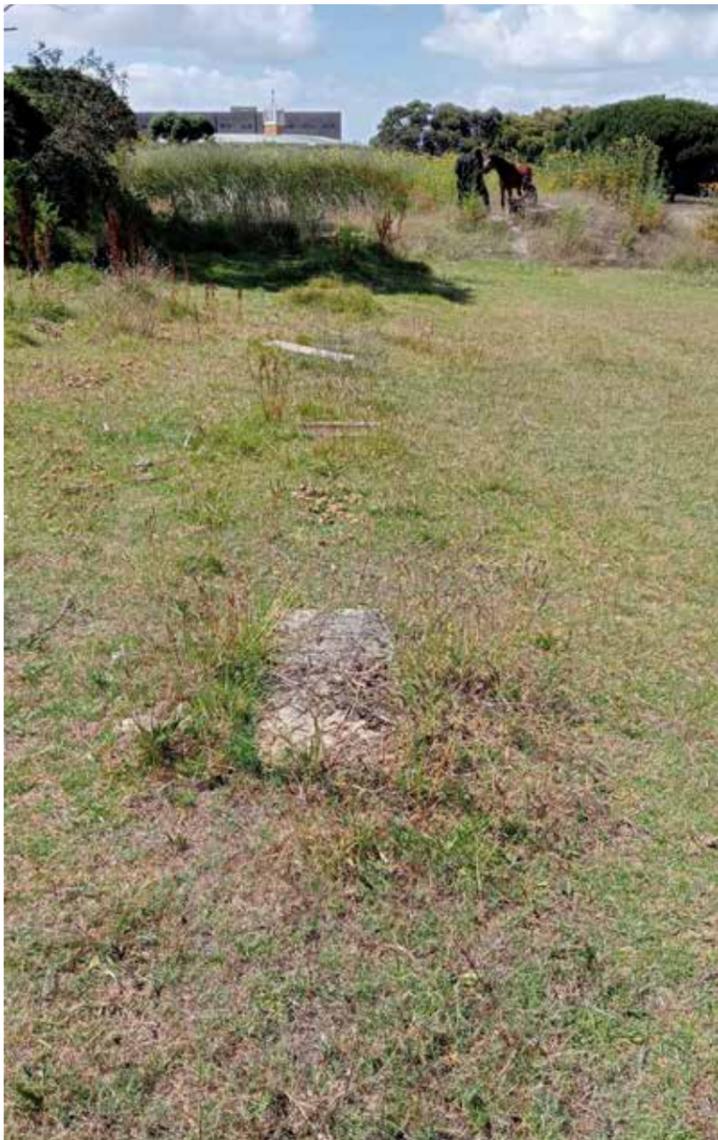
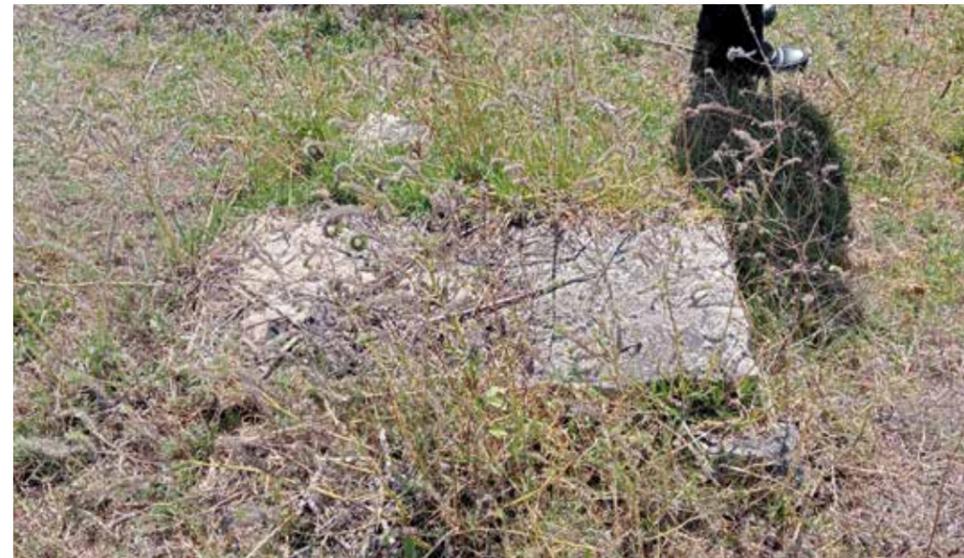
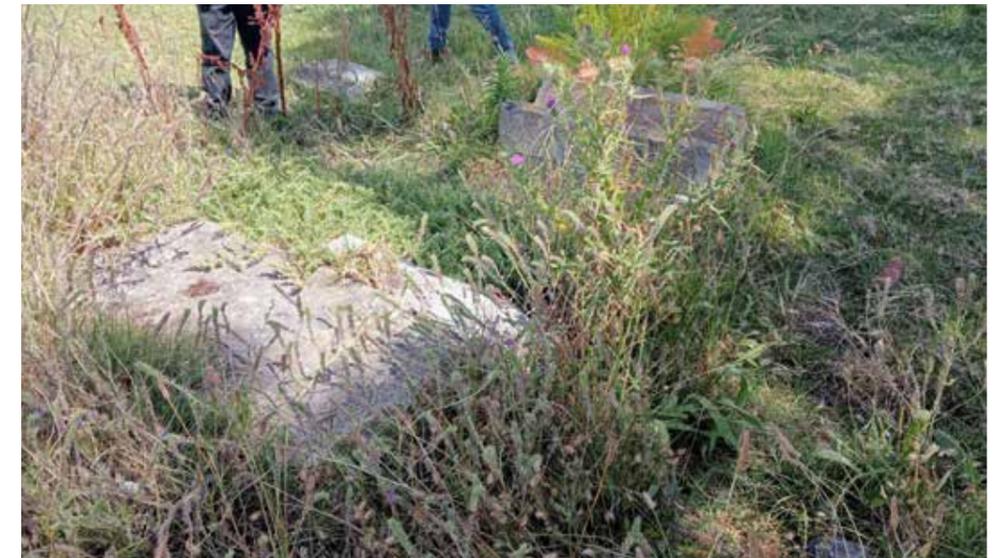
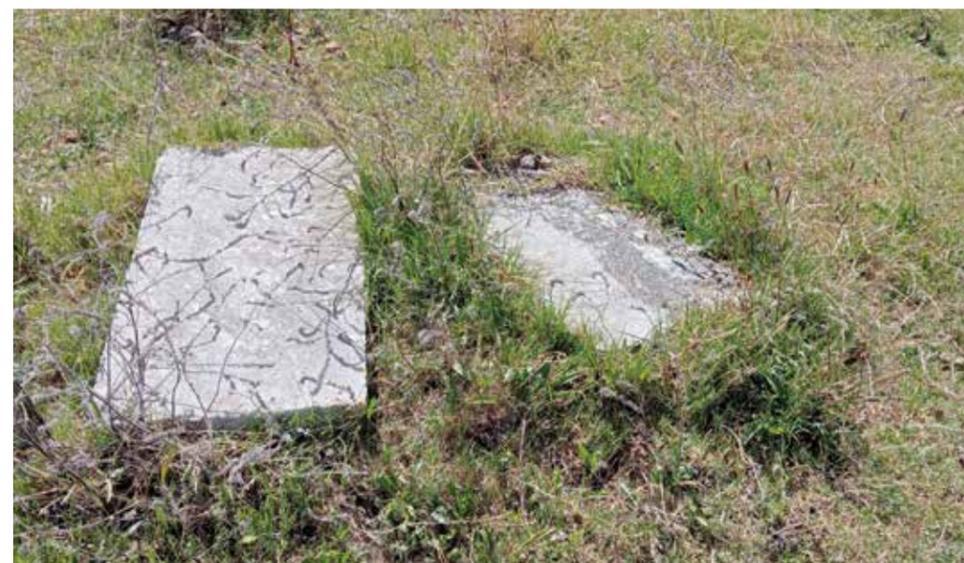
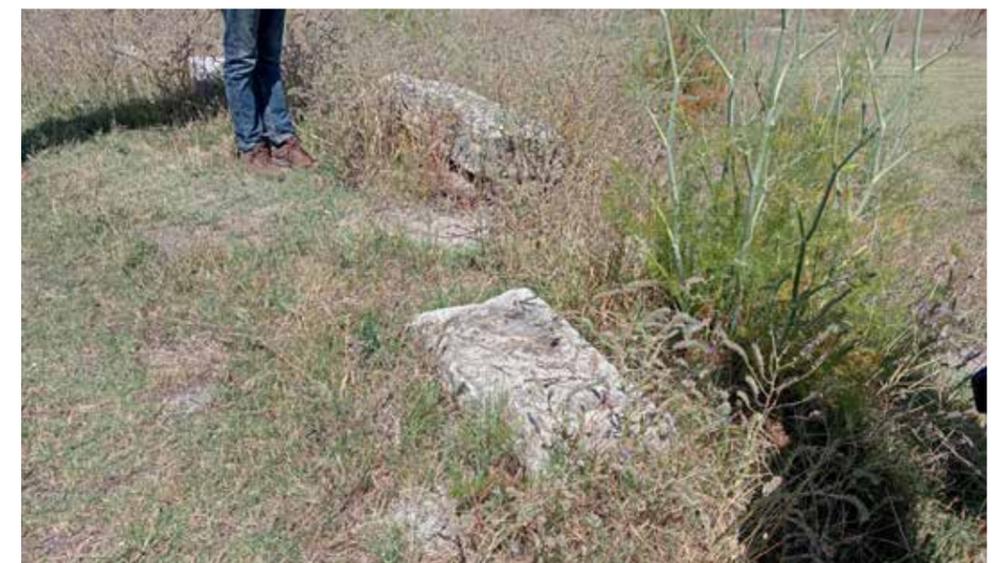
Figure 58. The alignment of various slabs and chunks of concrete and granite leading from the one rectangular feature towards the dam, that appears to indicate a water pipeline alignment (above and left), and various slabs and chunks near the dam (RSA, 2024)

- Figure 58. The alignment of various slabs and chunks of concrete and granite leading from the one rectangular feature towards the dam, that appears to indicate a water pipeline alignment (above and left), and various slabs and chunks near the dam (RSA, 2024)
