ARCHAEOLOGICAL IMPACT ASSESSMENT OUDE MOLEN VILLAGE, ERF 26439-RE, CAPE TOWN

HWC REF: 21022615SB0330E

submitted in terms of Section 38(4) of the NHRA (1999) for
OUDE MOLEN PRECINCT, ERF 26439-RE,
ALEXANDER ROAD, PINELANDS, CAPE TOWN

FINAL AIA

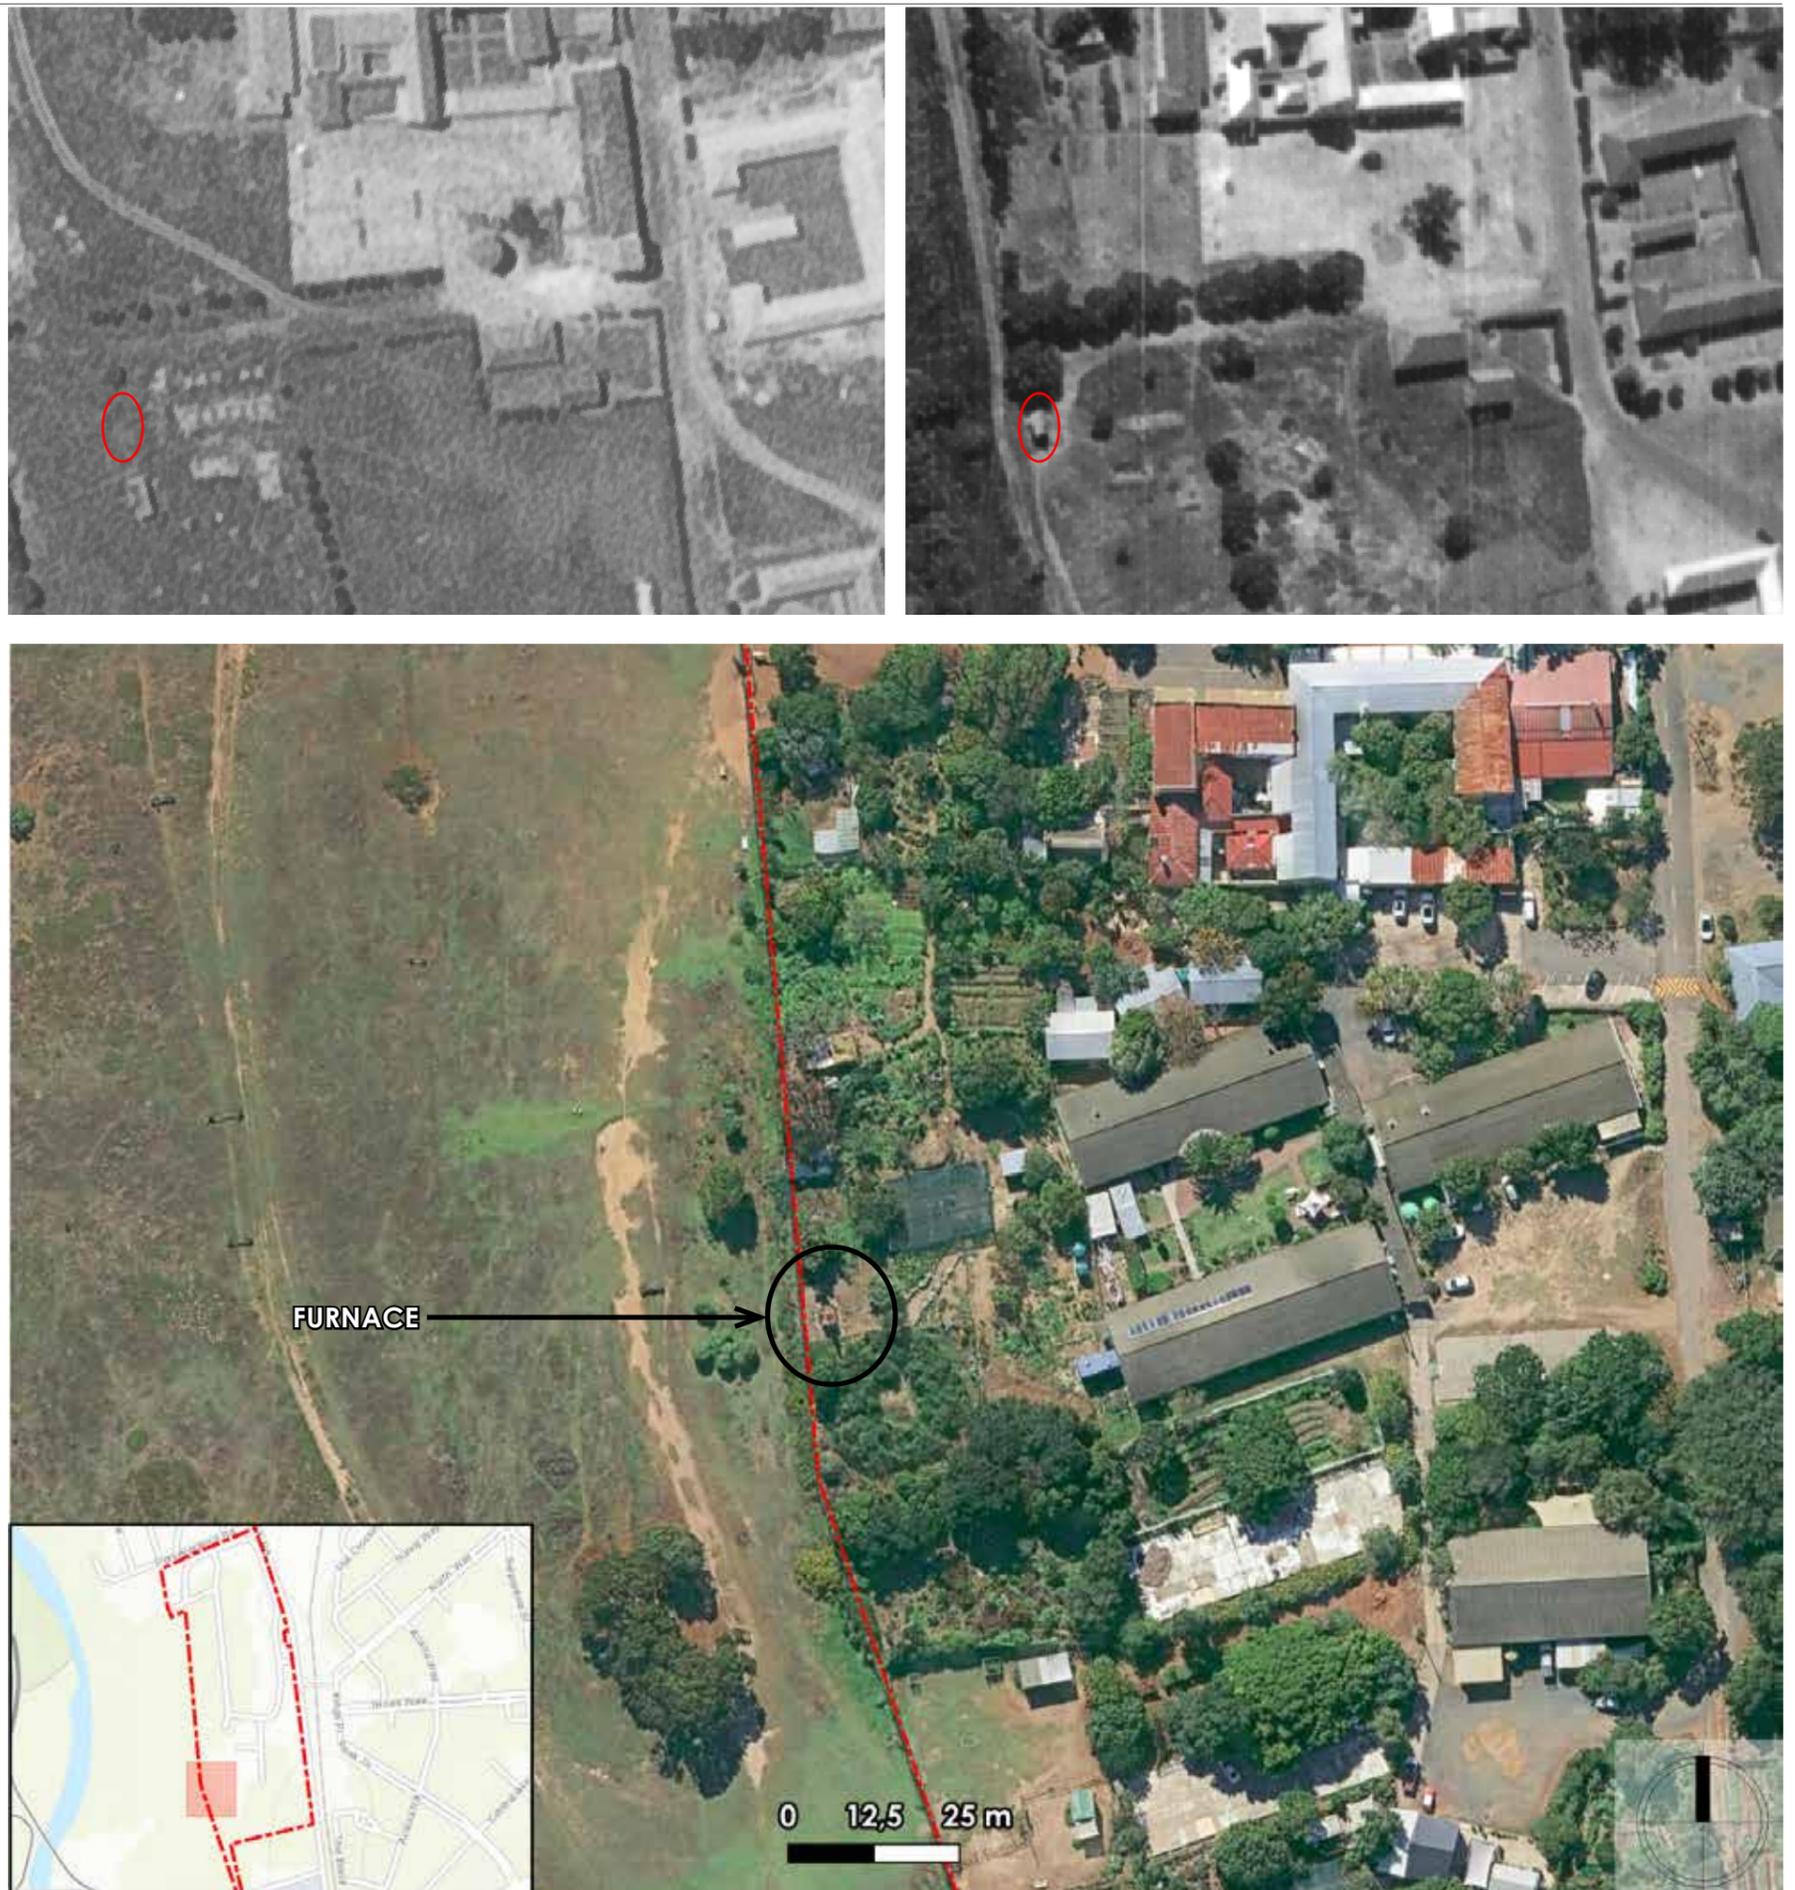
The structure is first evident on aerials in 1968, and does not appear on the 1958 aerial; it was likely associated with the use of the H-shaped ward built for black men in 1957. It is, thus, not very old, and certainly not contemporaneous with the colonial period or slavery. The structure certainly holds symbolic and associational significance for the Goringhaicona group at Oude Molen, and the disjuncture between the history of the structure and the stories associated with it does not negate this significance. Indeed, the macabreness of the story associated with this structure speaks to a collective trauma that cannot and should not be dismissed.

Figure 59. The 1958 (top left) and 1968 (top right) aerials (CDNGI, 2024), and the location of the furnace (above) (RSA, 2024)

On inspection, the furnace was found to be clearly mid-C20th in origin, built of high-fired, mass-produced brick, and secured with railway track I-beams. The structure is 2600mm long, with the furnace 1550mm deep, and has two arched apertures, one above the other; the interior of the structure is walled off beyond the furnace. The chimney is located centrally on the opposite end to the furnace; it stands 475mm proud of the structure, and is 700mm wide. The barrel vault is 2250mm high, and the whole structure 2150mm wide.

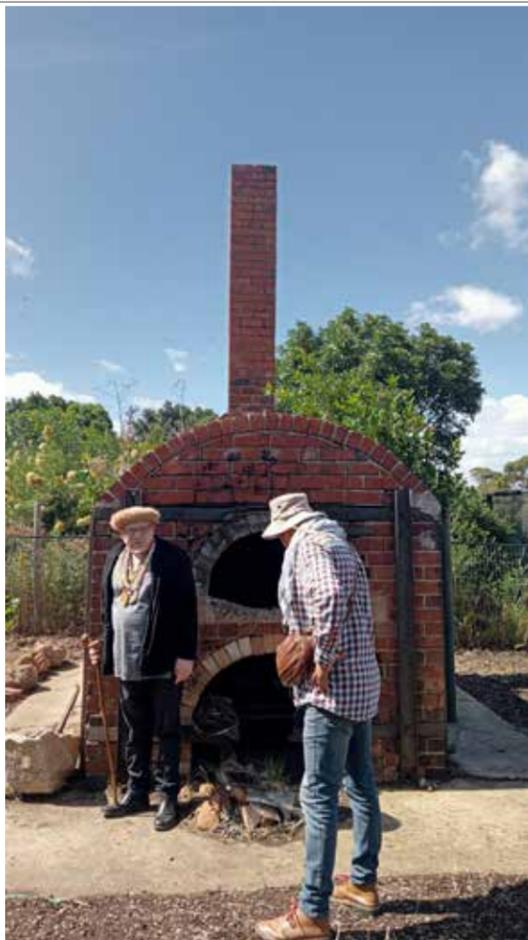
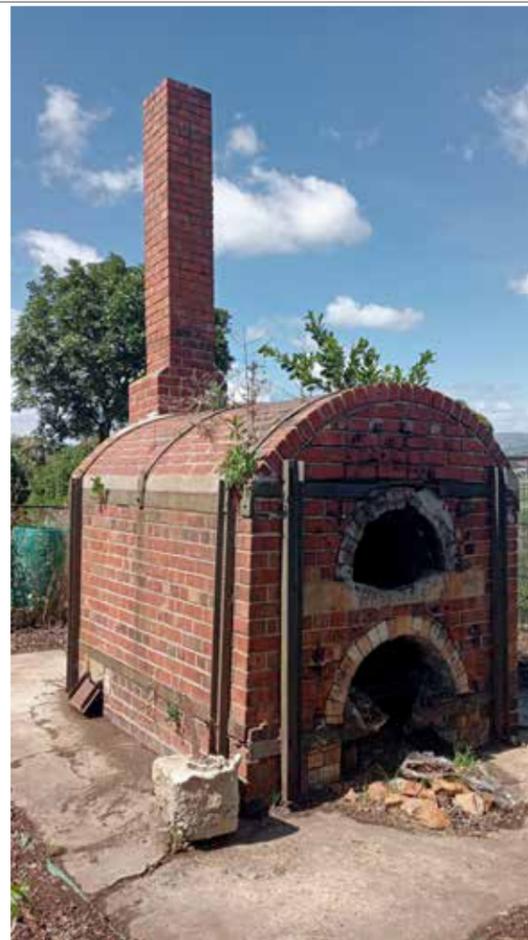
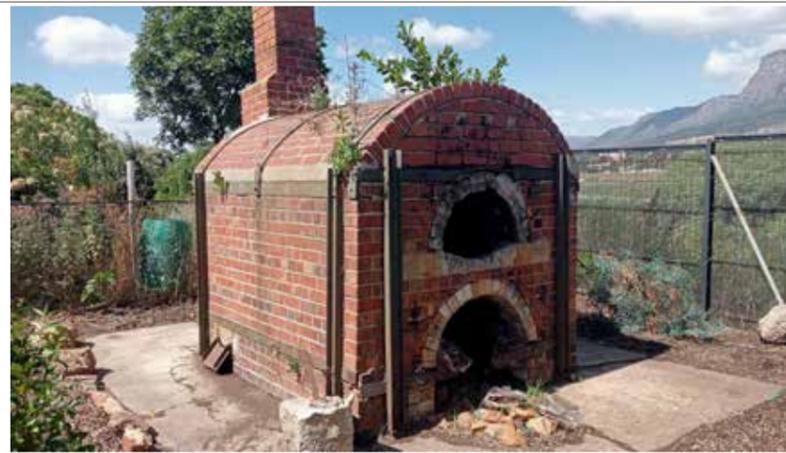
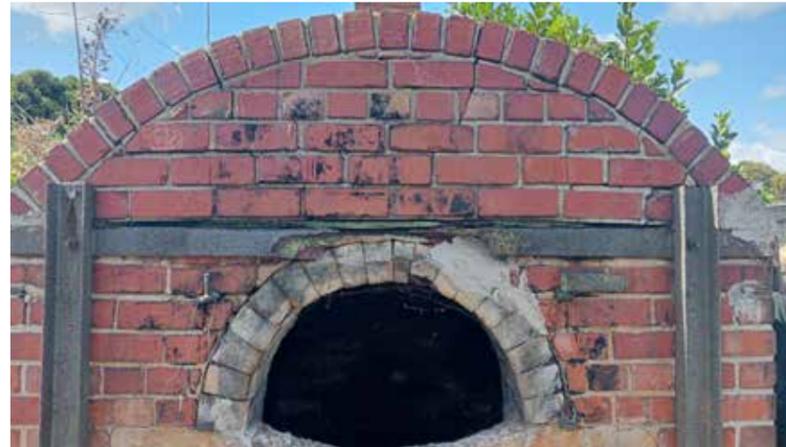
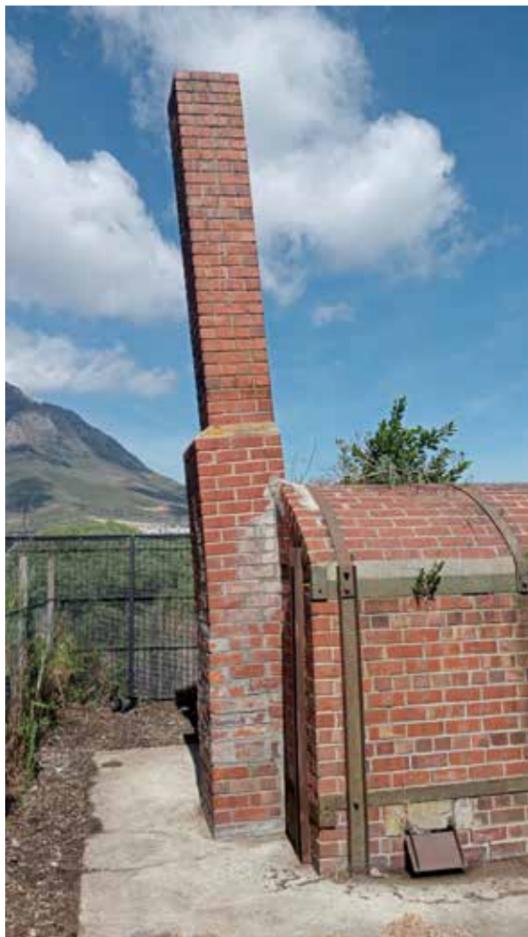
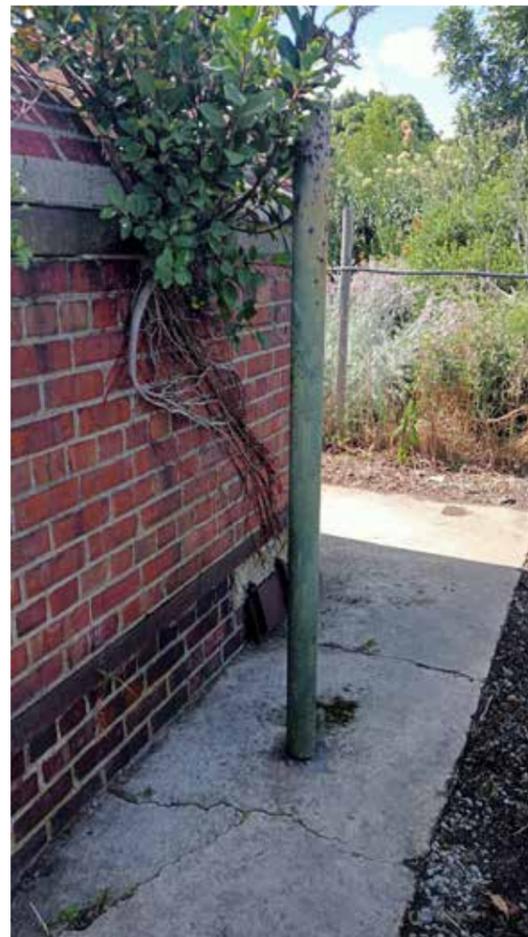
Figure 60. The furnace (RSA, 2024)

Figure 61. Detail of the furnace (RSA, 2024)

Figure 62. Medical waste near the furnace (RSA, 2024)

- Figure 59. The 1958 (top left) and 1968 (top right) aerials (CDNGI, 2024), and the location of the furnace (above) (RSA, 2024)
- Figure 60. The furnace (RSA, 2024)

- Figure 61. Detail of the furnace (RSA, 2024)
- Figure 62. Medical waste near the furnace (RSA, 2024)
- Figure 63. OMP Precinct Plan Preferred Alternative: Compilation (SVA, 2025)

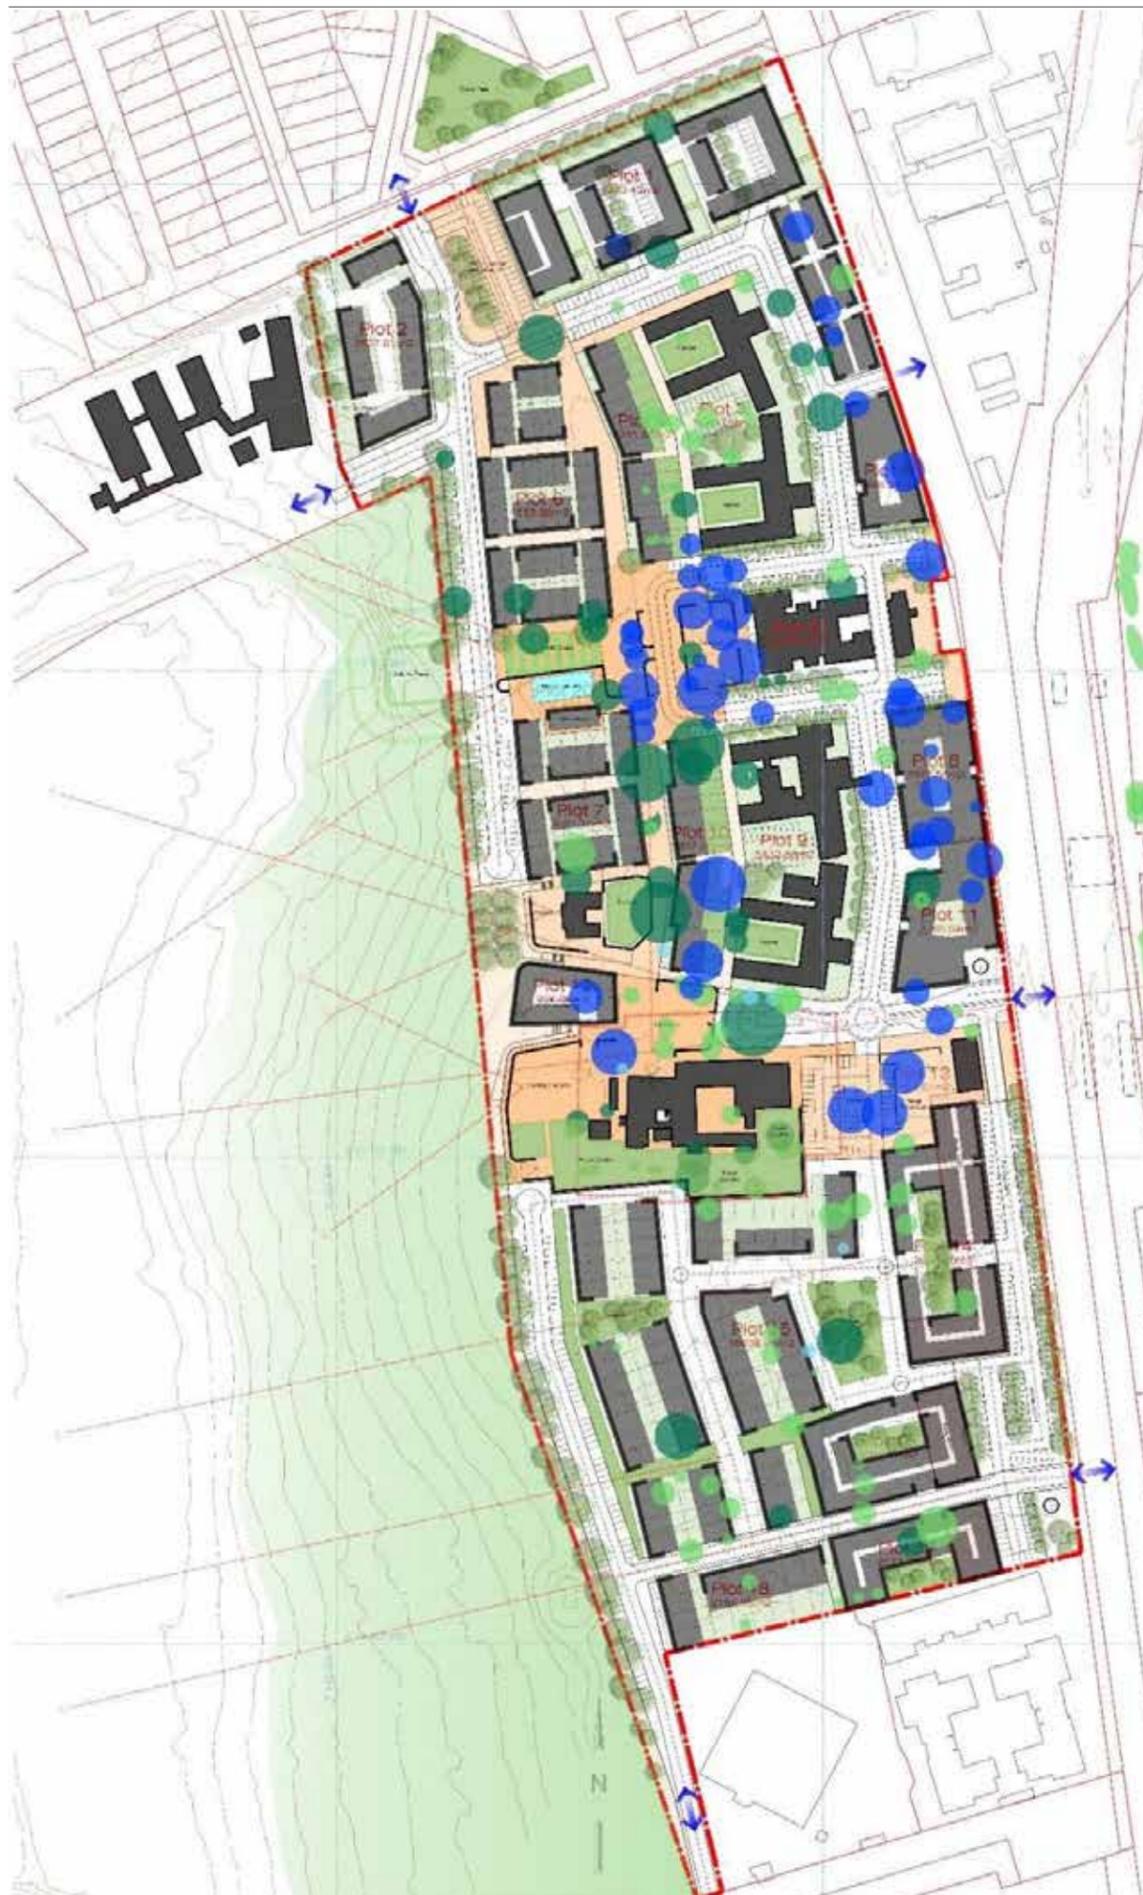
Figure 63. OMP Precinct Plan Preferred Alternative: Compilation (SVA, 2025)

The preferred design precinct plan (Figure 63) has been developed during 2023/2024, and was informed by the draft HIA (Postlethwayt, 2024).

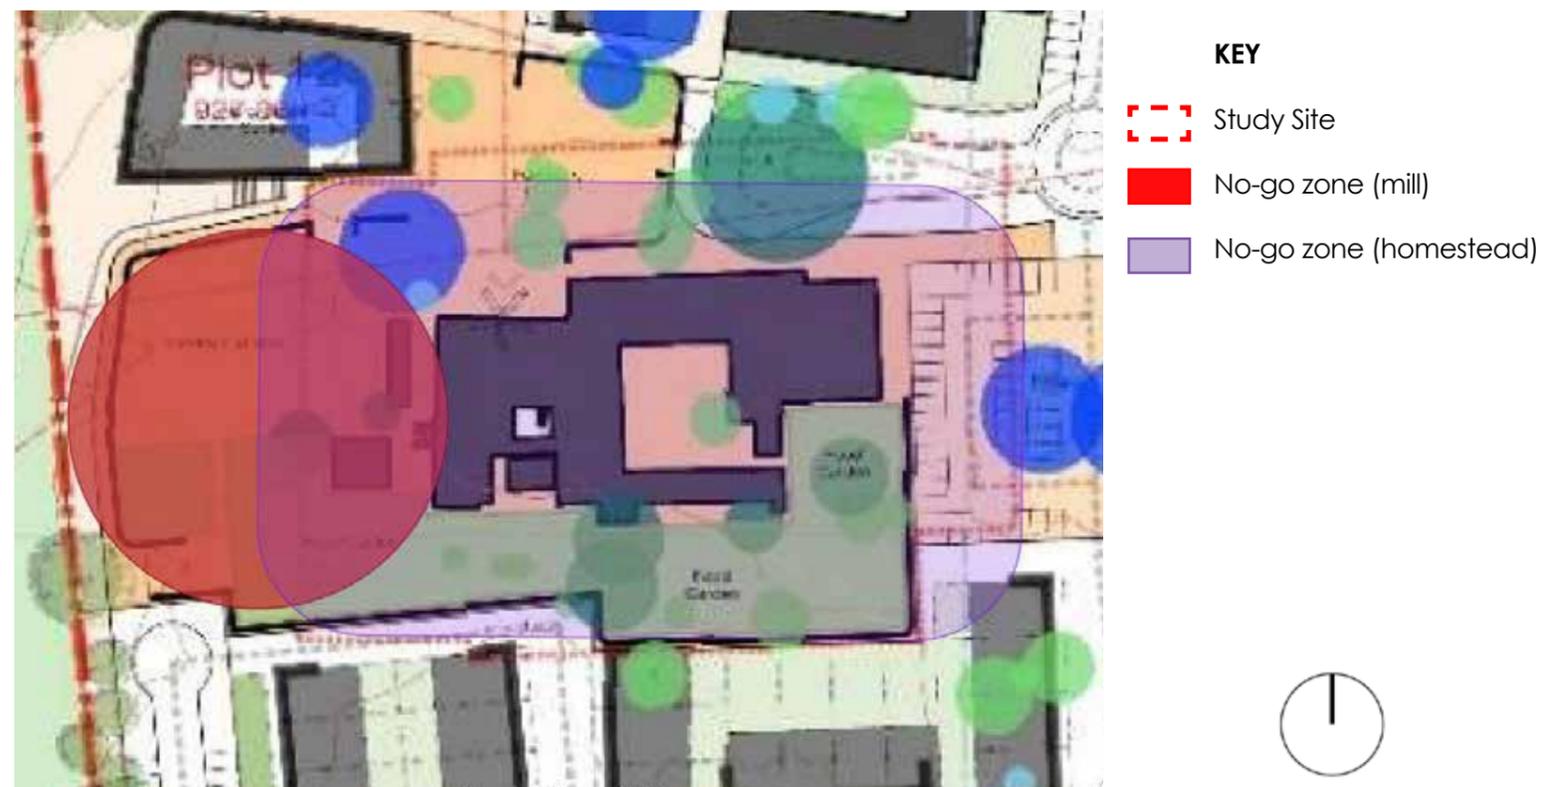
Figure 64. Extent of the high sensitivity zones overlaid on the updated SDP showing the extended garden area south of the homestead (RSA, 2025)

- Additionally to the mitigation provided in Section 8.1 on page 37, test trenching in the area of the proposed food garden south of the homestead should be undertaken to ensure that no below ground archaeological deposits are damaged by soil preparation activities
