# DESKTOP ARCHAEOLOGICAL IMPACT ASSESSMENT: REDEVELOPMENT OF 353 MAIN ROAD, SEA POINT

**HWC REF: 24020910**

*submitted in terms of Section 38(4) of the NHRA (1999) for proposed redevelopment of 353  
on Main, Erf 1424, Sea Point, Cape Town*

Prepared by Rennie Scurr Adendorff on behalf of Zutari for the Western Cape Government

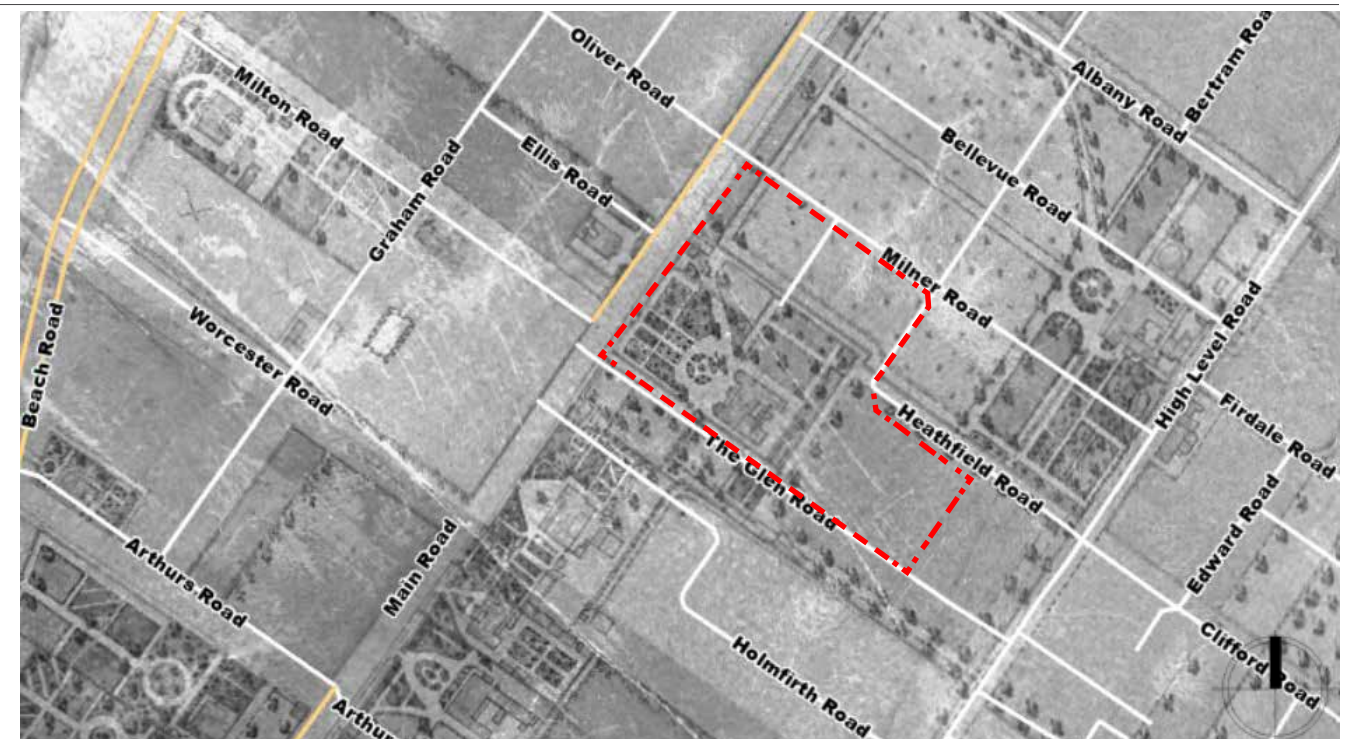
Figure 8. 1878 Wilson Map shows the homestead set in formal grounds, with central fountain, and the development of the surrounding street grid. Site outlined red. (CoCT EGSViewer, 2025)

- Figure 8. 1878 Wilson Map shows the homestead set in formal grounds, with central fountain, and the development of the surrounding street grid. Site outlined red. (CoCT EGSViewer, 2023)

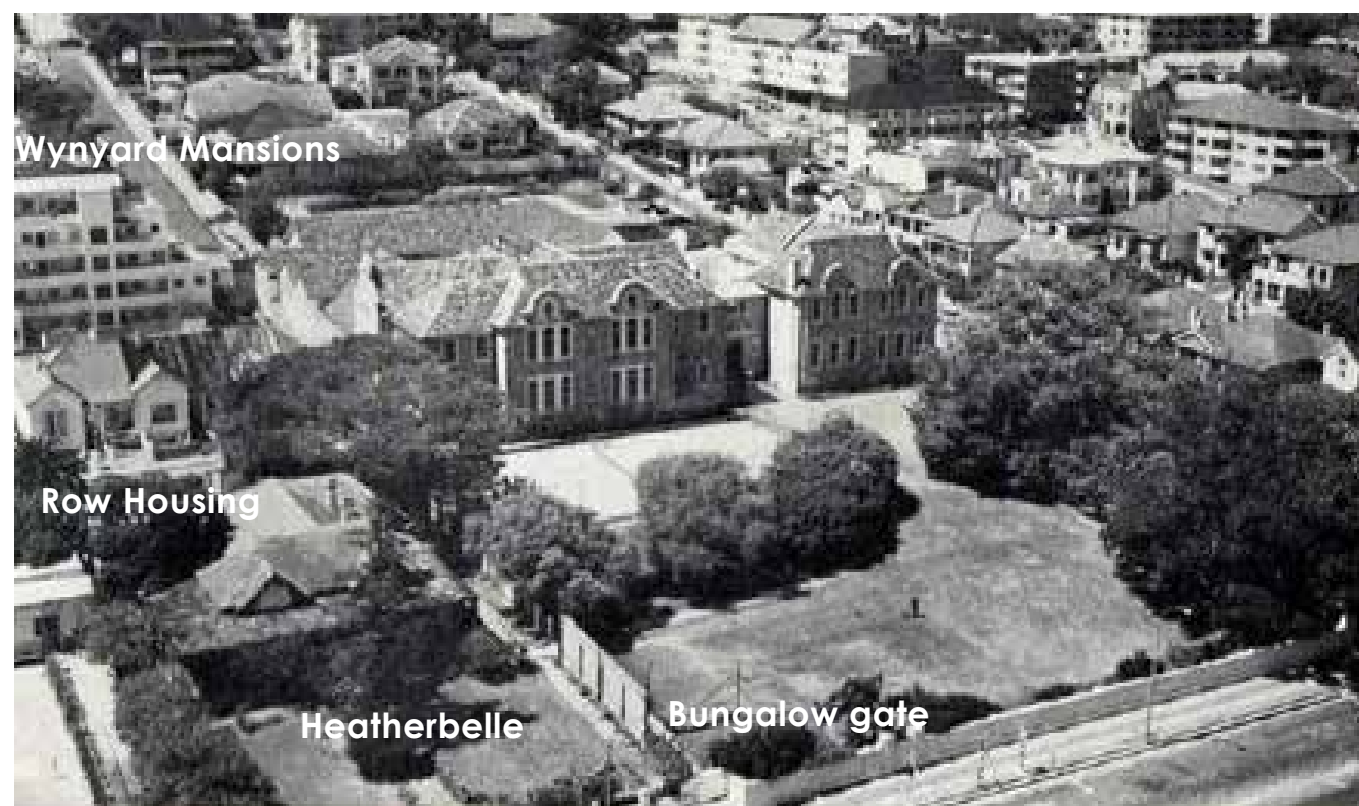
Figure 10. Site post 1955, with Wynyard Mansions set behind the row houses, which are not yet demolished; Heatherbelle Villa in the foreground. The Bungalow has been demolished, but opening in the boundary wall remains. (O'Donoghue, 2011)

Figure 10. Site post 1955, with Wynyard Mansions set behind the row houses, which are not yet demolished; Heatherbelle Villa in the foreground. The Bungalow has been demolished, but opening in the boundary wall remains. (O'Donoghue, 2011)

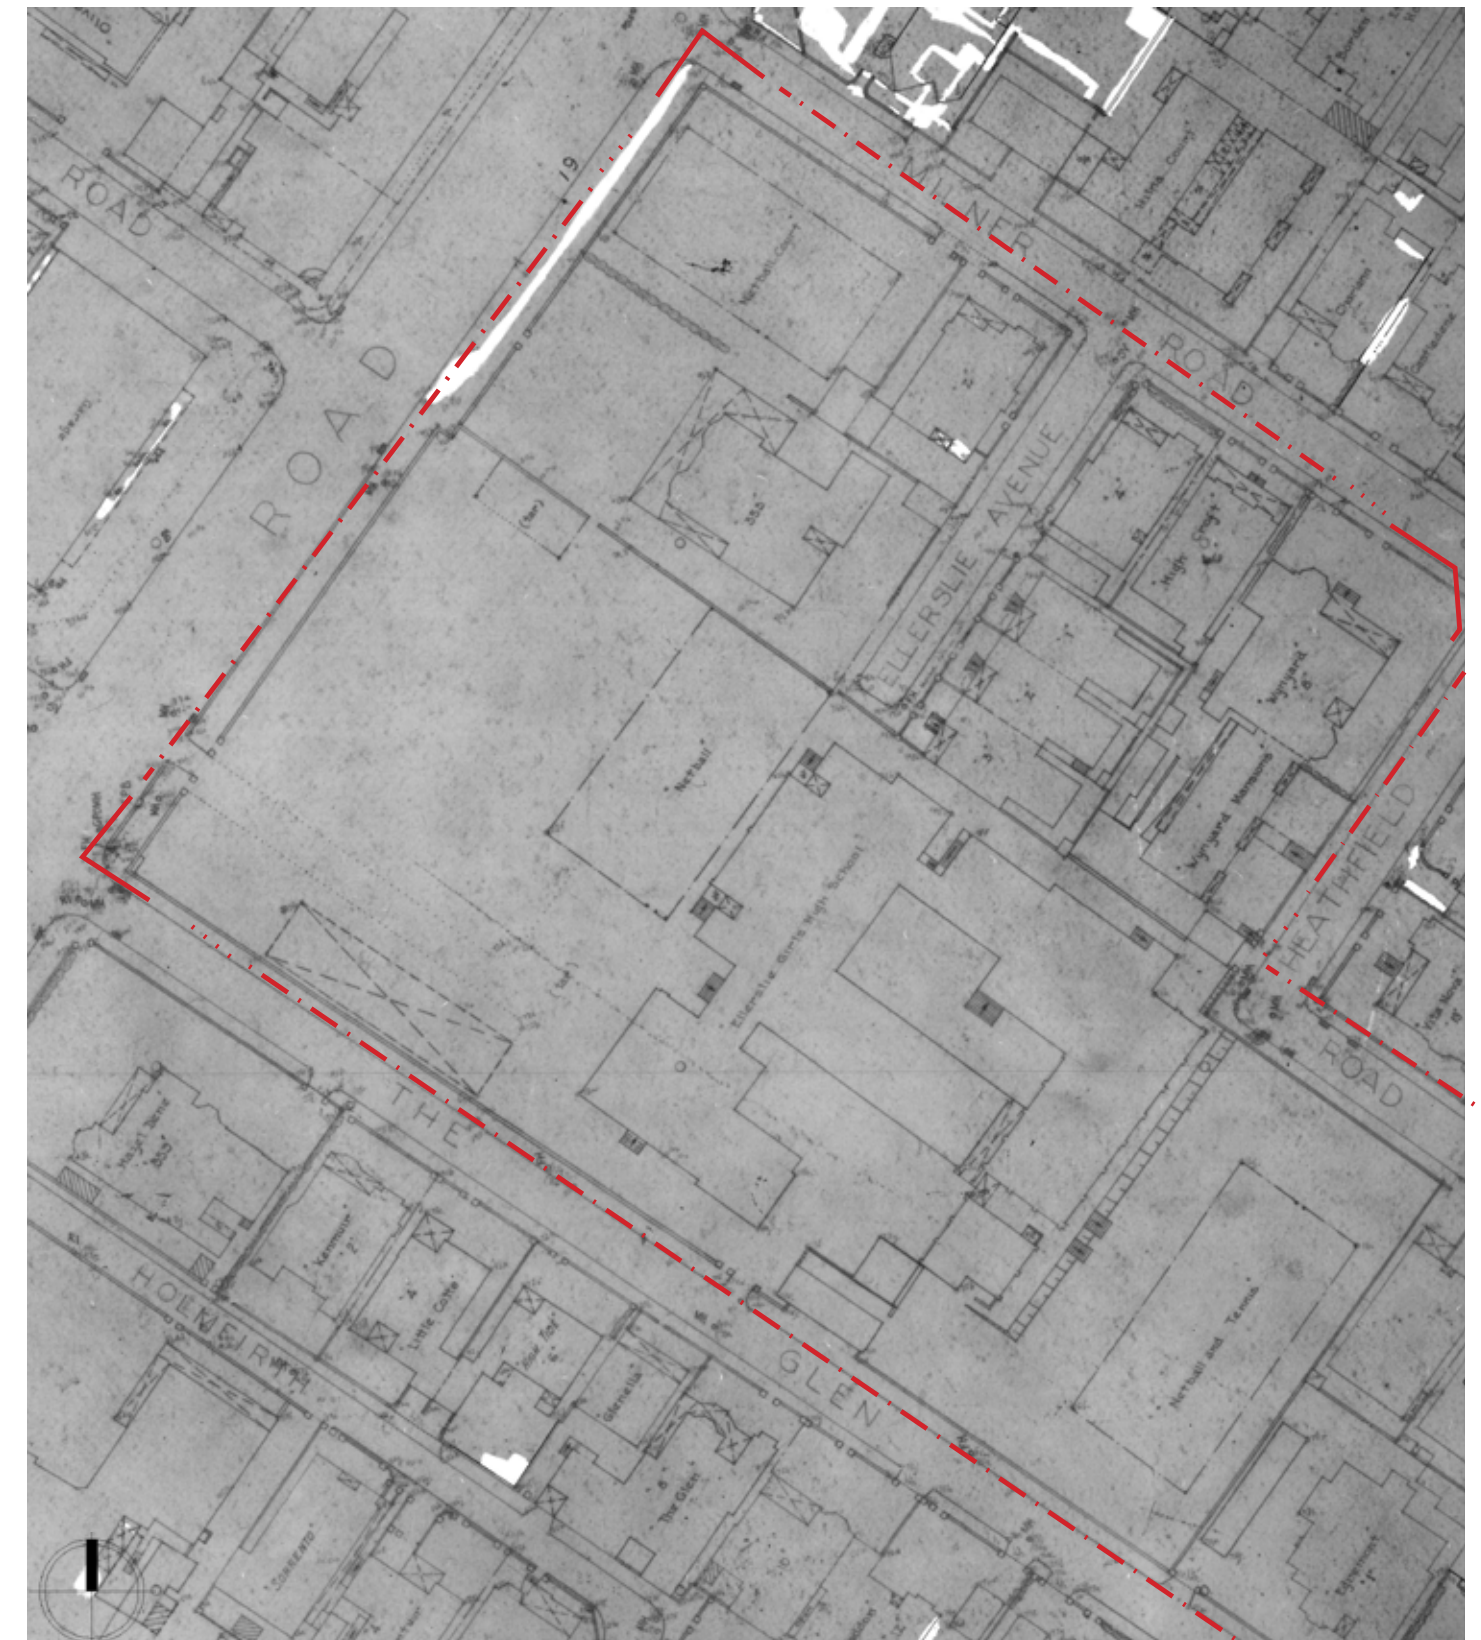
Figure 11. c1950 shows the Ellerslie school building complex. The Bungalow has been demolished and new sports grounds introduced. (CoCT, 2023)

Figure 11. c1950 shows the Ellerslie school building complex. The Bungalow has been demolished and new sports grounds introduced. (CoCT, 2023)

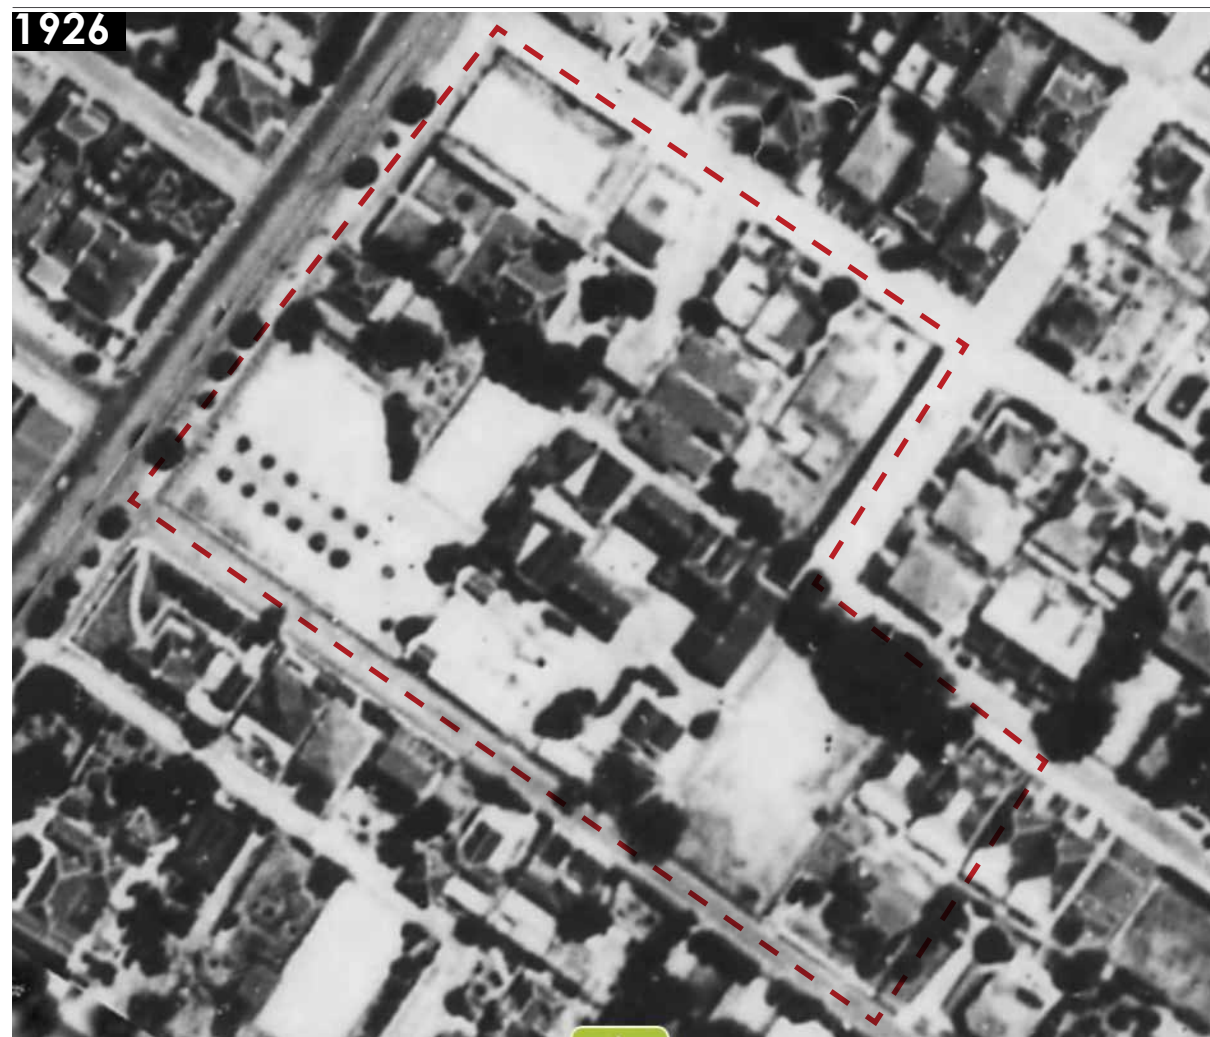
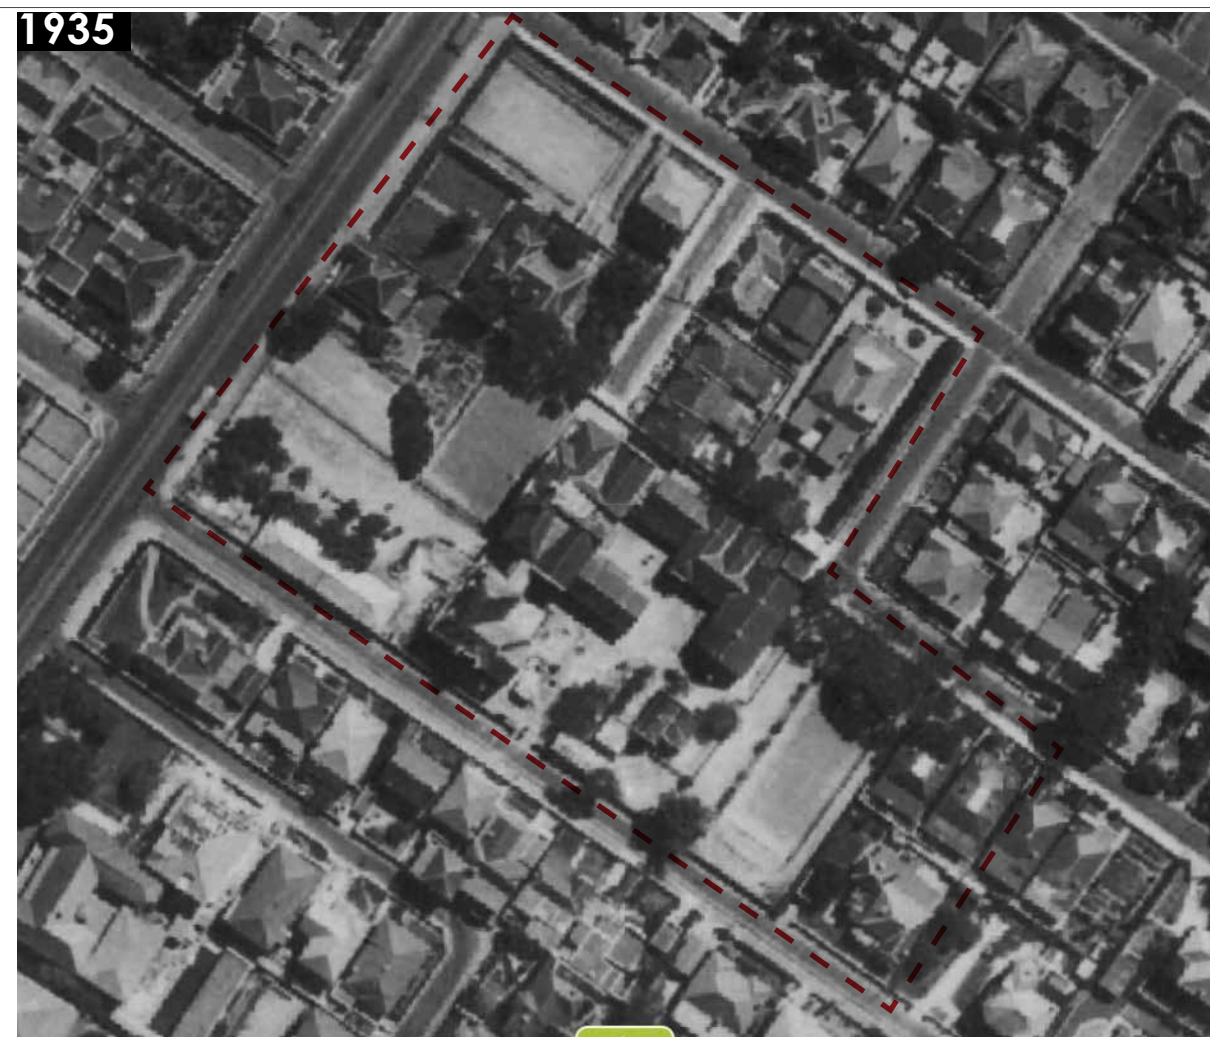
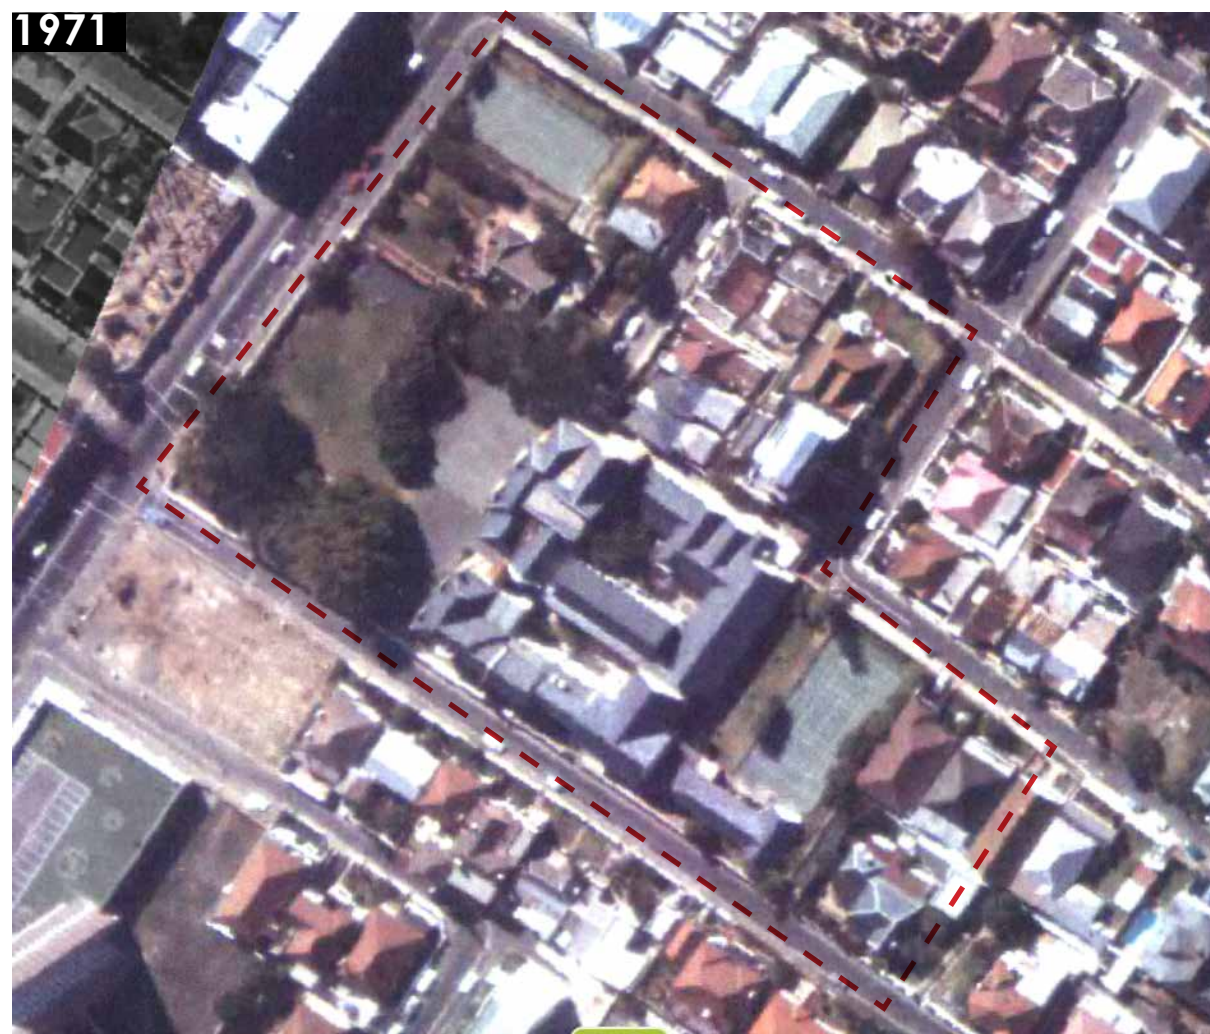
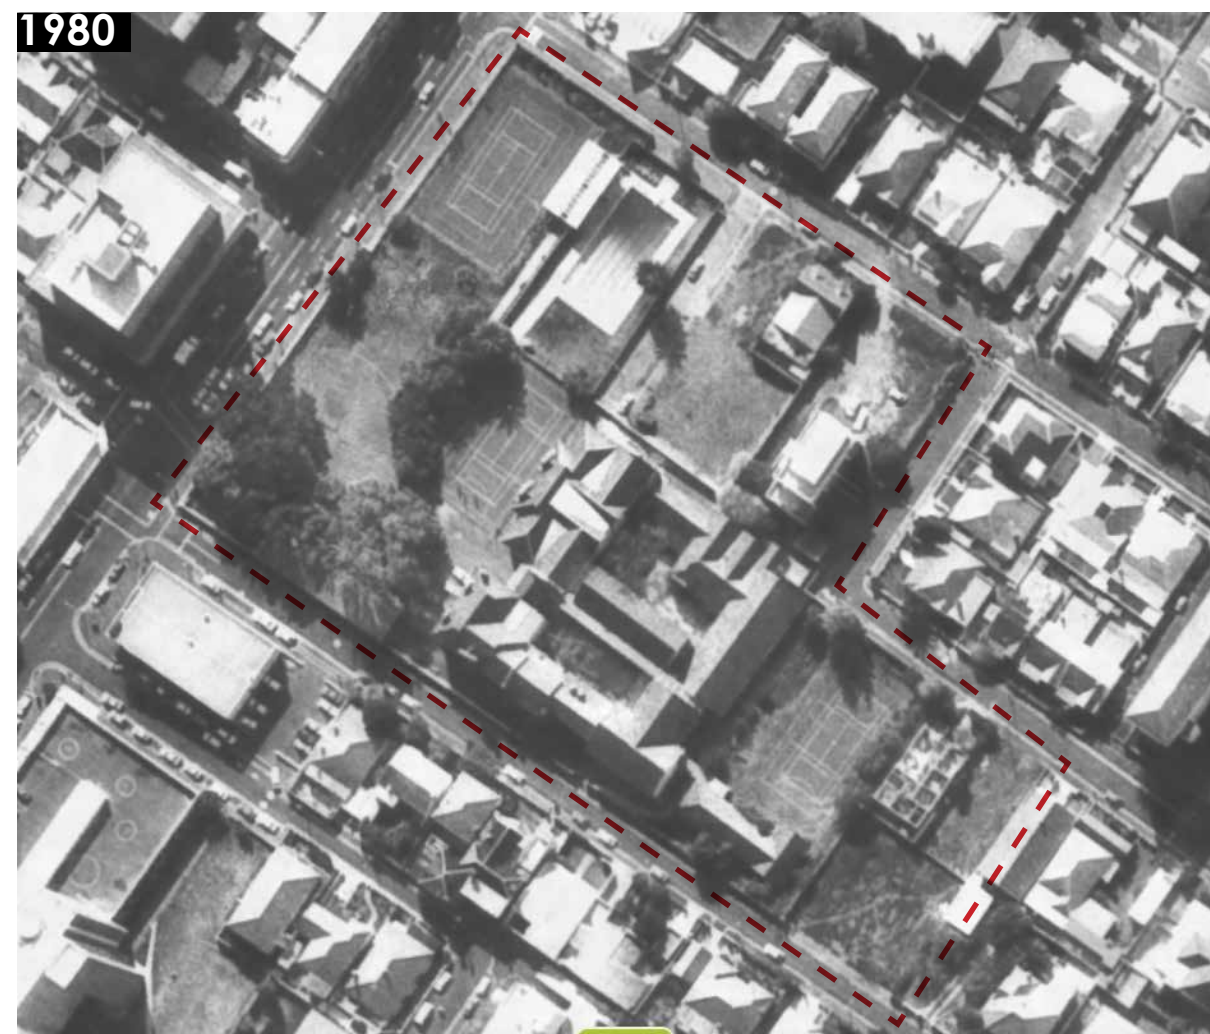
Figure 12. Site change through time (CoCT EGSViewer, 2023)

- 1926 Highlights:
- New wild fig avenue drive terminating at original homestead.
  - School building with kindergarten and hall and rear extension.
  - Site surrounded by residential dwellings

- 1935 Highlights:
- New structure has replaced the homestead
  - Bike shed erected

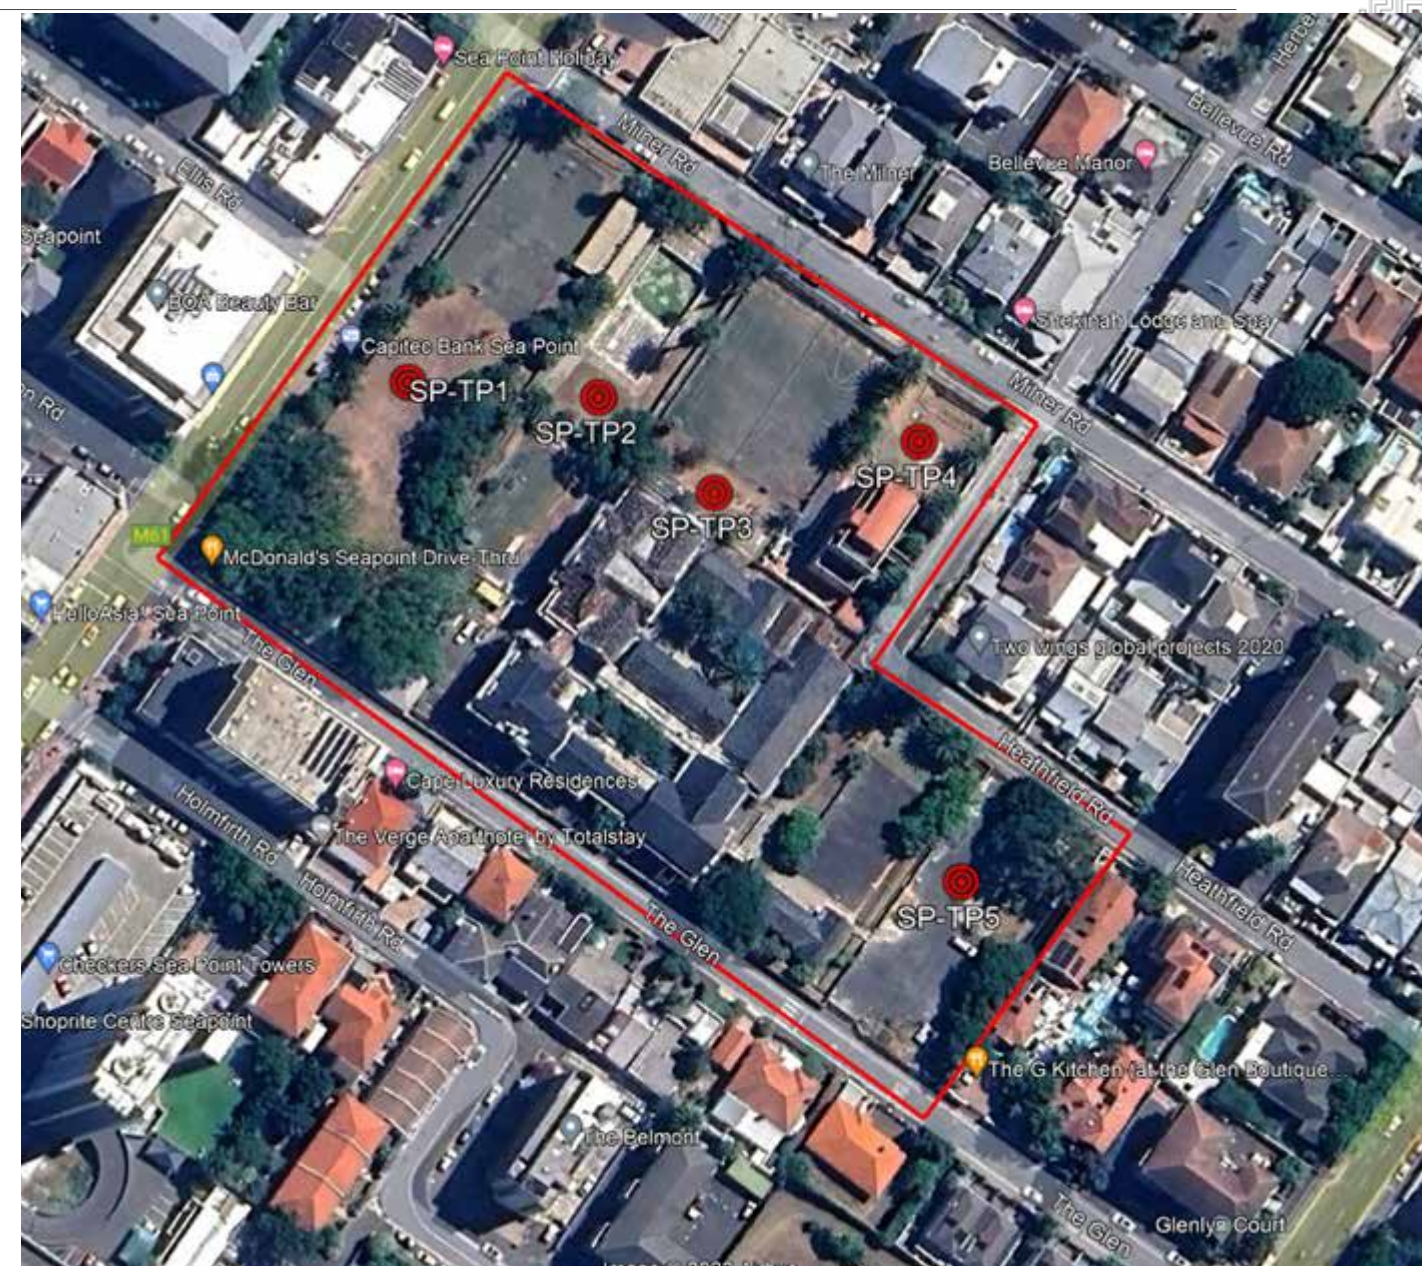
Figure 13. The location of the test pits (RSA, 2024)

Five holes were dug across the site, with care taken in siting the holes to avoid the area around the historic homestead which was identified as potentially holding archaeological significance. Holes were hand dug to a depth of 1.5m, and inspected by the archaeologist during excavation, and prior to backfilling.

The outcomes of the geotesting revealed no evidence for below ground structures, features, or deposits. Two sherds of C19th/C20th European transfer printed earthenware ceramics were retrieved from excavation of Test Pits 1 and 3 - the two pits closest to the homestead site and to the school building. Test Pit 1 had some slate debris and redbrick rubble in the south eastern corner of the trench, but this did not appear to reflect in situ structural remains. Test Pit 4 revealed a horizontal concrete feature across the western extent of the trench, but this was not considered of any great age or significance.
