DESKTOP STUDY OF EXISTING BUILDINGS

OUDE MOLEN PRECINCT, CAPE TOWN

08 December 2020

Draft Report - Revision 03

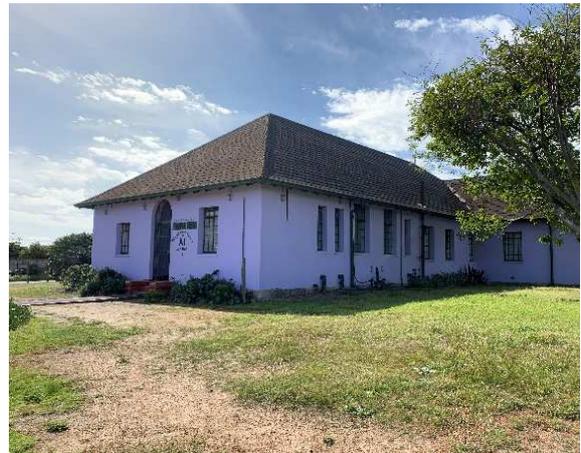
Figure 5: Block A - View of Exterior from Street (SVA, 2020)

RETAIN / DEMOLISH STRUCTURE	Retain
OCCUPIED / VACANT	Occupied
DESCRIPTION OF PLACE / CONTEXT	
Single story plastered brick modest structure with slate roof and steel-frame windows. Structure is somewhat isolated from the rest of the precinct being located on the northern boundary.	
GENERAL NOTES:	
Slate roof is a modern addition - original clay tile roof has been replaced at some point.	
RECOMMENDATIONS:	
General maintenance on roofs/gutters.	
The building is well suited for shared accommodation, a school or offices.

The block is in good condition and should be retained. It is well suited for shared accommodation such as a backpackers/guest house, or to house students. It could also be used as office space for businesses or small workshop spaces. It could also possibly be adapted and used by a school as well.

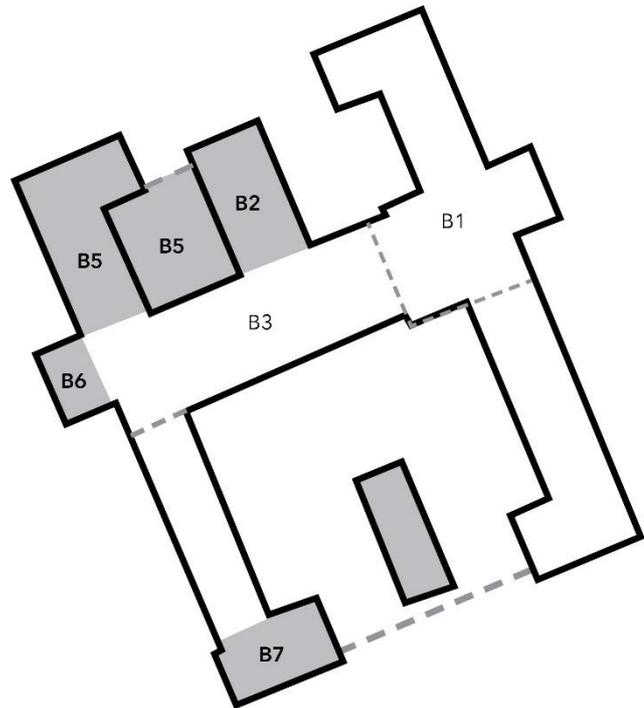
Figure 23: Block B - Plan. (SVA, 2020).

Majority of the structure has burnt down at some point in time and what remains is in poor condition. Most of the building is vacant, but there are a number of families living in the parts that have a roof.

The diagram to the right indicated the occupied areas of the building in grey, and the vacant areas in white.

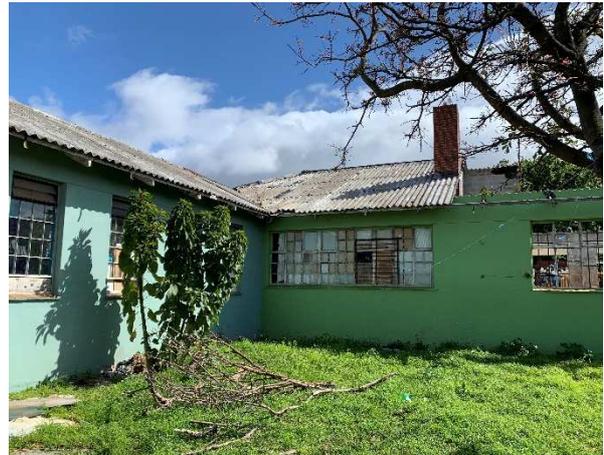
Figure 25: Block B - Unit B1. Exterior View. (SVA, 2020).

OCCUPIED / VACANT	Vacant
DESCRIPTION OF PLACE / CONTEXT	
Building was once a single-storey brick structure.	
GENERAL NOTES:	
Building is generally in a state of ruin.	
RECOMMENDATIONS:	
Roof could contain asbestos - investigation required if alterations are going to take place.	
The building is well suited for residential uses, schools, offices, workshops/studios, boutique retail, etc.

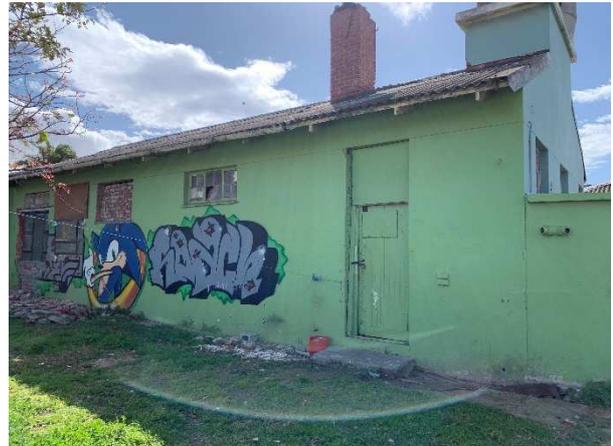
Figure 31: Block B - Unit B2. Exterior View. (SVA, 2020).

OCCUPIED / VACANT	Vacant
DESCRIPTION OF PLACE / CONTEXT	
Single story plastered brick modest structure with clay roof and steel-frame windows.	
GENERAL NOTES:	
Building is generally in fair condition overall. Lack of regular maintenance evident.	
RECOMMENDATIONS:	
Roof could contain asbestos - investigation required if alterations are going to take place.	
The building is well suited for residential uses, schools, offices, workshops/studios, boutique retail, etc.

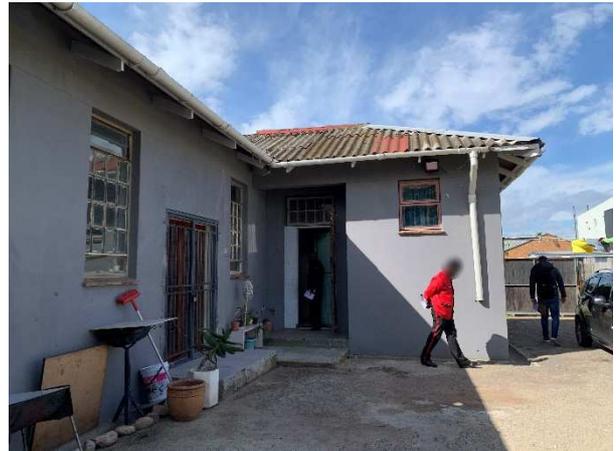
Figure 33: Block B - Unit B5. Exterior View. (SVA, 2020).

DESCRIPTION OF PLACE / CONTEXT	
Single story plastered brick modest structure with clay roof and steel-frame windows.	
GENERAL NOTES:	
Structure is in fair overall condition with lack of maintenance evident to exterior.	
RECOMMENDATIONS:	
Buildings requires roof and general exterior maintenance.	
The building is well suited for residential uses, schools, offices, workshops/studios, boutique retail, etc.

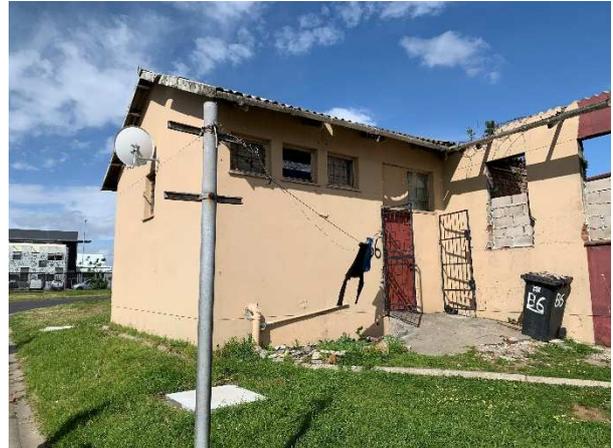
Figure 37; Block B - Unit B6. Exterior View. (SVA, 2020).

DESCRIPTION OF PLACE / CONTEXT	
Single story plastered brick modest structure with clay roof and steel-frame windows.	
GENERAL NOTES:	
Structure is in fair overall condition with little maintenance evident to exterior. Lack of regular maintenance evident.	
RECOMMENDATIONS:	
Buildings requires roof and general maintenance. Roof could contain asbestos - investigation required if alterations are going to take place.	
The building is well suited for residential uses, schools, offices, workshops/studios, boutique retail, etc.

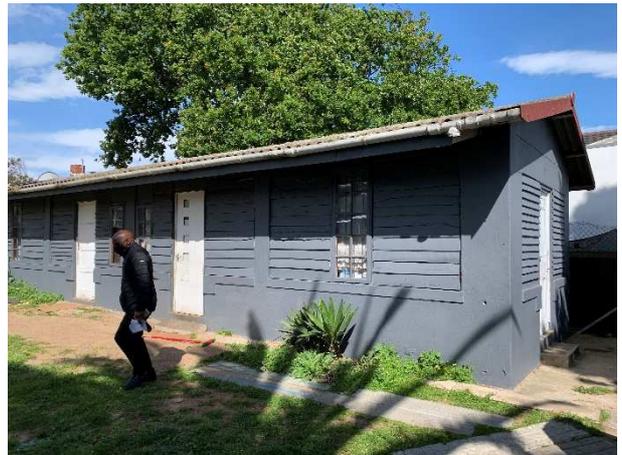
Figure 39: Block B - Unit B7. Exterior View. (SVA, 2020).

OCCUPIED / VACANT	Occupied
DESCRIPTION OF PLACE / CONTEXT	
Single story plastered brick modest structure with clay roof and steel-frame windows.	
GENERAL NOTES:	
Structure is in fair overall condition with little maintenance evident to exterior. Lack of regular maintenance evident.	
RECOMMENDATIONS:	
Urgent Action: Buildings require roof and general maintenance. Roof could contain asbestos - investigation required if alterations are going to take place.	
The building is well suited for residential uses, schools, offices, workshops/studios, boutique retail, etc.

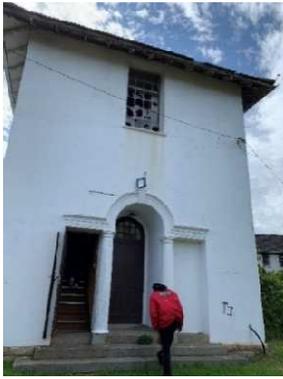
OCCUPIED / VACANT	Occupied
DESCRIPTION OF PLACE / CONTEXT	
2-story plastered brick structure with clay tile roof, wooden floors and timber-frame windows.	
GENERAL NOTES:	
Vacant for over 12 months at present. Lack of regular maintenance evident. This space includes a well-preserved example of the original ward layout.	
RECOMMENDATIONS:	
General roof and exterior maintenance.	
The building is well suited for residential uses, schools, offices, workshops/studios, or boutique retail,

Figure 56: Block C - Unit C6. Exterior View and Interior Walkway. (SVA, 2020).

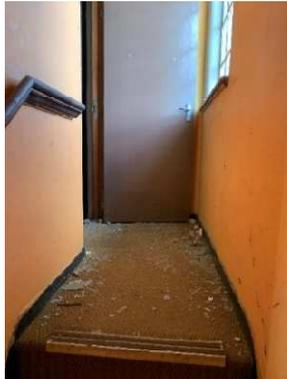
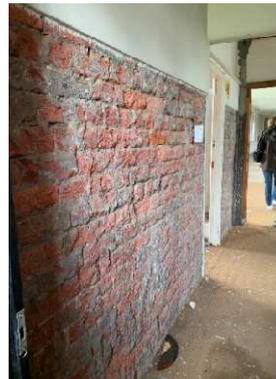
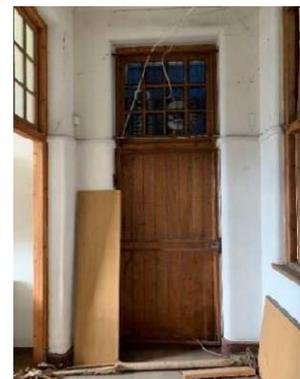
Figure 57: Block C - Unit C6. Interior Views (SVA, 2020).

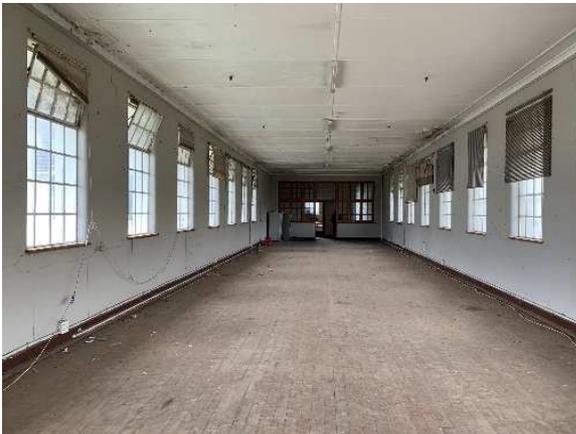
Figure 58: Block C - Unit C6. Interior View (SVA, 2020).

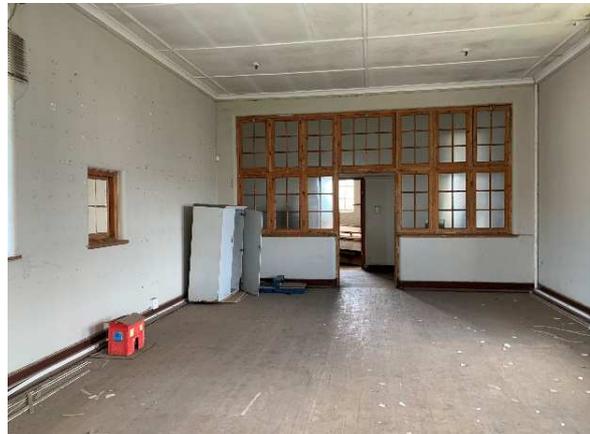
Figure 59: Block C - Unit C6. Interior View (SVA, 2020).

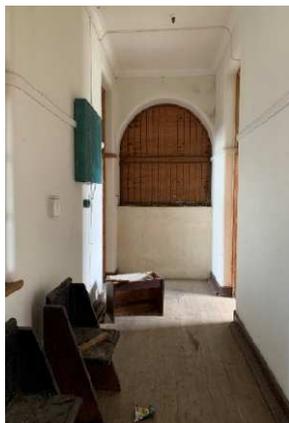
Figure 60: Block C - Unit C6. Interior Views (SVA, 2020).

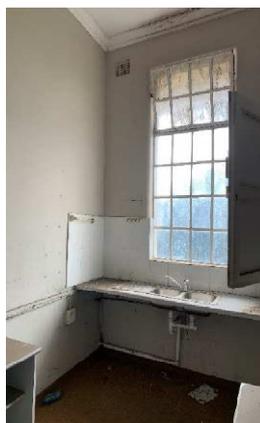
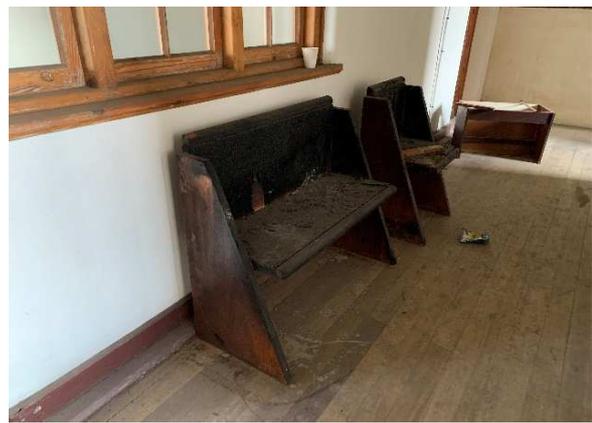
Figure 61: Block C - Unit C6. Furniture. (SVA, 2020).

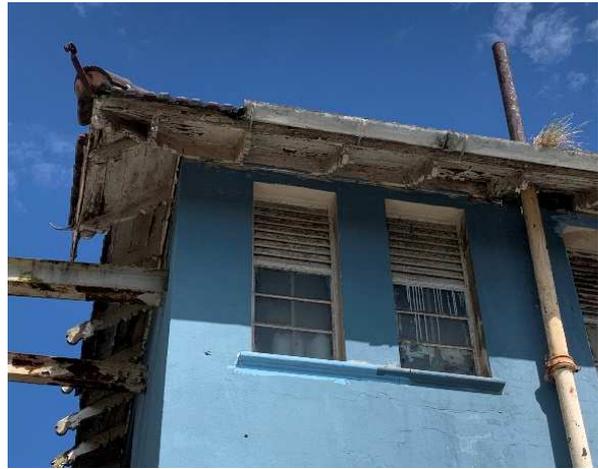
Interior is in poor condition overall.	
RETAIN / DEMOLISH STRUCTURE	Retain
OCCUPIED / VACANT	Occupied
DESCRIPTION OF PLACE / CONTEXT	
2-storey plastered brick structure with clay tile roof, wooden floors and timber-frame windows.	
GENERAL NOTES:	
Lack of regular maintenance evident - structure has deteriorated considerably over the years.	
RECOMMENDATIONS:	
Structural assessment of roof required. General roof and exterior maintenance.	
The building is well suited for residential uses, schools, offices, workshops/studios, or boutique retail,

Figure 63: Block C- Unit C7. Exterior View of Roof and Windows. (SVA, 2020).

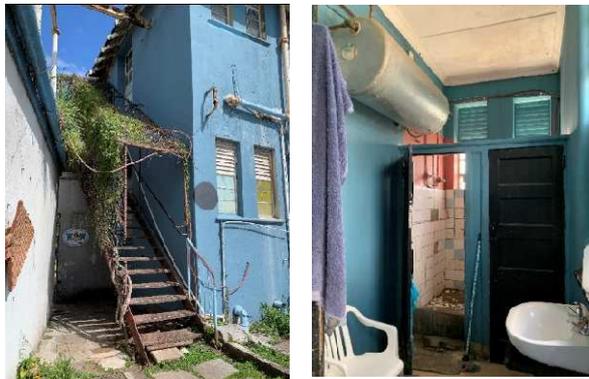
Figure 64: Block C- Unit C7. Exterior and Interior Views. (SVA, 2020).

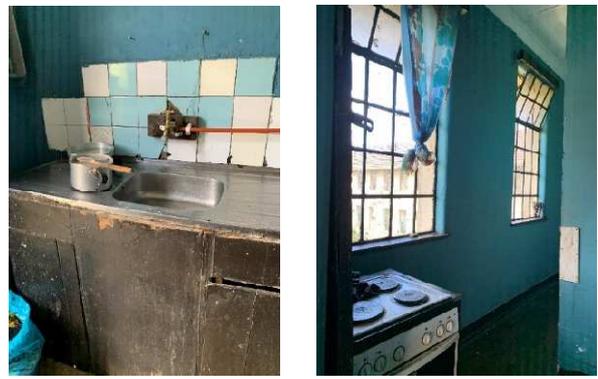
Figure 65: Block C- Unit C7. Interior Views. (SVA, 2020).

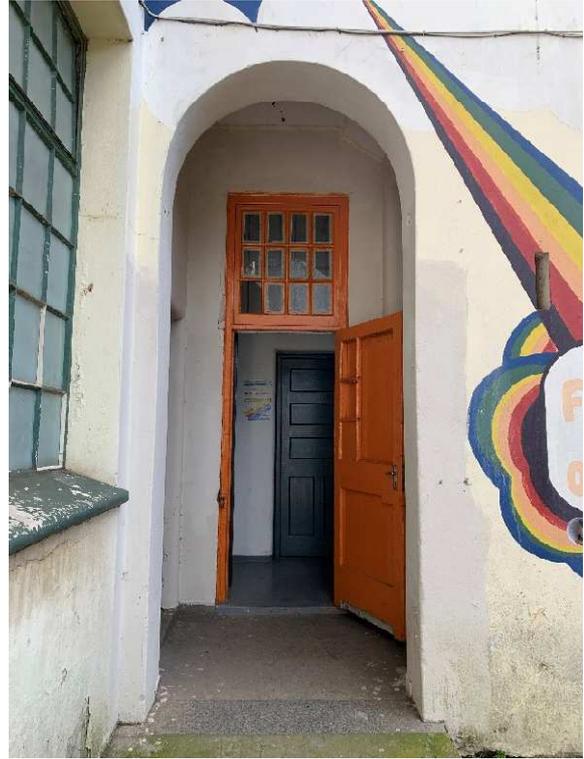
Interior	Poor
General Comments:	
Interior is in poor condition overall.	
RETAIN / DEMOLISH STRUCTURE	Retain
OCCUPIED / VACANT	Occupied
DESCRIPTION OF PLACE / CONTEXT	
2-story plastered brick structure with clay tile roof, wooden floors and timber-frame windows.	
GENERAL NOTES:	
Lack of regular maintenance evident - structure has deteriorated considerably over the years.	
RECOMMENDATIONS:	
Structural assessment of roof required. General roof and exterior maintenance.	
The building is well suited for residential uses, schools, offices, workshops/studios, or boutique retail,

Figure 67: Block C - Unit C8/1 & C8/2. Exterior View. (SVA, 2020).

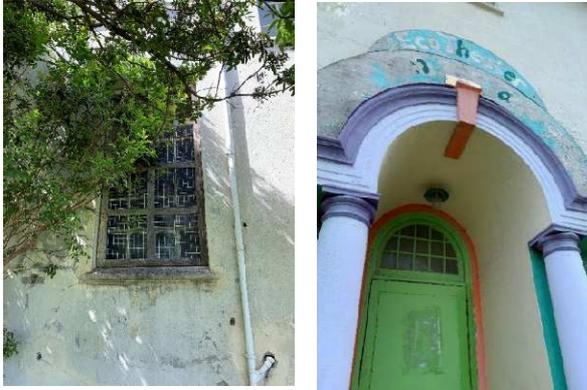
OCCUPIED / VACANT	Occupied
DESCRIPTION OF PLACE / CONTEXT	
2-story plastered brick structure with clay tile roof, wooden floors and timber-frame windows.	
CURRENT USE:	
Current use/s	Residential
GENERAL NOTES:	
Ongoing Sewer drainage issues and roof leaks. Lack of regular maintenance evident.	
RECOMMENDATIONS:	
General roof and exterior maintenance.	
The building is well suited for residential uses, schools, offices, workshops/studios, or boutique retail.

Figure 68: Block C - Unit C2/C9 - Exterior Views (SVA, 2020).

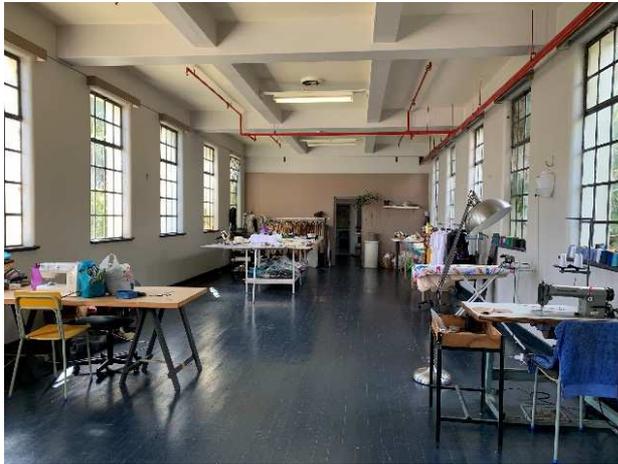
Interior	Good/ Fair
General Comments:	
Building interior is well maintained overall.	
RETAIN / DEMOLISH STRUCTURE	Retain
OCCUPIED / VACANT	Occupied
DESCRIPTION OF PLACE / CONTEXT	
2-story plastered brick structure with clay tile roof, wooden floors and timber-frame windows.	
GENERAL NOTES:	
Lack of regular maintenance evident.	
RECOMMENDATIONS:	
General roof and exterior maintenance.	
The building is well suited for residential uses, schools, offices, workshops/studios, boutique retail.

Figure 82: Block D - Unit D2. Interior View. (SVA, 2020).

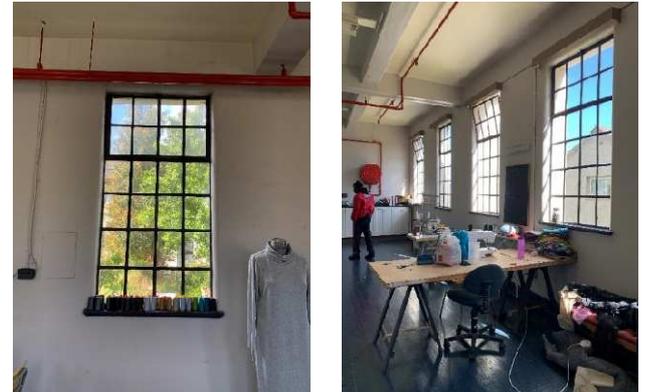
Figure 85: Views of Interior Windows

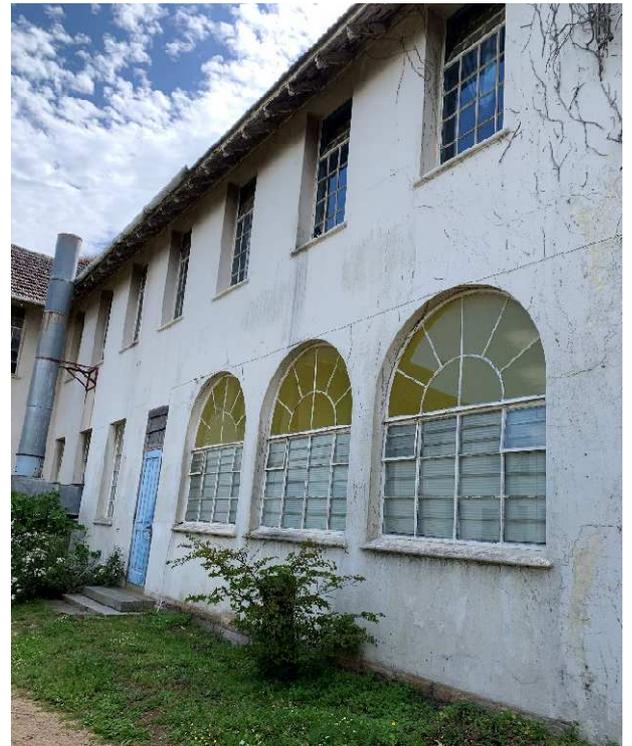
Figure 87: Block D - Unit D3. Exterior View (SVA, 2020).

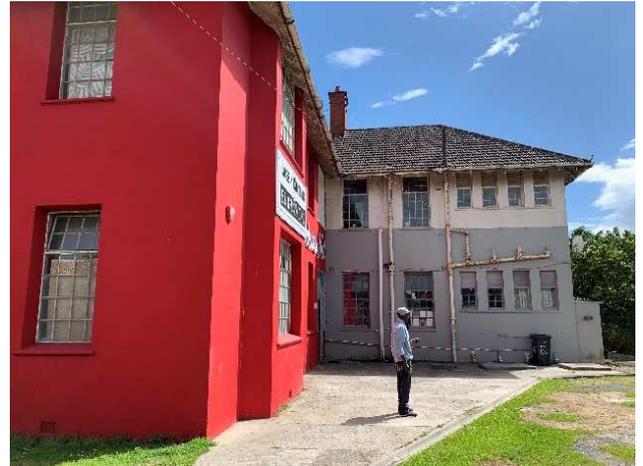
Figure 91: Block D - Unit D 4, 5, 7. Exterior View. (SVA, 2020).

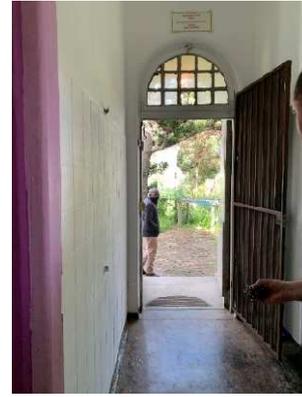
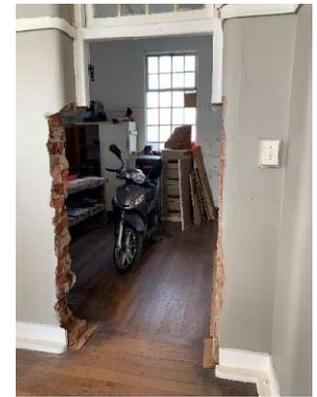
GENERAL CONDITION - INTERIOR:	
Interior	Fair
General Comments:	
Building interior is in fair condition overall.	
RETAIN / DEMOLISH STRUCTURE	Retain
OCCUPIED / VACANT	Occupied
DESCRIPTION OF PLACE / CONTEXT	
2-story plastered brick structure with clay tile roof, wooden floors and timber-frame windows.	
GENERAL NOTES:	
Lack of regular maintenance evident.	
RECOMMENDATIONS:	
General roof and exterior maintenance.	
The building is well suited for residential uses, schools, offices, workshops/studios, boutique retail.

Figure 93: Block D - Unit D 4, 5, 7. Interior Views. (SVA, 2020).

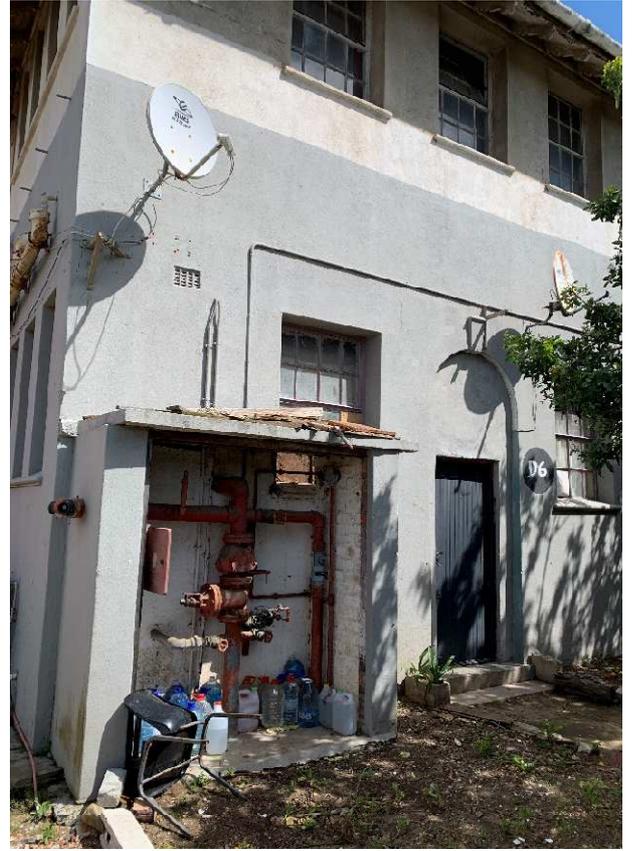
Figure 99: Block D - Unit D6. Exterior View. (SVA, 2020).

RETAIN / DEMOLISH STRUCTURE	Retain
OCCUPIED / VACANT	Occupied
DESCRIPTION OF PLACE / CONTEXT	
2-story plastered brick structure with clay tile roof, wooden floors and timber-frame windows.	
GENERAL NOTES:	
Lack of regular maintenance evident.	
RECOMMENDATIONS:	
General roof and exterior maintenance.	
The building is well suited for residential uses, schools, offices, workshops/studios, boutique retail.

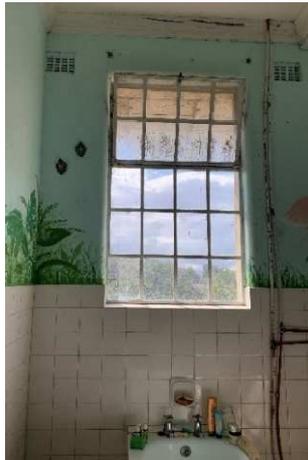
Interior	Good/ Fair
General Comments:	
Possibly the best-preserved original interior of the entire Medical Facility	
RETAIN / DEMOLISH STRUCTURE	Retain
OCCUPIED / VACANT	Occupied
DESCRIPTION OF PLACE / CONTEXT	
2-story plastered brick structure with clay tile roof, wooden floors and timber-frame windows.	
GENERAL NOTES:	
Lack of regular maintenance evident.	
RECOMMENDATIONS:	
General roof and exterior maintenance. Interior should be preserved as it is mostly original.	
The building is well suited for residential uses, schools, offices, workshops/studios, boutique retail.

Figure 100: Block D - Unit D10. Interior Views of original Bathroom (SVA, 2020).

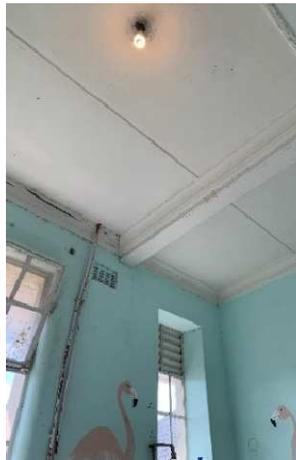
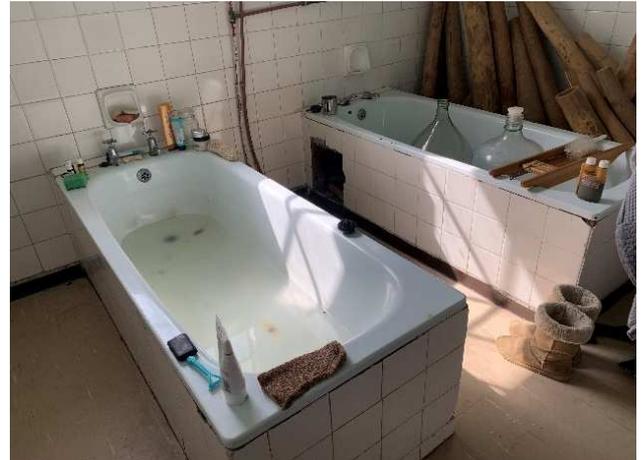
Figure 101: Block D - Unit D10. Interior View of original Bathroom (SVA, 2020).

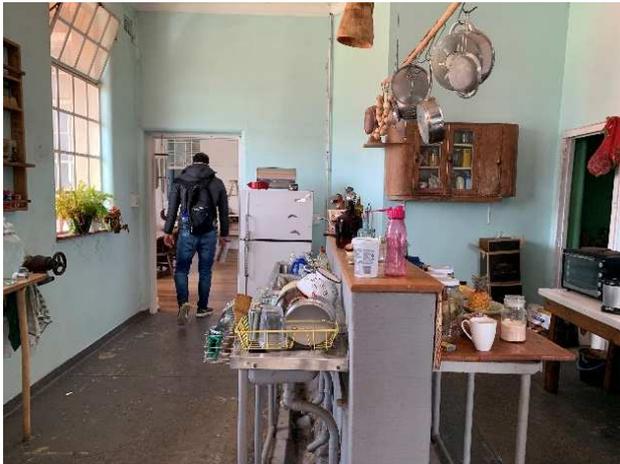
Figure 106: Block D - Unit D10. Interior View of original ablation facilities, now used as a kitchen. (SVA, 2020).

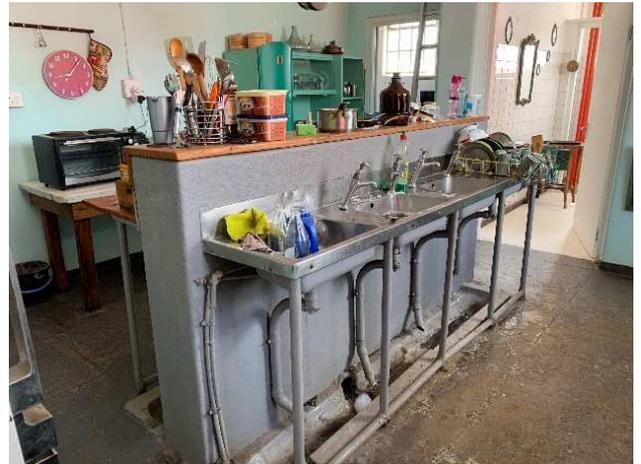
Figure 107: Block D - Unit D10. Interior View of original ablation facilities, now used as a kitchen. (SVA, 2020).

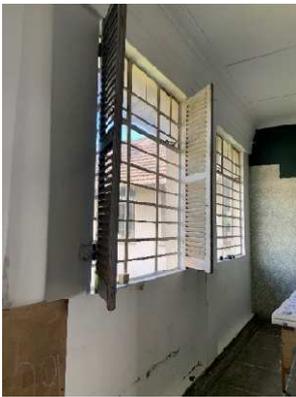
Figure 108: Block D - Unit D10. Interior Views of windows and fireplace. (SVA, 2020).

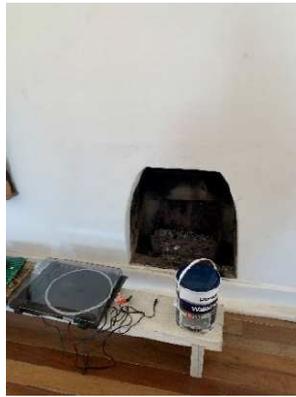
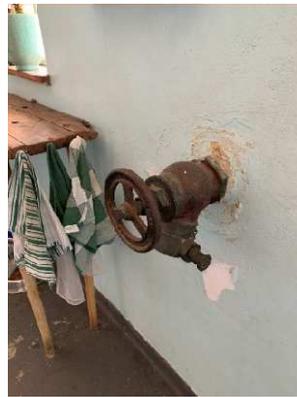
Figure 109: Block D - Unit D10. Interior Views of ablutions and retro-fitted fire services. (SVA, 2020).

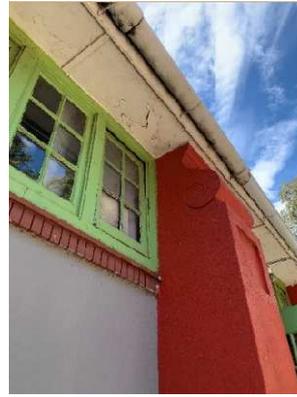
It is generally in a fair condition, but lack of regular maintenance is evident. The interior spaces tend to be fairly well maintained by the tenants.

Figure 115: Exterior View of Wall

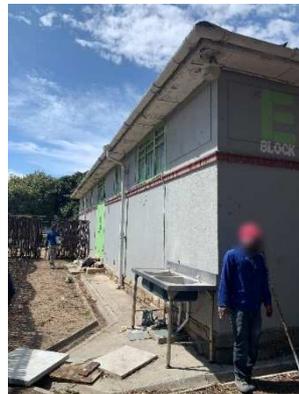
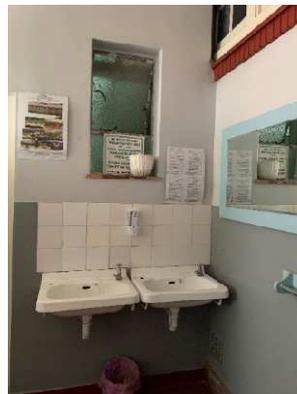
Figure 119: Interior Views of Ablutions (added at a later date). (SVA, 2020).

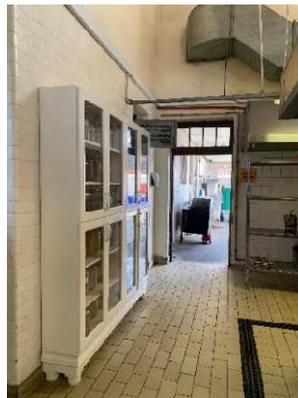
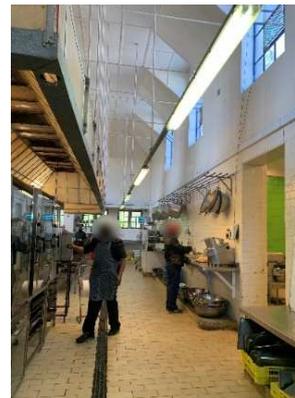
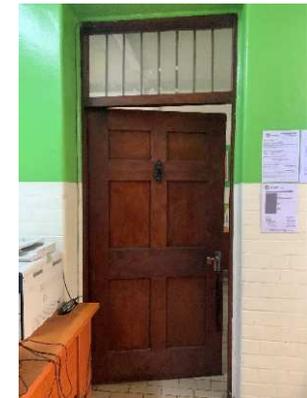
Figure 125: Unit E-1. Interior View. (SVA, 2020).

This building is in generally good condition. It is well suited to be used for gatherings, indoor activities and could be used to host a small market. The supporting spaces could be used on a permanent commercial basis as they currently are, or could be used as service spaces when the main hall space is in use.

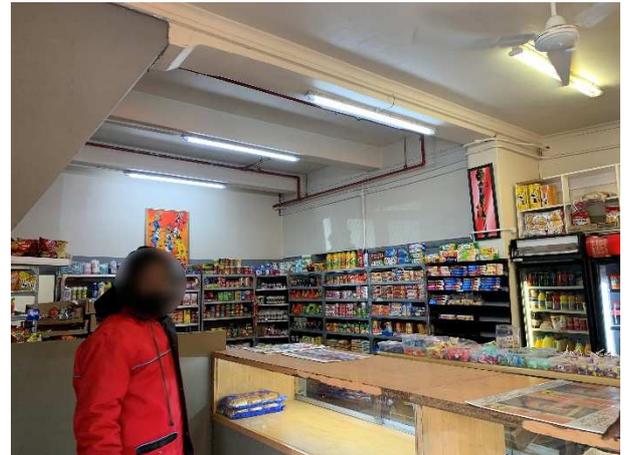
Figure 129: Block F - Unit F1. Interior View, (SVA, 2020).

This Café is a later addition and is not part of the original ward building.	
GENERAL NOTES:	
Lack of regular maintenance evident.	
RECOMMENDATIONS:	
General roof and exterior maintenance.	
The building is well suited for residential uses, schools, offices, workshops/studios, or boutique retail.

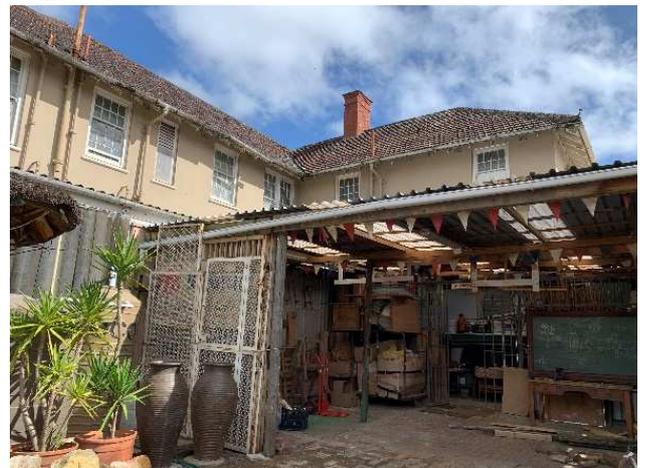
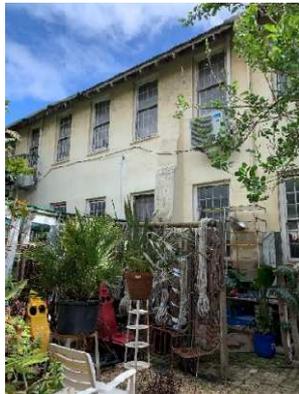
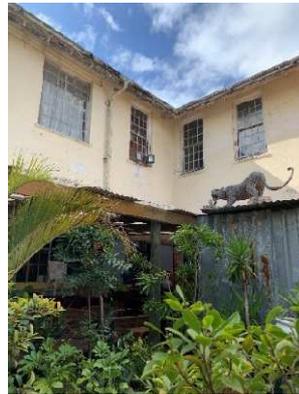
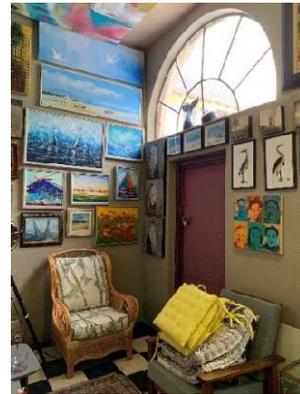
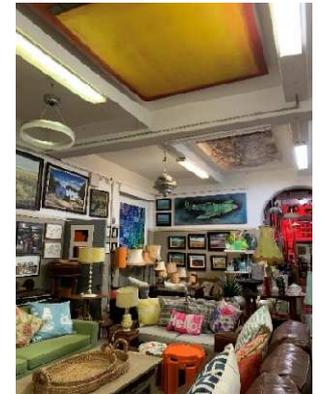
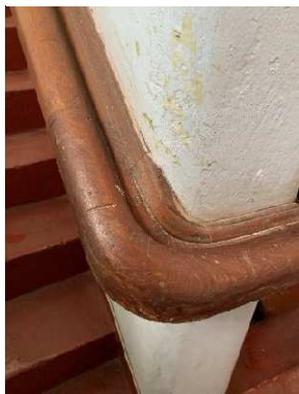
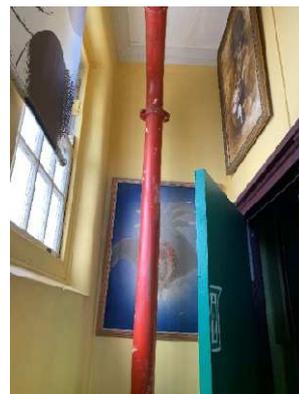
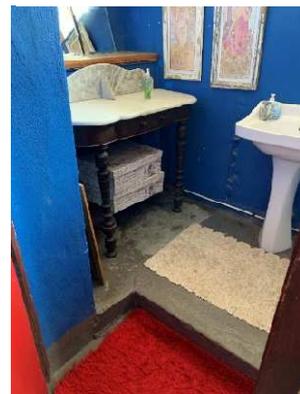
General Comments:	
Building interior is fairly good condition overall.	
RETAIN / DEMOLISH STRUCTURE	Retain
OCCUPIED / VACANT	Occupied
DESCRIPTION OF PLACE / CONTEXT	
2-story plastered brick structure with clay tile roof, wooden floors and timber-frame windows.	
GENERAL NOTES:	
Lack of regular exterior maintenance evident.	
RECOMMENDATIONS:	
General roof and exterior maintenance.	
The building is well suited for residential uses, schools, offices, workshops/studios, or boutique retail.

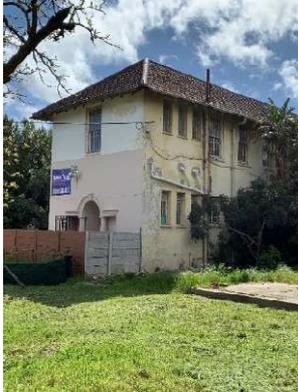
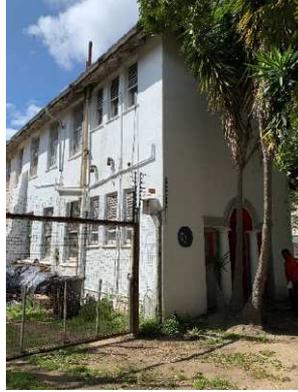
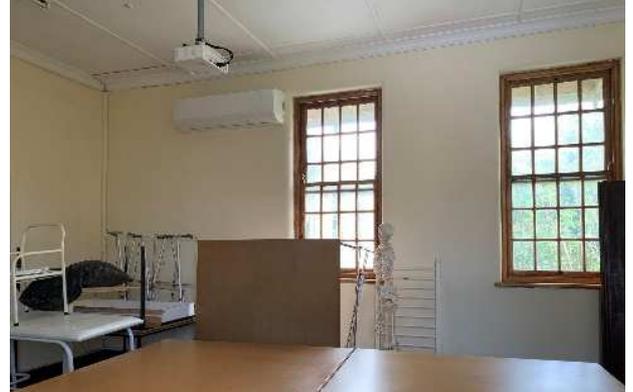
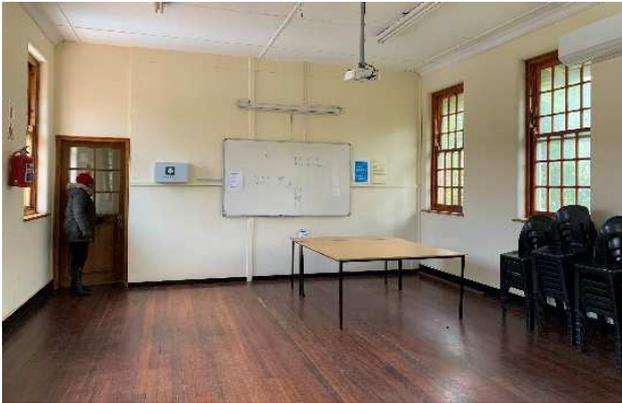
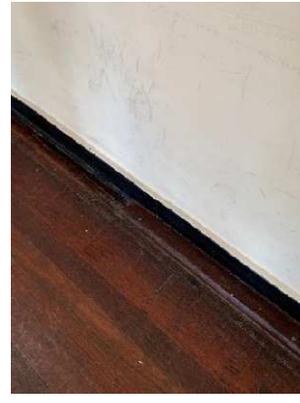
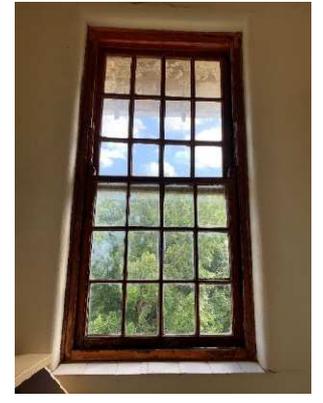
NAME AND LOCATION:	
Stand number/s	26439
Township	Pinelands, Cape Town
Street address	Oude Molen Eco-Village - Unit F5
GIS reference	33°56'21.37"S / 18°29'21.19"E
Name of place	Robin Trust Training College
Previous/alternative name/s	Valkenberg East Psychiatric Hospital
Unit Number	F5
ARCHITECT	DATE OF COMPLETION
Unknown	1920s
BUILDING STYLE	BUILDING TYPE
Utilitarian	Medical Facility Ward
TITLE DEED INFORMATION	
n/a	
NOTABLE SITE FEATURES	
Well-developed courtyard gardens albeit with lack of regular maintenance. Views toward river on the west.	
ENVIRONMENT	
Surrounding buildings are of similar scale - 2 storeys in height. Part of Block F of the original Medical Facility.	
PREVIOUS USE	CURRENT USE
Medical Facility Ward	Training Facility
GENERAL CONDITION - EXTERIOR:	
Roofs	Fair
Walls	Fair
Doors / Windows	Fair
General Comments:	
Building exterior is in fair condition overall	
GENERAL CONDITION - INTERIOR:	
Interior	Good/ Fair

General Comments:	
Building interior is fairly good condition overall.	
RETAIN / DEMOLISH STRUCTURE	Retain
OCCUPIED / VACANT	Occupied
DESCRIPTION OF PLACE / CONTEXT	
2-storey plastered brick structure with clay tile roof, wooden floors and timber-frame windows.	
GENERAL NOTES:	
Lack of regular maintenance evident.	
RECOMMENDATIONS:	
General roof and exterior maintenance.	
The building is well suited for residential uses, schools, offices, workshops/studios, or boutique retail.

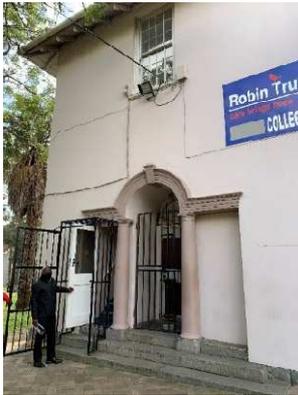
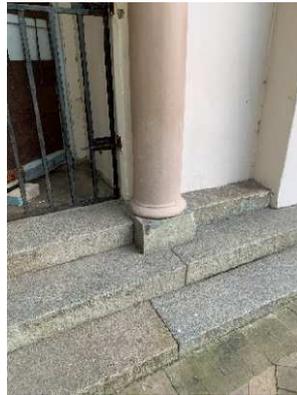
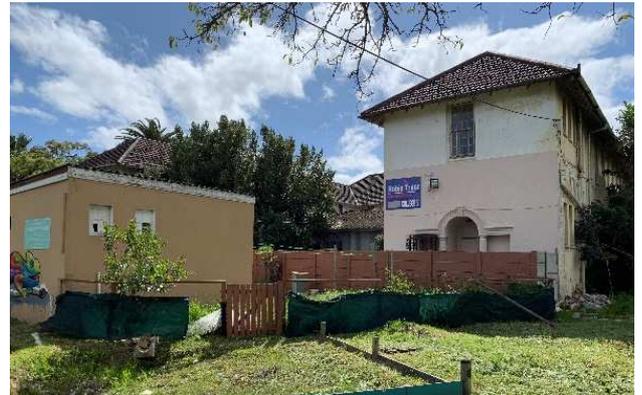
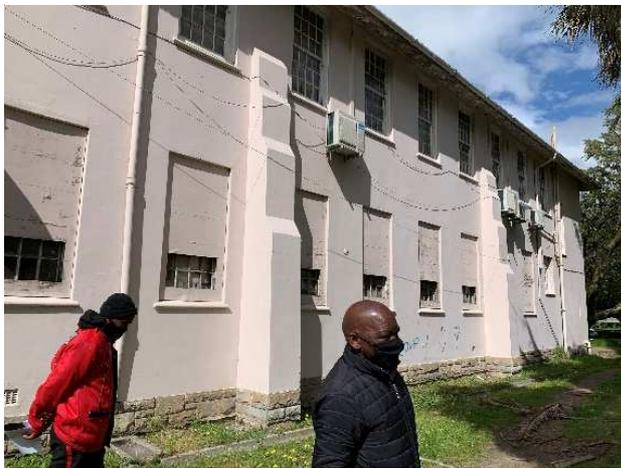
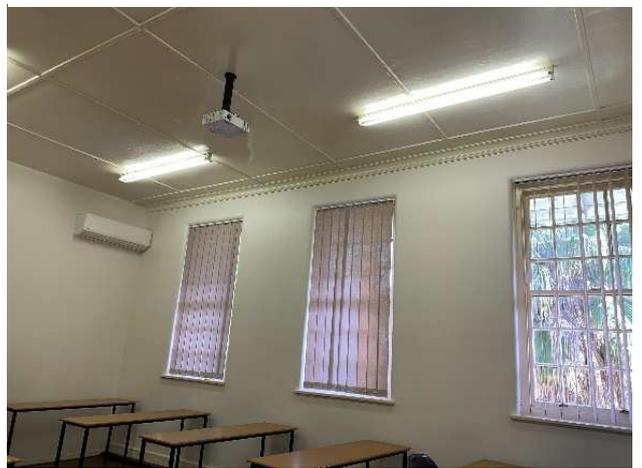
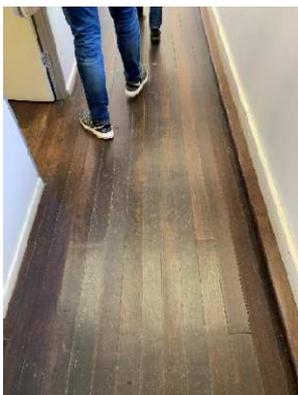
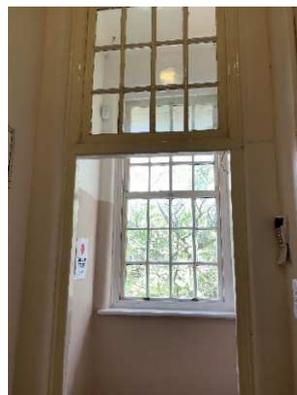
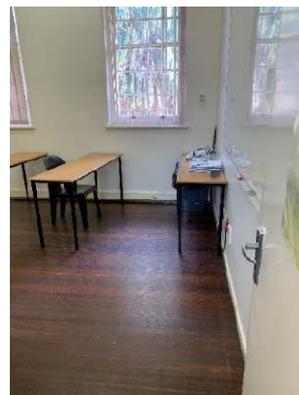
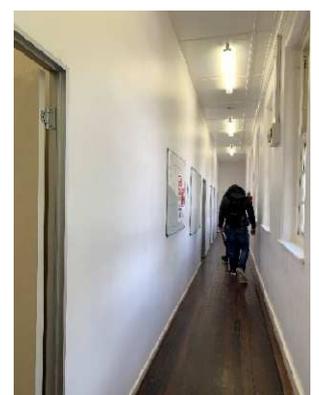
General Comments:	
Building interior is fairly good condition overall.	
RETAIN / DEMOLISH STRUCTURE	Retain
OCCUPIED / VACANT	Occupied
DESCRIPTION OF PLACE / CONTEXT	
2-storey plastered brick structure with clay tile roof, wooden floors and timber-frame windows.	
GENERAL NOTES:	
Lack of regular maintenance evident.	
RECOMMENDATIONS:	
General roof and exterior maintenance.

The building is well suited for residential uses, schools, offices, workshops/studios, or boutique retail.

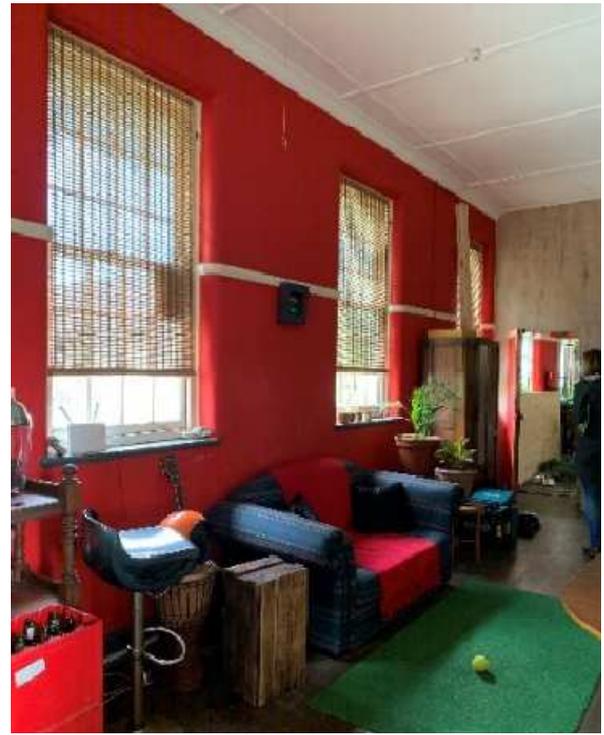
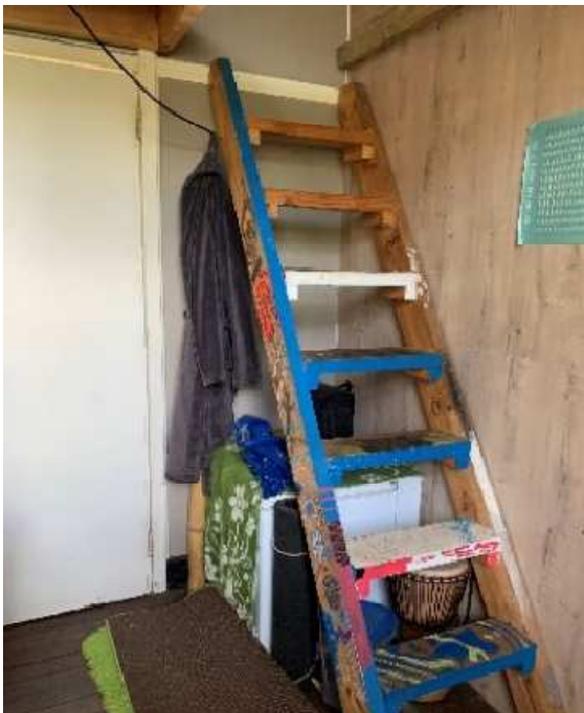
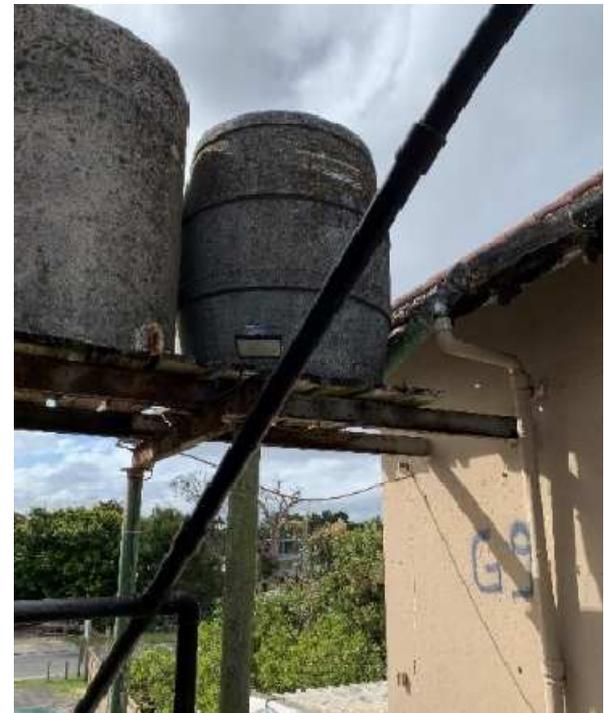
General Comments:	
Building interior is fairly good condition overall.	
RETAIN / DEMOLISH STRUCTURE	Retain
OCCUPIED / VACANT	Occupied
DESCRIPTION OF PLACE / CONTEXT	
2-story plastered brick structure with clay tile roof, wooden floors and timber-frame windows.	
GENERAL NOTES:	
Lack of regular maintenance evident.	
RECOMMENDATIONS:	
General roof and exterior maintenance.	
The building is well suited for residential uses, schools, offices, workshops/studios, or boutique retail.

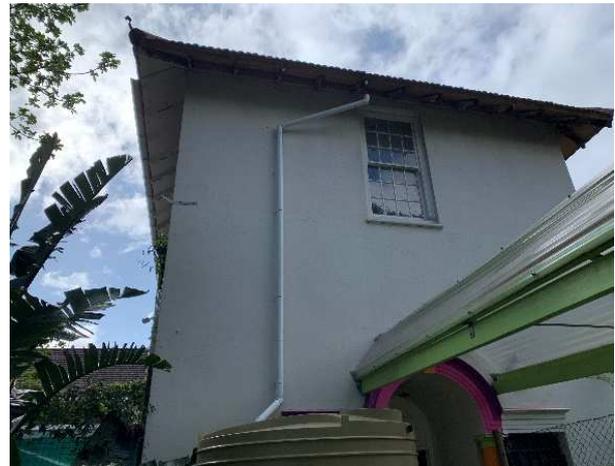
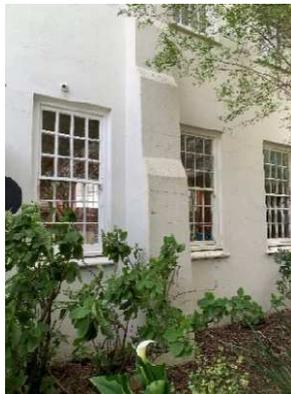
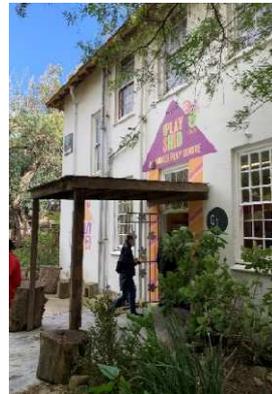
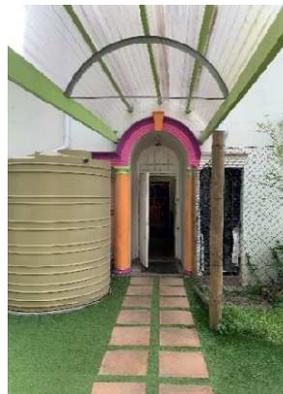
RETAIN / DEMOLISH STRUCTURE	Retain
OCCUPIED / VACANT	Occupied
DESCRIPTION OF PLACE / CONTEXT	
2-story plastered brick structure with clay tile roof, wooden floors and timber-frame windows.	
GENERAL NOTES:	
Lack of regular exterior maintenance evident.	
RECOMMENDATIONS:	
General roof and exterior maintenance.	
The building is well suited for residential uses, schools, offices, workshops/studios, or boutique retail.

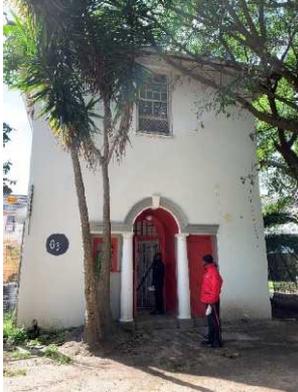
OCCUPIED / VACANT	Occupied
DESCRIPTION OF PLACE / CONTEXT	
2-story plastered brick structure with clay tile roof, wooden floors and timber-frame windows.	
GENERAL NOTES:	
Lack of regular exterior maintenance evident.	
RECOMMENDATIONS:	
General roof and exterior maintenance.	
The building is well suited for residential uses, schools, offices, workshops/studios, or boutique retail.

Figure 165: Block G - Unit G3. Exterior Views. (SVA, 2020).

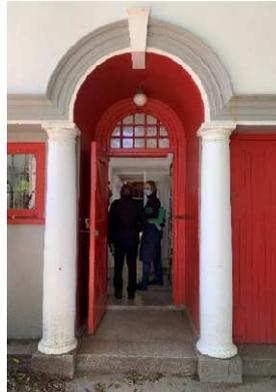
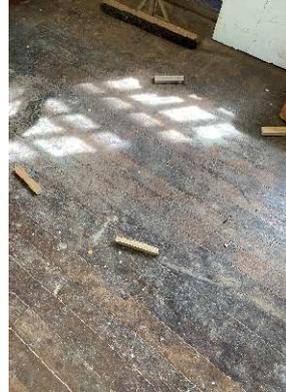
Figure 166: Block G - Unit G3. Interior Views. (SVA, 2020).

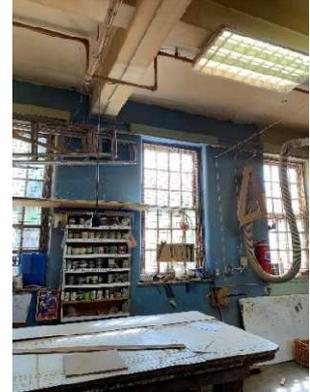
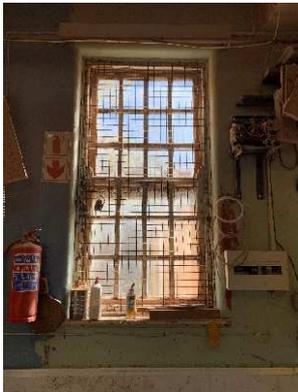
Figure 167: Block G - Unit G3. Interior Views. (SVA, 2020).

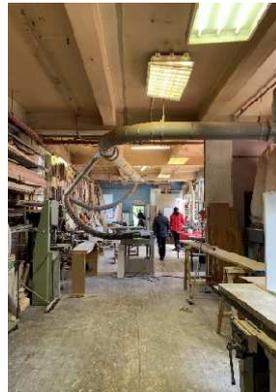
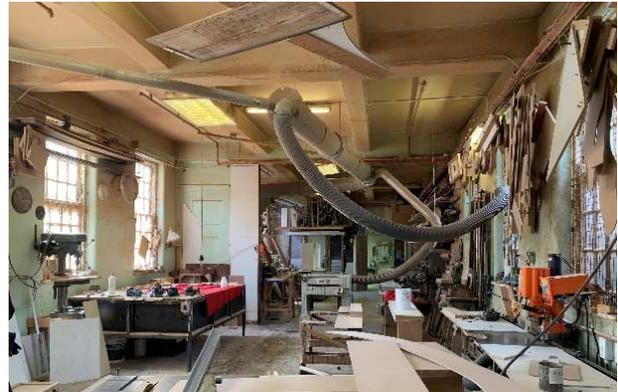
Figure 168: Block G - Unit G3. Interior View. (SVA, 2020).

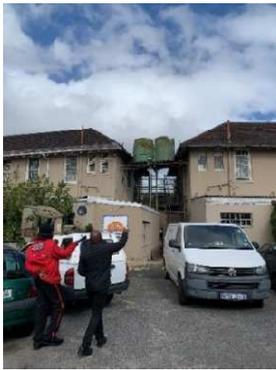
RETAIN / DEMOLISH STRUCTURE	Retain
OCCUPIED / VACANT	Occupied
DESCRIPTION OF PLACE / CONTEXT	
2-storey plastered brick structure with clay tile roof, wooden floors and timber-frame windows.	
GENERAL NOTES:	
Lack of regular exterior maintenance evident.	
RECOMMENDATIONS:	
Structural assessment of certain balconies and existing roof elements required. General roof and exterior maintenance.	
The building is well suited for residential uses, schools, offices, workshops/studios, or boutique retail.

Figure 169: Block G - River Lodge Backpackers. Exterior View. (SVA, 2020).

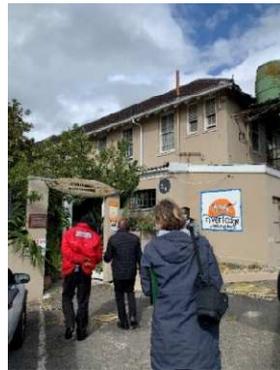
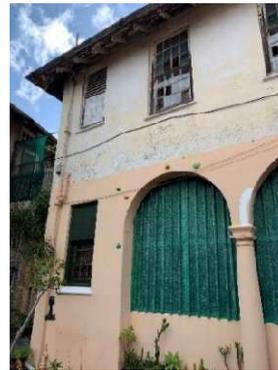
Figure 170: Block G - River Lodge Backpackers. Exterior View. (SVA, 2020).

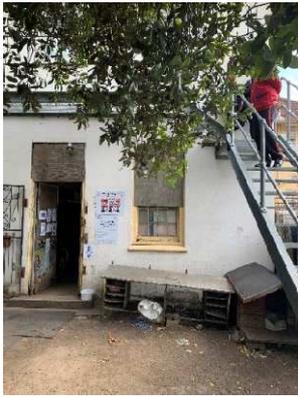
RETAIN / DEMOLISH STRUCTURE	Retain
OCCUPIED / VACANT	Occupied
DESCRIPTION OF PLACE / CONTEXT	
2-story plastered brick structure with clay tile roof, wooden floors and timber-frame windows.	
GENERAL NOTES:	
Lack of regular exterior maintenance evident.	
RECOMMENDATIONS:	
General roof and exterior maintenance.	
The building is well suited for residential uses, schools, offices, workshops/studios, or boutique retail.

Figure 180: Block G - Unit G7. Exterior View. (SVA, 2020).

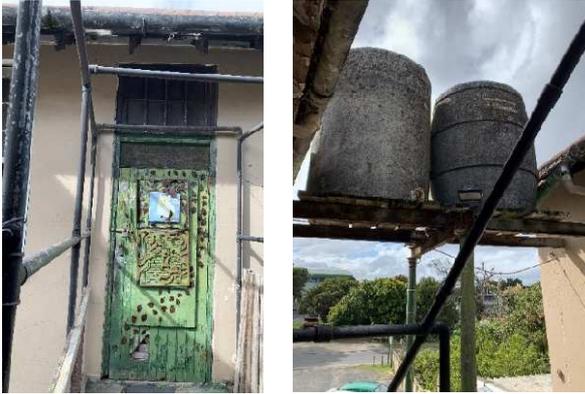
OCCUPIED / VACANT	Occupied
DESCRIPTION OF PLACE / CONTEXT	
2-storey plastered brick structure with clay tile roof, wooden floors and timber-frame windows.	
GENERAL NOTES:	
Lack of regular exterior maintenance evident.	
RECOMMENDATIONS:	
General roof and exterior maintenance.	
The building is well suited for residential uses, schools, offices, workshops/studios, or boutique retail.

Figure 184: Block G - Unit G9. Exterior Views and Features. (SVA, 2020).

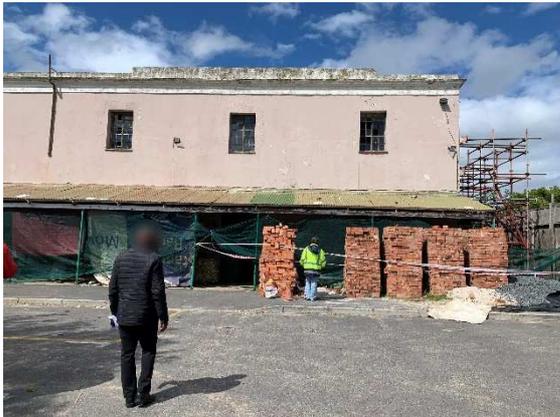
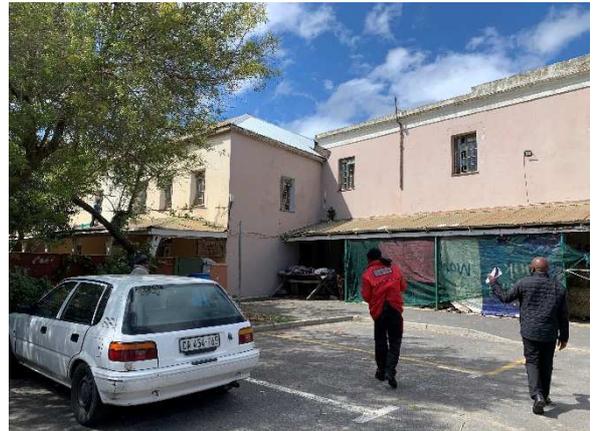
Despite its heritage and historical significance the structure has suffered partial collapse in recent years due to ongoing lack of maintenance and is in urgent need of repair in order to preserve its integrity.

Exterior is in poor condition overall and in a state of collapse.	
RETAIN / DEMOLISH STRUCTURE	Retain
OCCUPIED / VACANT	Vacant
DESCRIPTION OF PLACE / CONTEXT	
2-story plastered brick structure with clay tile roof, wooden floors and timber-frame windows.	
GENERAL NOTES:	
Structure is of very high heritage and historical significance.	
RECOMMENDATIONS:	
Urgent Action: Structure requires urgent roof repairs as well structural integrity stabilisation of existing walls in order to limit further damage.	
The building is well suited for a museum / tourist visitors centre.

Figure 196: Block H - Unit H1. Exterior View. (SVA, 2020).

Figure 197: Block H - Unit H1. Exterior View. (SVA, 2020).
