DESKTOP STUDY OF EXISTING BUILDINGS

OUDE MOLEN PRECINCT, CAPE TOWN

08 December 2020

Draft Report - Revision 03

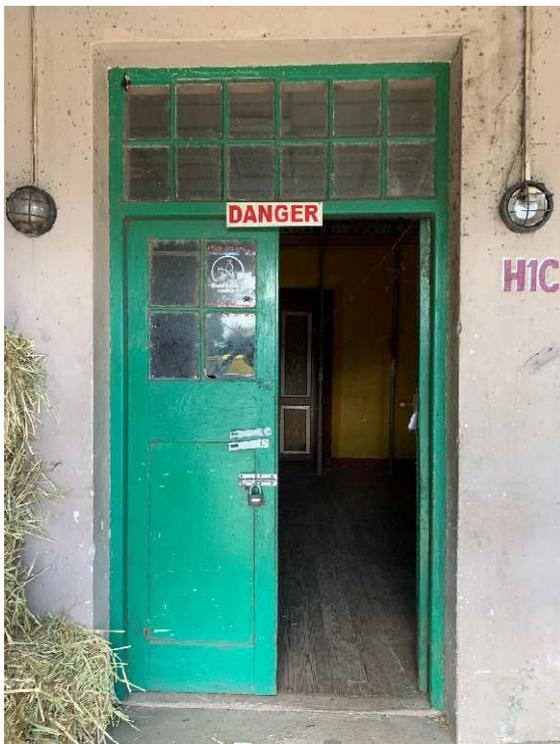
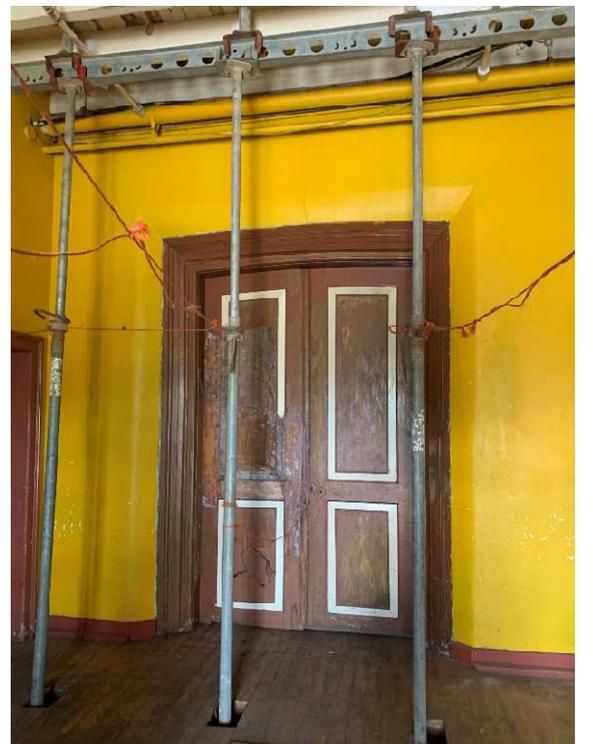
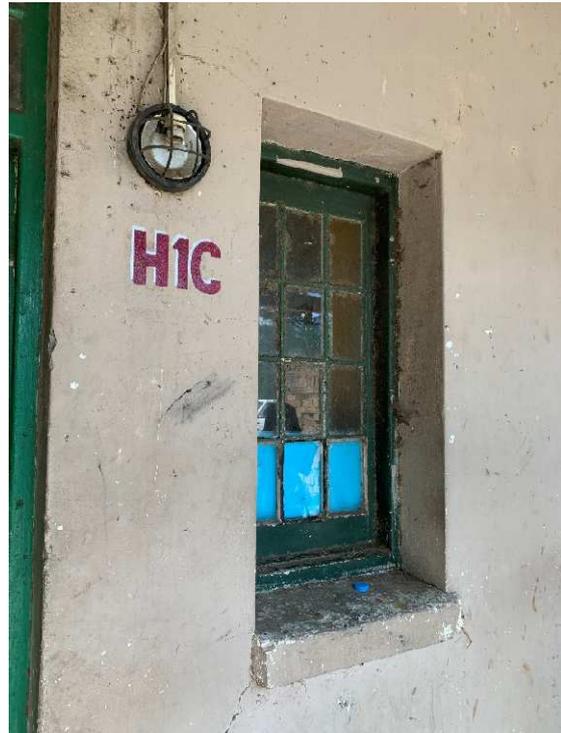
Figure 198: Block H - Unit H1. Feature Elements. (SVA, 2020).

Figure 199: Block H - Unit H1. Feature Elements. (SVA, 2020).

Figure 205: Block H - Unit H1. Feature Elements. (SVA, 2020).

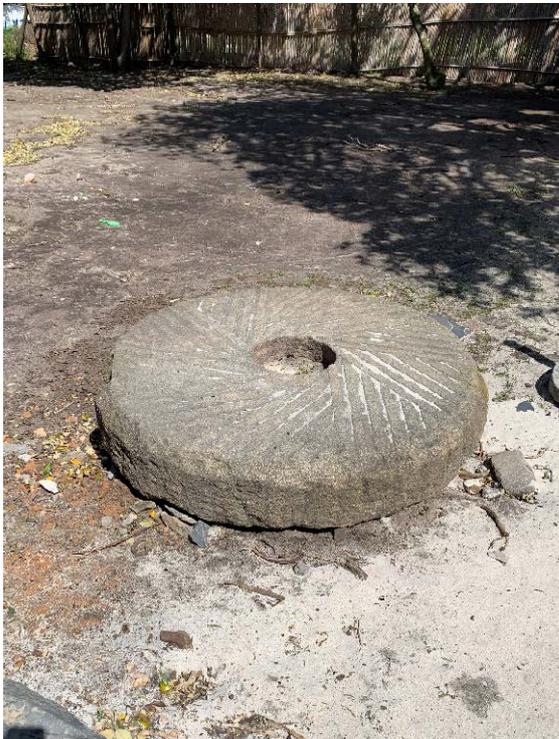
Figure 206: Block H - Unit H1. Old Mill Stone. (SVA, 2020).

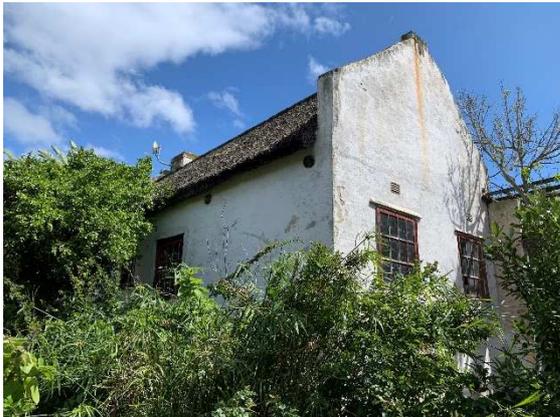
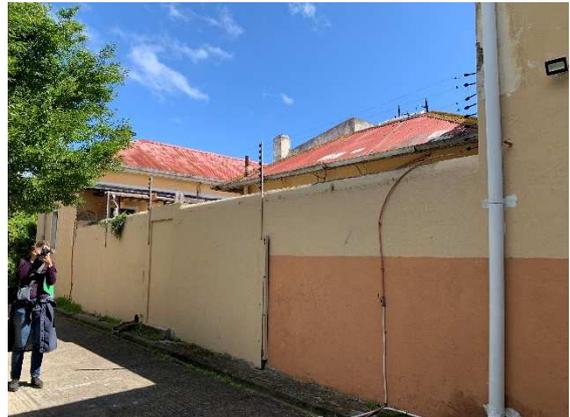
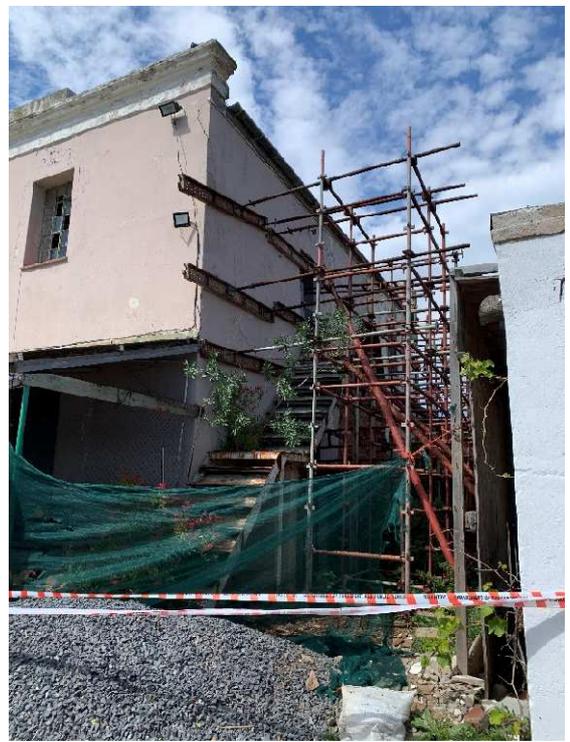
Figure 208: Block H - Unit H1. Exterior View. (SVA, 2020).

Figure 209: Block H - Unit H1. Exterior View. (SVA, 2020).

Figure 211: Block H - Unit H1. Exterior View. (SVA, 2020).

The Homestead is in a critical state of neglect. The majority of the building is vacant as it is too unsafe to occupy, having been unmaintained by the Western Cape Government (WCG) Department of Public Works (DPW) with the collapsed wall and damaged roof structure exposed to the elements since 2017, increasing the chances of total wall and part building collapse. Old yellowwood ceiling beams and some wide doorways survive, but all old joinery has been smothered in layers of paint (D. Hart 1997: 4 in Hislop 2020). The remaining casement windows in the *voorhuis* are in a very bad condition.

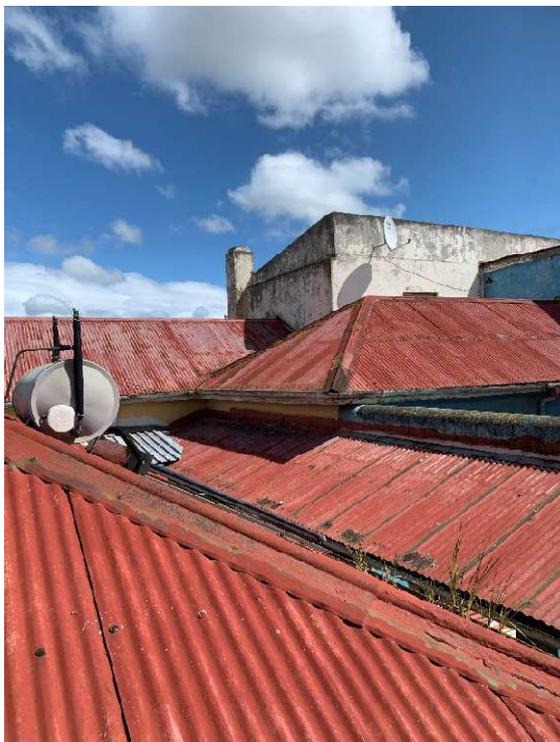
Figure 210: Block H - Unit H1. View of Roof. (SVA, 2020).

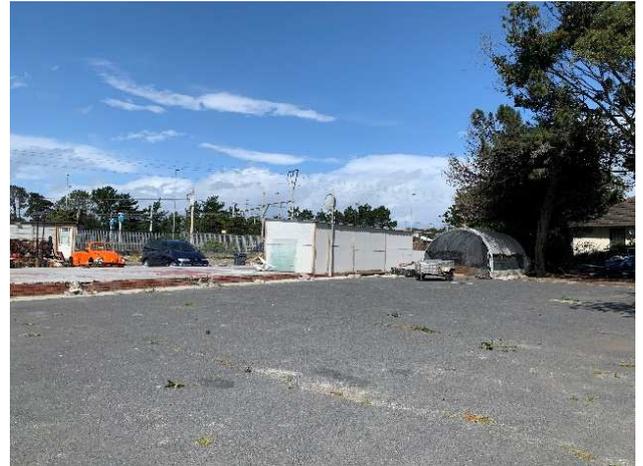
Block I is a much later addition to the complex of buildings. It comprises series of prefabricated shed-like structures, similar to the buildings at Block T and Block U. The structure burned down in 2019 and all that remains at present is a concrete base. There is a small café / tuckshop on the site.

Figure 224: Block I - View of Site. (SVA, 2020).

This structure has already been demolished as a result of fire damage. The remaining concrete plinth and small shed type structures could be demolished and the site used for a new development.

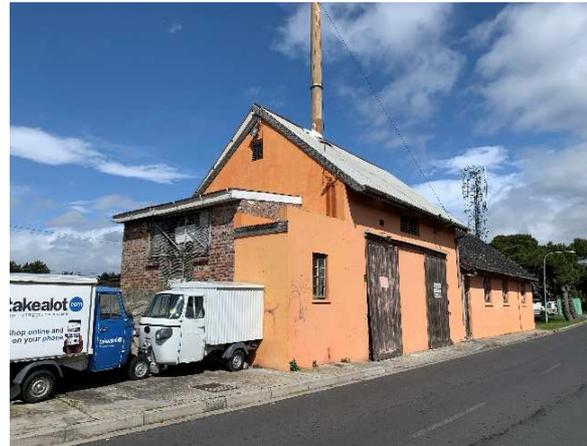
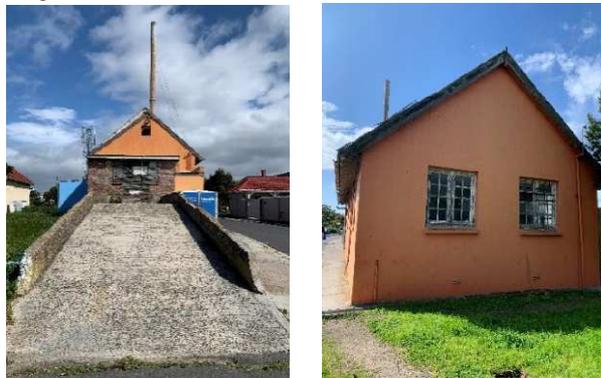
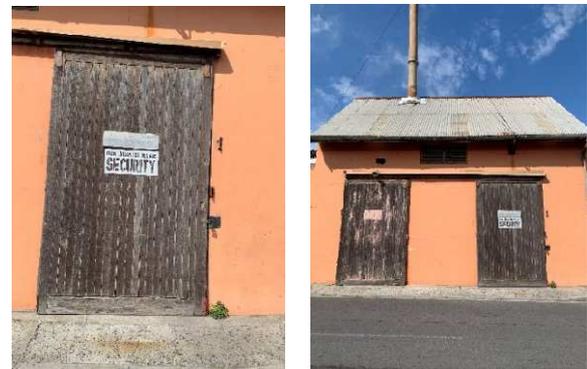
The structure is in fair condition overall although lack of regular maintenance is evident.

Figure 227: Block L - Exterior View. (SVA, 2020).

Figure 228: Block L - Exterior View. (SVA, 2020).

Figure 229: Block L - Exterior View. (SVA, 2020).

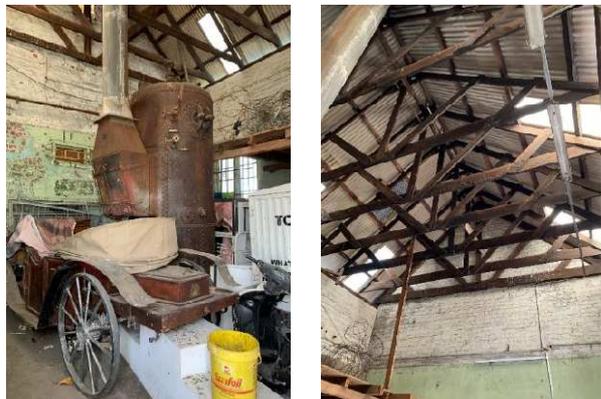
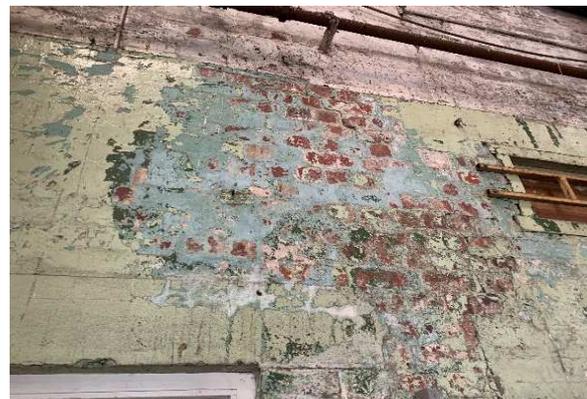
OCCUPIED / VACANT	Partly occupied
DESCRIPTION OF PLACE / CONTEXT	
Surrounding buildings are of predominantly larger scale - 2 storeys in height.	
GENERAL NOTES:	
Interior boasts original boiler equipment which appears well preserved overall. Part of the building is currently being used as security offices.	
RECOMMENDATIONS:	
Urgent Action: Building requires urgent maintenance and preservation of original boiler equipment which is of historical and heritage value.	
This small building is well suited for a coffee shop/roastery, artist's studio, or boutique retail.

Figure 230: Block L - Interior View. (SVA, 2020).

Figure 231: Block L - Interior View. (SVA, 2020).

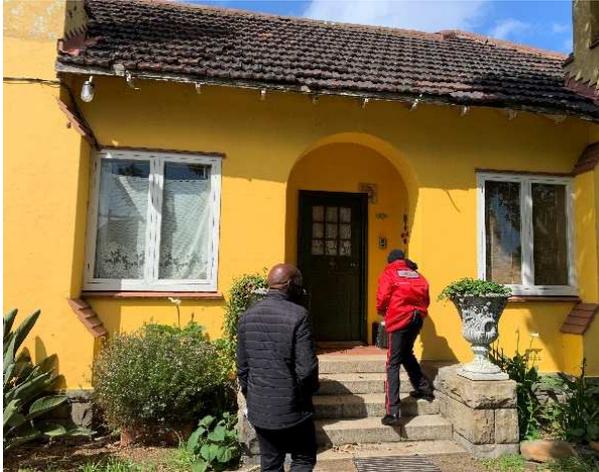
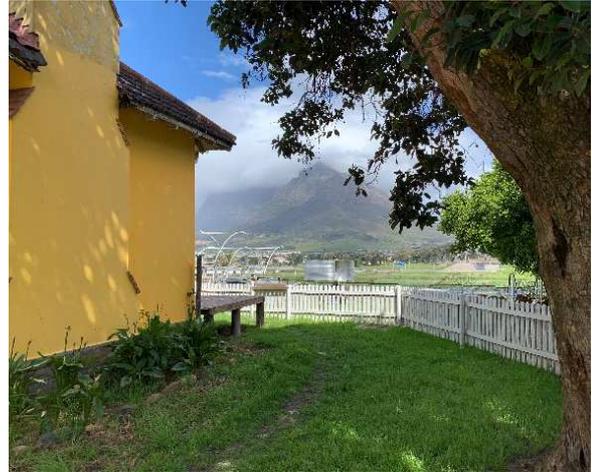
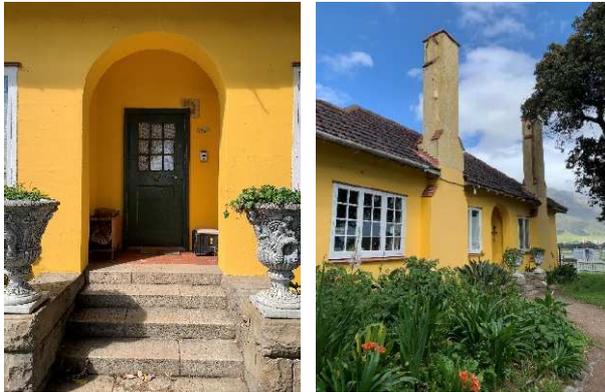
The building is generally in a fair condition, but lack of regular maintenance is evident. Roof maintenance required in order to avoid further moisture damage to interior. Structural assessment of various cracks recommended.

RETAIN / DEMOLISH STRUCTURE	Retain
OCCUPIED / VACANT	Occupied
DESCRIPTION OF PLACE / CONTEXT	
Single-story plastered brick structure with clay tile roof, wooden floors and timber-frame windows. Structure is unique within its context	
GENERAL NOTES:	
Roof leaks evident around chimneys and large cracks evident on certain walls	
RECOMMENDATIONS:	
Roof maintenance required in order to avoid further moisture damage to interior. Structural assessment of crack required.	
Ideally suited for residential uses, but could also be used as office space.

Figure 233: Block Q - Exterior View. (SVA, 2020).

Figure 235: Block Q - Exterior View. (SVA, 2020).

Figure 236: Block Q - Exterior View. (SVA, 2020).

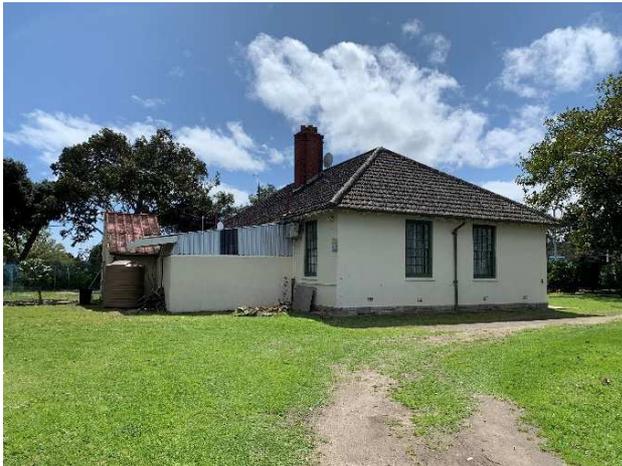
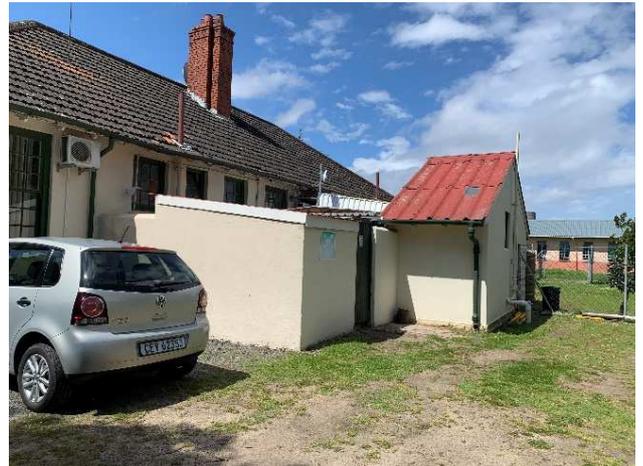
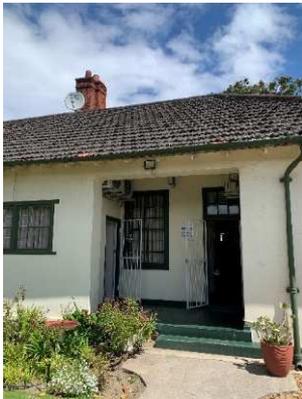
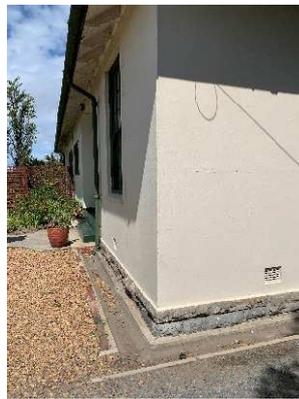
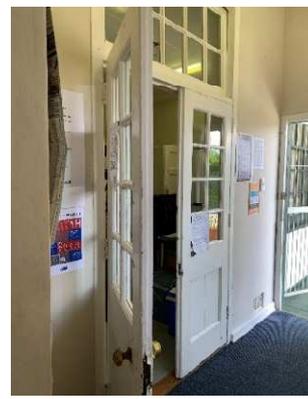
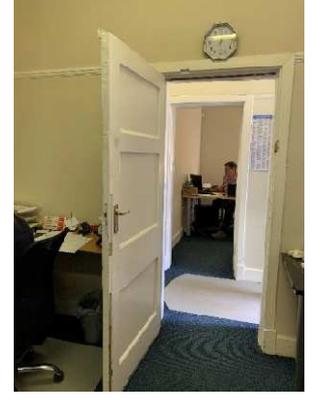
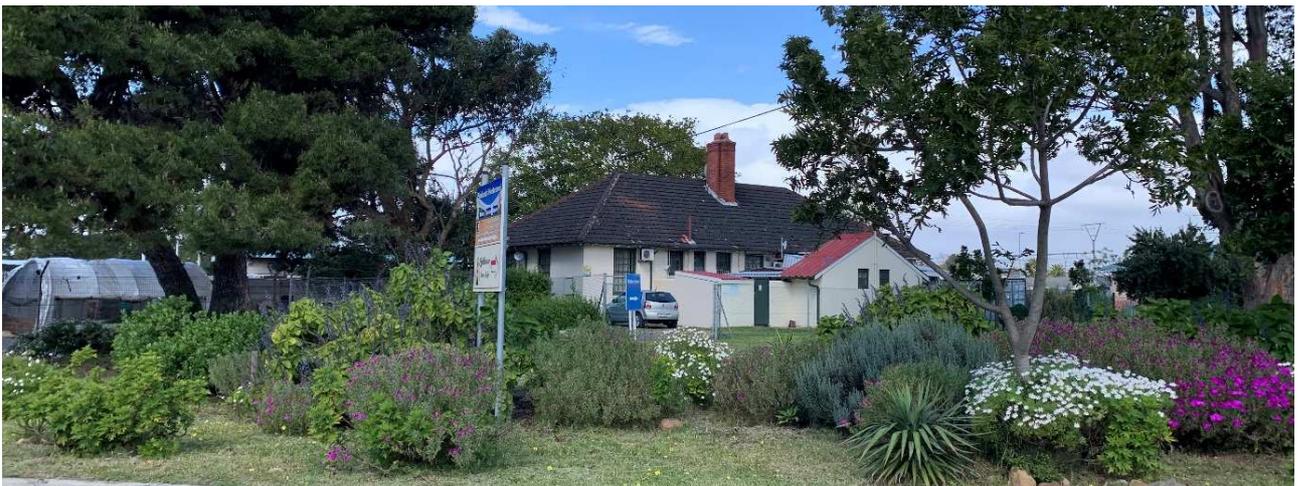
The building is currently used by the Robin Trust administration team and is generally in a fair condition, but lack of regular maintenance is evident.

GENERAL NOTES:	
Facility appears well maintained overall.	
RECOMMENDATIONS:	
Urgent Action: General maintenance required	
This building is ideally suited for residential uses or as office space.

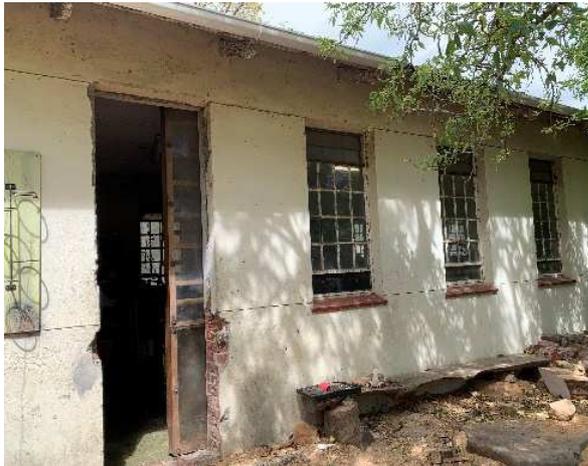
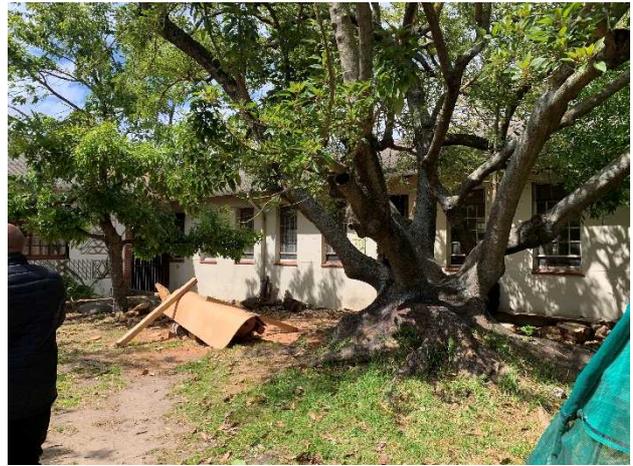
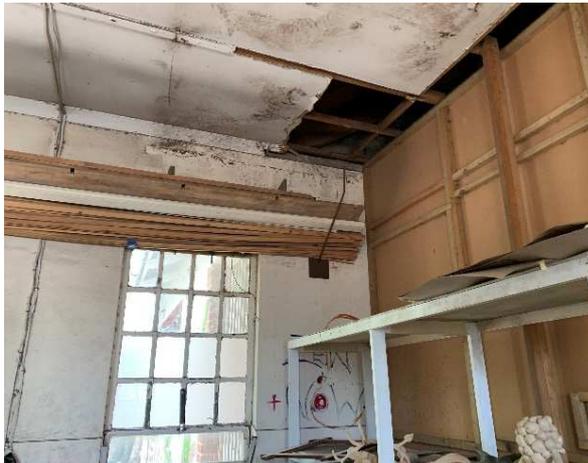
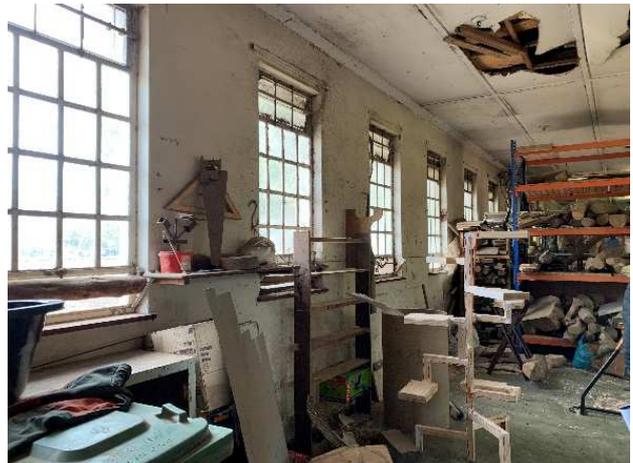
GENERAL NOTES:	
Lack of regular maintenance evident.	
RECOMMENDATIONS:	
Urgent Action: Maintenance required	
The building is well suited for residential uses, schools, offices, workshops/studios, or boutique retail.

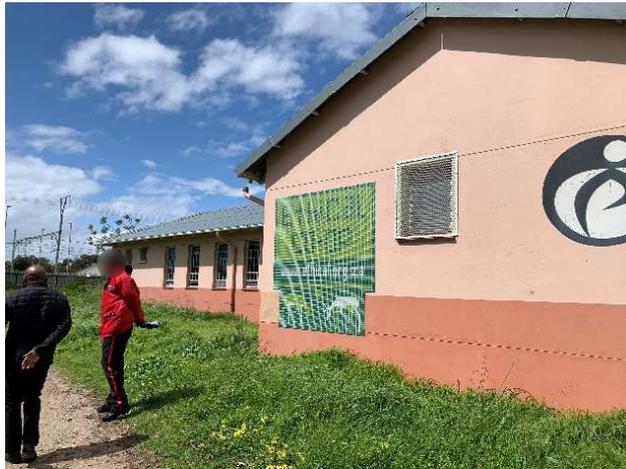
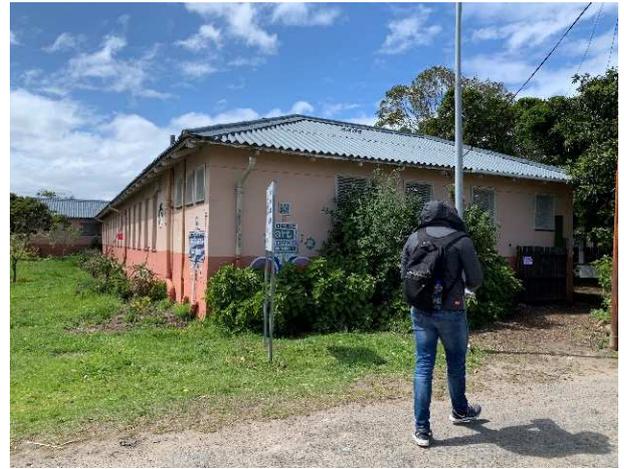
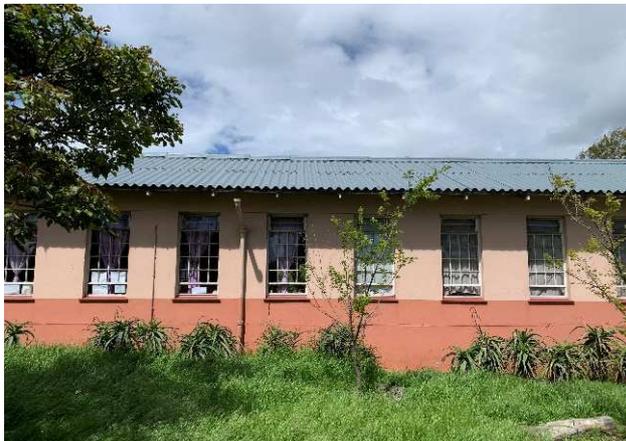
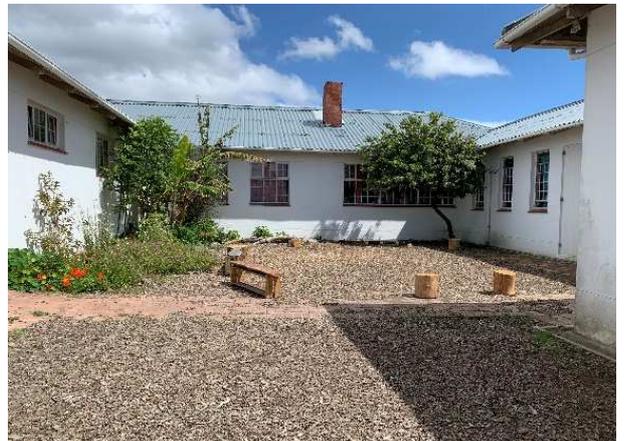
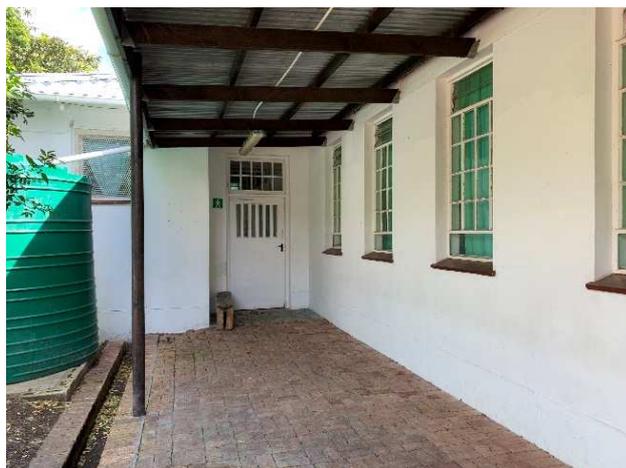
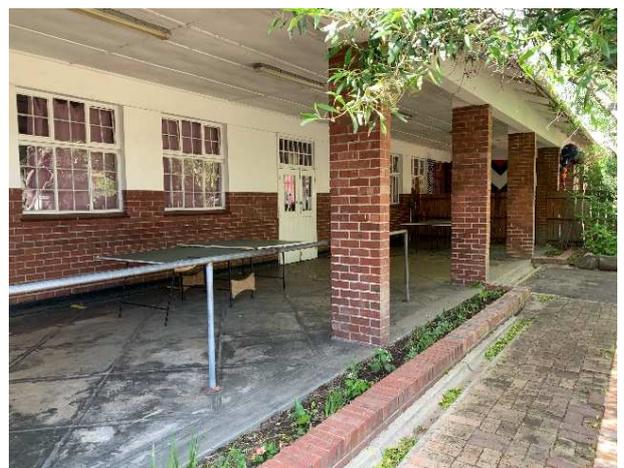
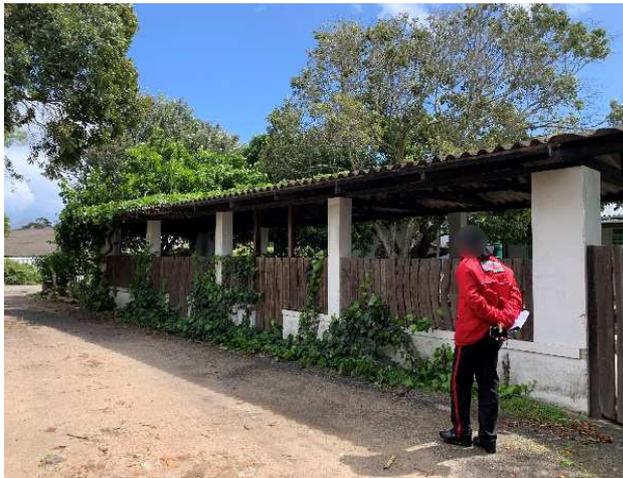
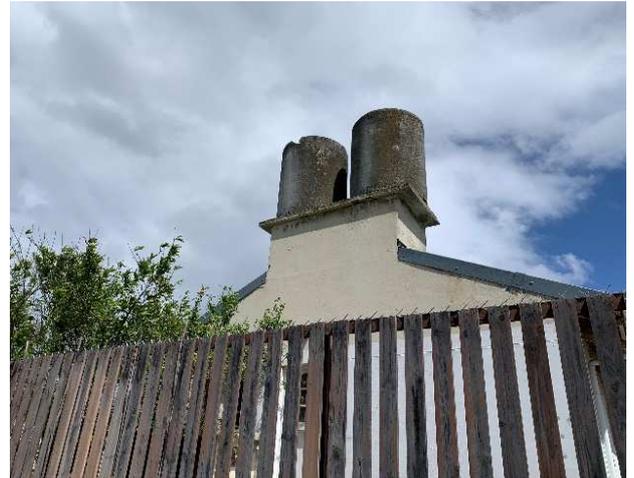
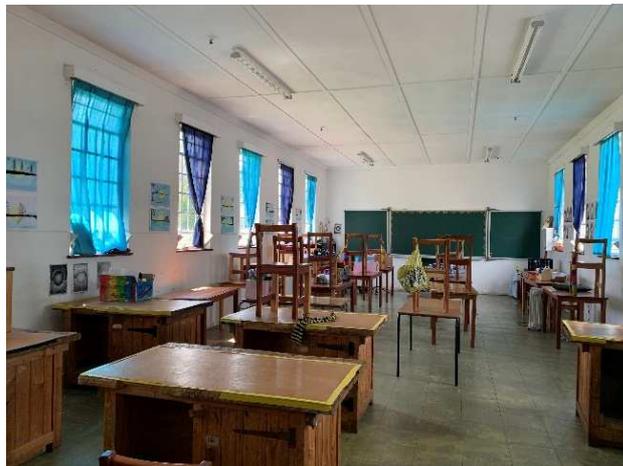
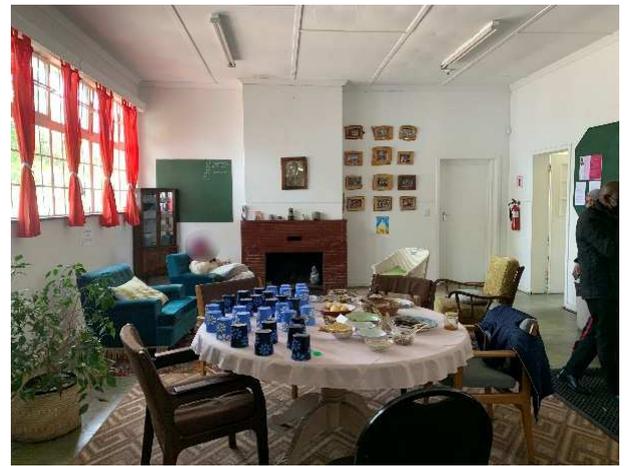
Single-storey plastered brick structure with fiber-cement roof and steel frame windows	
GENERAL NOTES:	
Lack of regular exterior maintenance evident.	
RECOMMENDATIONS:	
Urgent Action: General maintenance required	
The building is well suited for residential uses, schools, offices, workshops/studios, boutique retail.

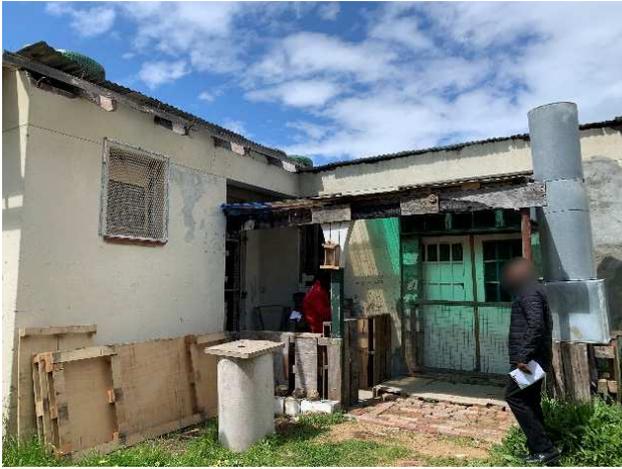
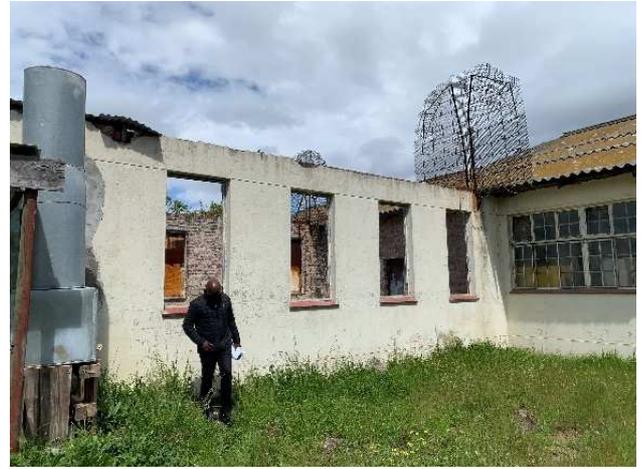
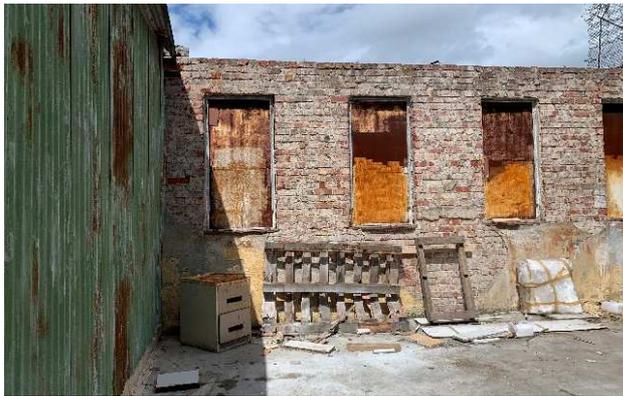
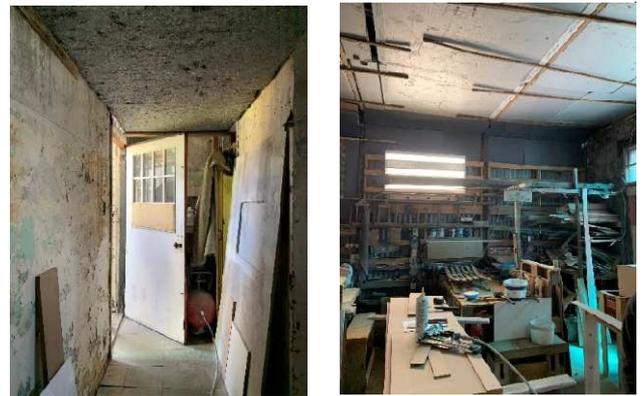
GENERAL NOTES:	
Lack of regular maintenance evident.	
RECOMMENDATIONS:	
Urgent Action: General maintenance required	
The building is well suited for residential uses, schools, offices, workshops/studios, boutique retail.

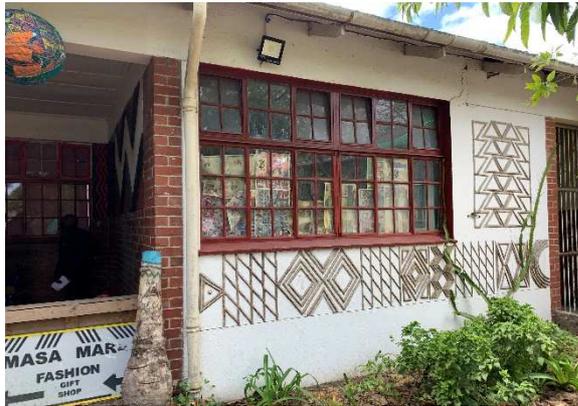
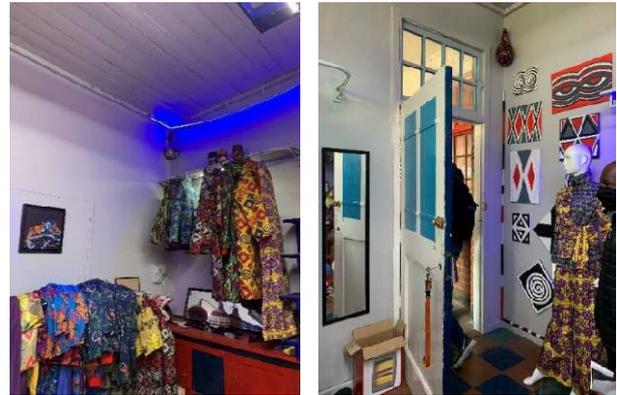
GENERAL NOTES:	
Lack of regular maintenance evident.	
RECOMMENDATIONS:	
Urgent Action: General maintenance required	
The building is well suited for residential uses, schools, offices, workshops/studios, or boutique retail.

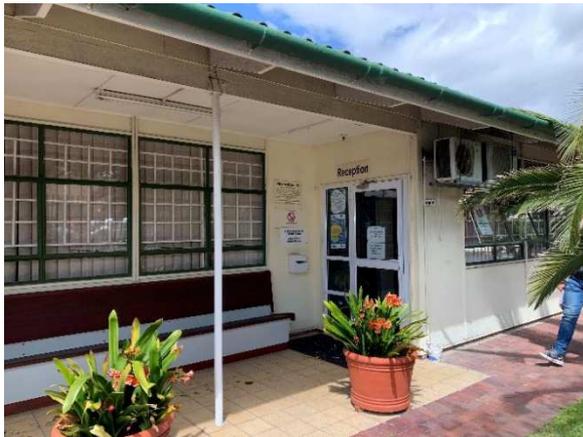
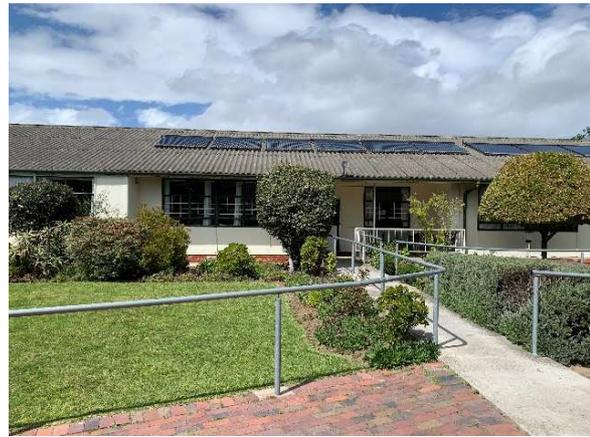
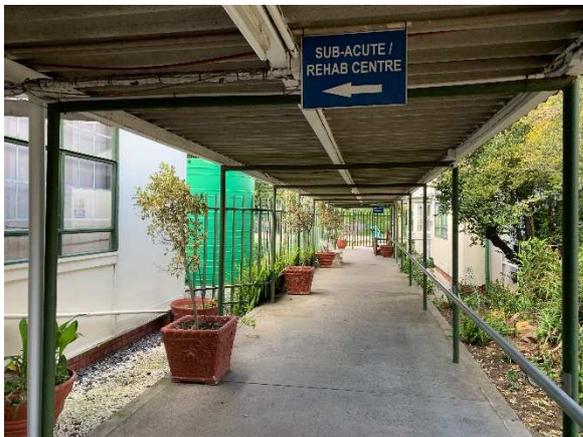
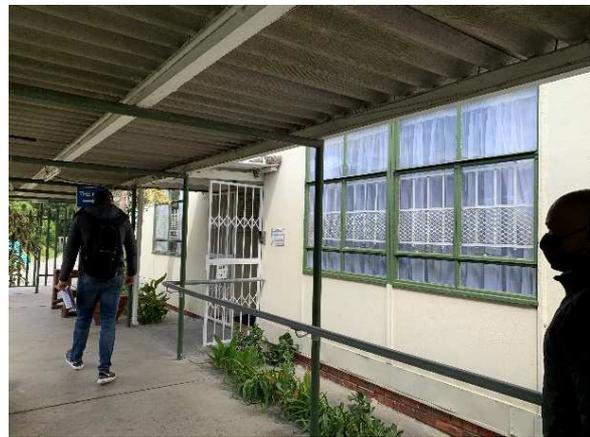
The buildings are in fairly good condition with well maintained garden spaces. The roof could contain asbestos, it is recommended that an investigation is conducted prior to any maintenance work.

GENERAL NOTES:	
Appears to be in good condition overall and well maintained	
RECOMMENDATIONS:	
Urgent Action: Roof could contain asbestos - investigation required prior to any maintenance work.	
The building is well suited for residential uses, health care, school/educational or offices.

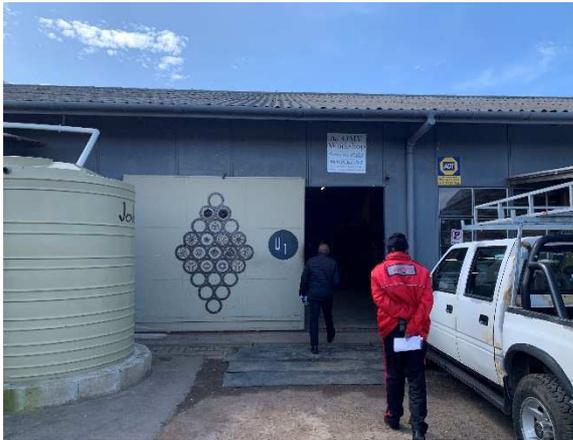
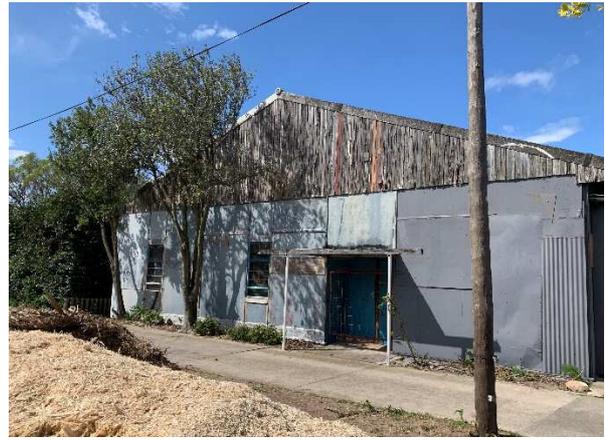
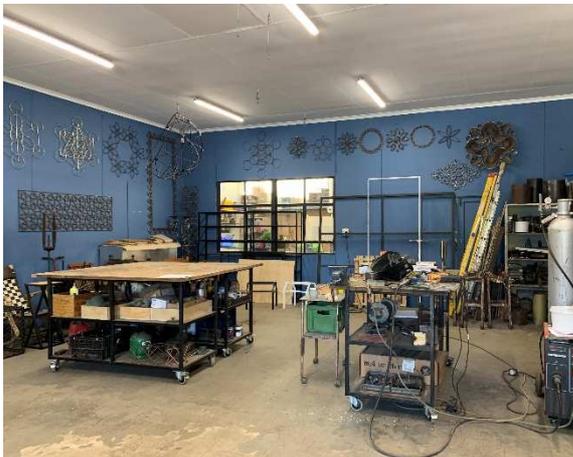
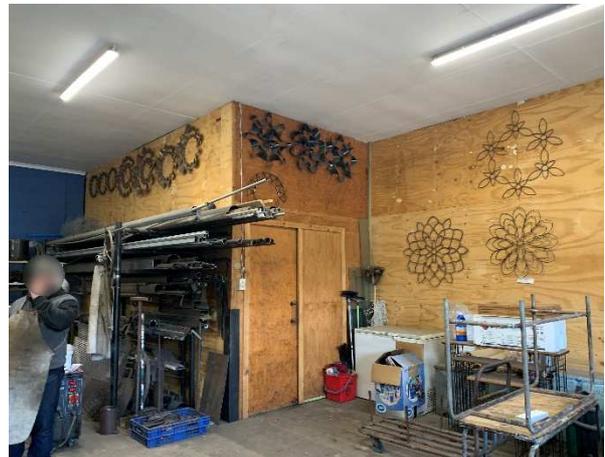
Block U is a prefabricated single storey shed-like structure built in the 1970's and is in fairly good condition. The roof could contain asbestos, it is recommended that an investigation is conducted prior to any maintenance work.

GENERAL NOTES:	
Operating business.	
RECOMMENDATIONS:	
General roof and exterior maintenance.	
The building is well suited as a workshop, restaurant or retail space.

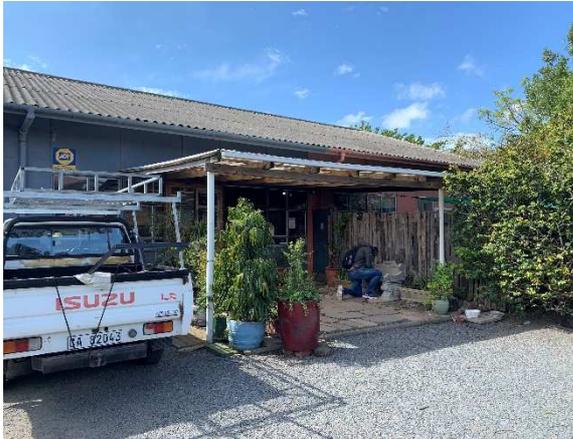
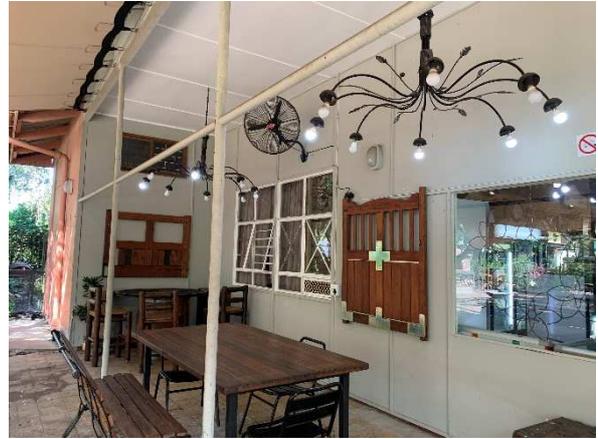
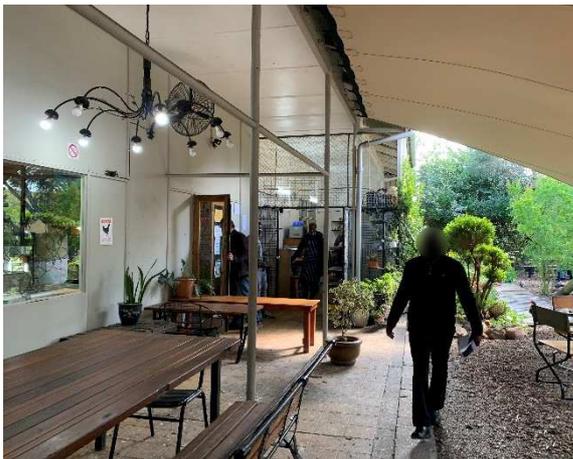
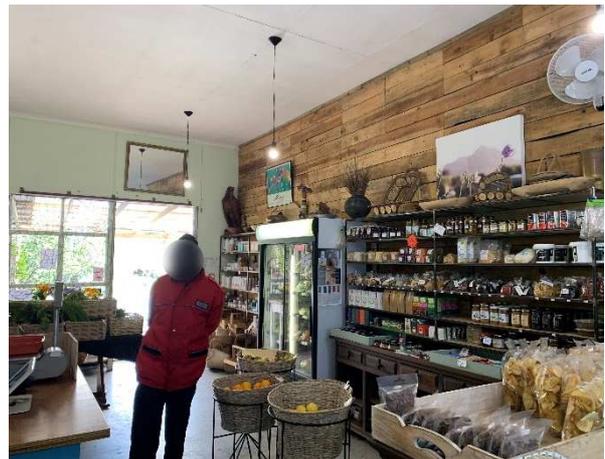
5.42.3 Unit U1

GENERAL NOTES:	
Operating business.	
RECOMMENDATIONS:	
General roof and exterior maintenance.	
The building is well suited as a workshop, restaurant or retail space.

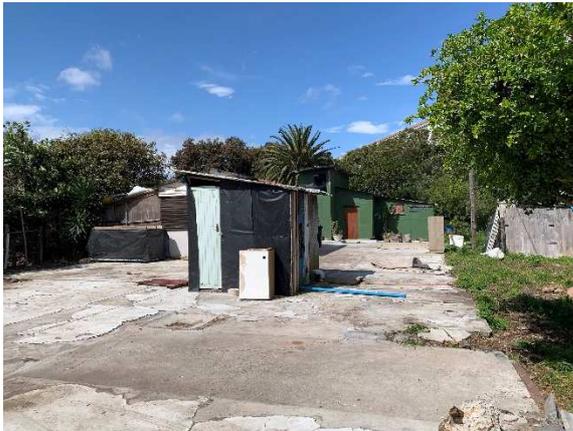
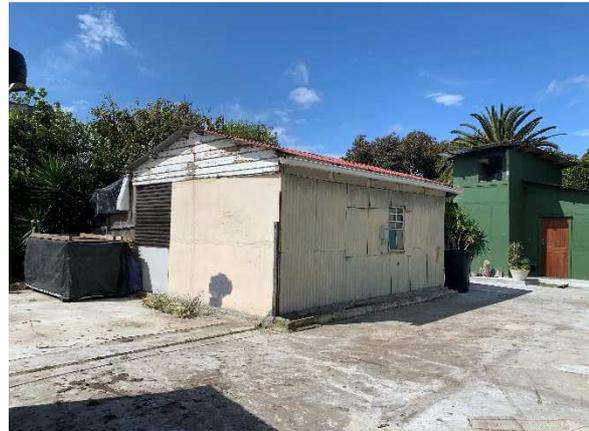
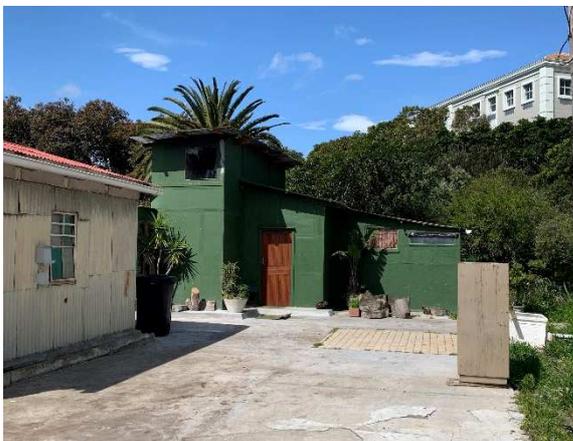
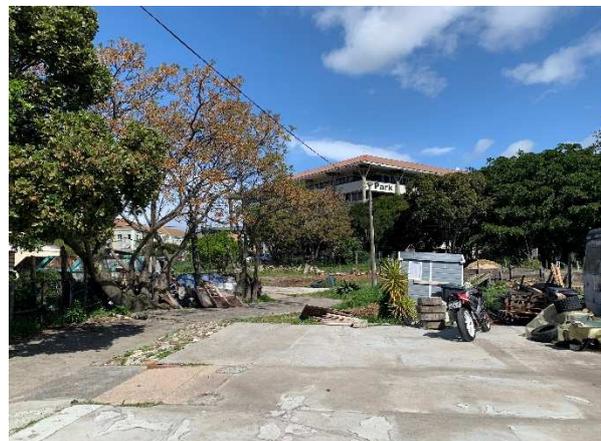
NAME AND LOCATION:	
Stand number/s	26439
Township	Pinelands, Cape Town
Street address	Oude Molen Eco-Village - Unit V1b / V1e
GIS reference	33°56'31.87"S / 18°29'21.14"E
Name of place	n/a
Previous/alternative name/s	n/a
Unit Number	V1b / V1e
ARCHITECT	DATE OF COMPLETION
Unknown	n/a
BUILDING STYLE	BUILDING TYPE
n/a	Ruin
TITLE DEED INFORMATION	
n/a	
NOTABLE SITE FEATURES	
Well established trees and greenery.	
ENVIRONMENT	
Surrounding buildings are of similar scale.	
PREVIOUS USE	CURRENT USE
n/a	Ruin
GENERAL CONDITION - EXTERIOR:	
Roofs	n/a
Walls	n/a
Doors / Windows	n/a
General Comments:	
n/a	
GENERAL CONDITION - INTERIOR:	
Interior	n/a
General Comments:	
n/a	
RETAIN / DEMOLISH STRUCTURE	Demolish
OCCUPIED / VACANT	Vacant
DESCRIPTION OF PLACE / CONTEXT	
Remains of what used to be shed-like structures	
GENERAL NOTES:	
Original structures have been demolished - only original concrete floor slabs remains	
RECOMMENDATIONS:	
General roof and exterior maintenance.

This structure has already been demolished. The remaining small shed type structures could be demolished and the site used for a new development.

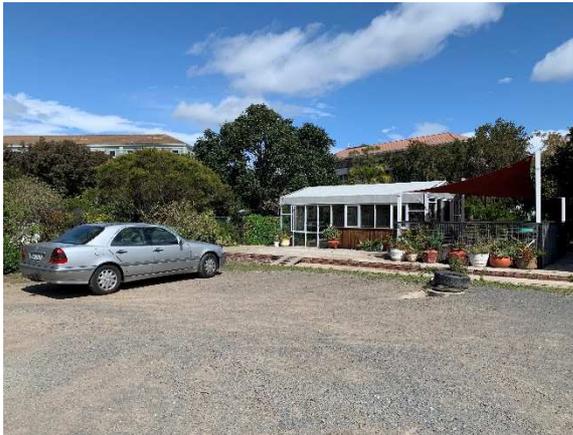
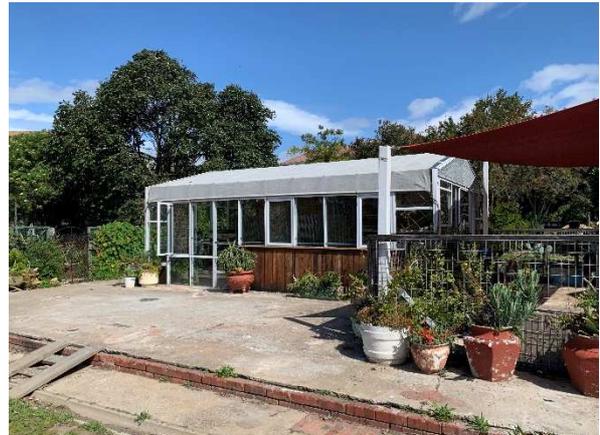
5.46.2 Unit V2

NAME AND LOCATION:	
Stand number/s	26439
Township	Pinelands, Cape Town
Street address	Oude Molen Eco-Village - Unit V2
GIS reference	33°56'30.85"S / 18°29'20.80"E
Name of place	n/a
Previous/alternative name/s	n/a
Unit Number	V2
ARCHITECT	DATE OF COMPLETION
Unknown	n/a
BUILDING STYLE	BUILDING TYPE
n/a	Ruin
TITLE DEED INFORMATION	
n/a	
NOTABLE SITE FEATURES	
Well established trees and greenery,	
ENVIRONMENT	
Surrounding buildings are of similar scale.	
PREVIOUS USE	CURRENT USE
n/a	Ruin
GENERAL CONDITION - EXTERIOR:	
Roofs	n/a
Walls	n/a
Doors / Windows	n/a
General Comments:	
n/a	
GENERAL CONDITION - INTERIOR:	
Interior	n/a
General Comments:	
n/a	
RETAIN / DEMOLISH STRUCTURE	Retain
OCCUPIED / VACANT	Vacant
DESCRIPTION OF PLACE / CONTEXT	
Remains of what used to be a warehouse	
GENERAL NOTES:	
Original structure has been demolished - only original concrete floor slab remains	
RECOMMENDATIONS:	
The original structure has already been demolished. There is now a small greenhouse on site that is in fair condition.

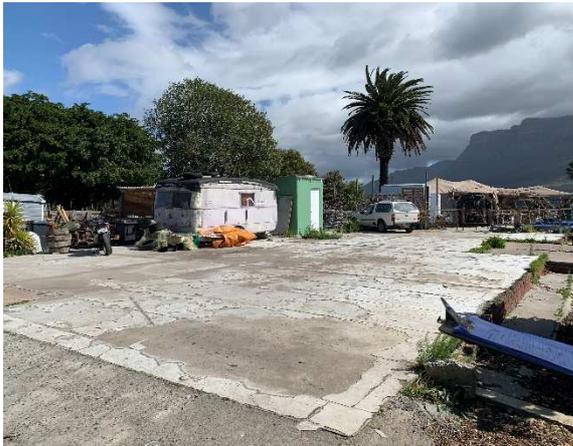
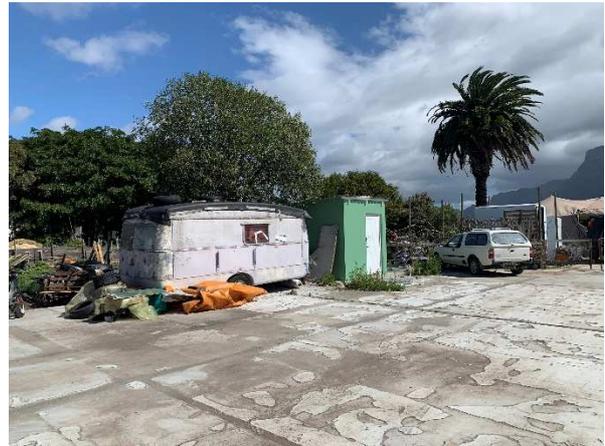
5.46.3 Unit V6

NAME AND LOCATION:	
Stand number/s	26439
Township	Pinelands, Cape Town
Street address	Oude Molen Eco-Village - Unit V6
GIS reference	33°56'31.56"S / 18°29'19.26"E
Name of place	n/a
Previous/alternative name/s	n/a
Unit Number	V6
ARCHITECT	DATE OF COMPLETION
Unknown	n/a
BUILDING STYLE	BUILDING TYPE
n/a	Ruin
TITLE DEED INFORMATION	
n/a	
NOTABLE SITE FEATURES	
Well established trees and greenery,	
ENVIRONMENT	
Surrounding buildings are of similar scale.	
PREVIOUS USE	CURRENT USE
n/a	Ruin
GENERAL CONDITION - EXTERIOR:	
Roofs	n/a
Walls	n/a
Doors / Windows	n/a
General Comments:	
n/a	
GENERAL CONDITION - INTERIOR:	
Interior	n/a
General Comments:	
n/a	
RETAIN / DEMOLISH STRUCTURE	Demolish
OCCUPIED / VACANT	Vacant
DESCRIPTION OF PLACE / CONTEXT	
Remains of what used to be a warehouse	
GENERAL NOTES:	
Original structure has been demolished - only original concrete floor slab remains	
RECOMMENDATIONS:	
The original structure has already been demolished. There is now a concrete plinth with informal dwellings on it. This area can be redeveloped.

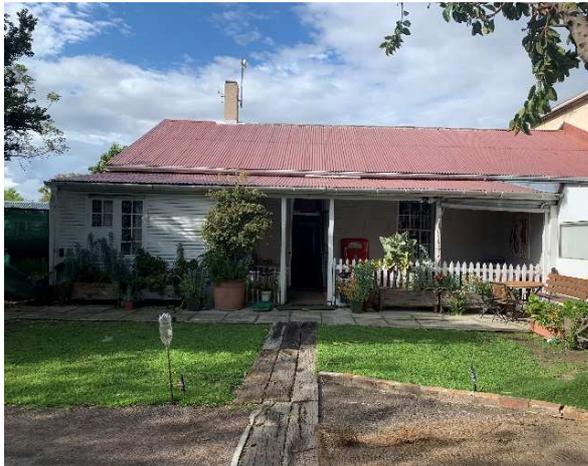
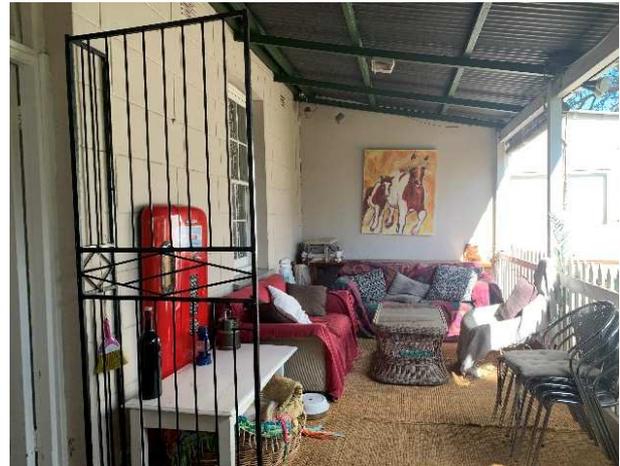
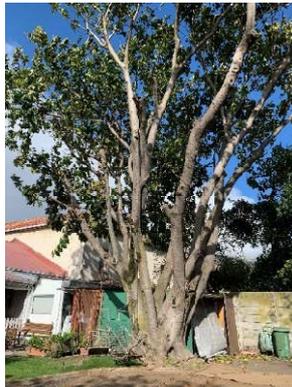
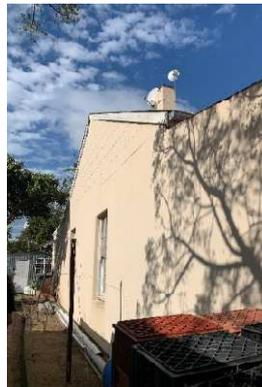
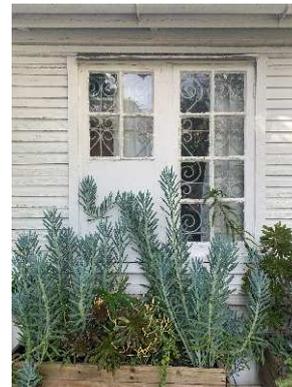
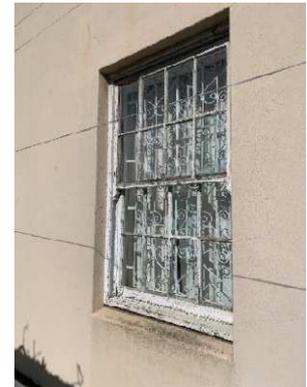
GENERAL NOTES:	
Structure is in overall good condition and mostly original	
RECOMMENDATIONS:	
General roof and exterior maintenance	
This building is ideally suited for residential uses, but could also be used as office space.

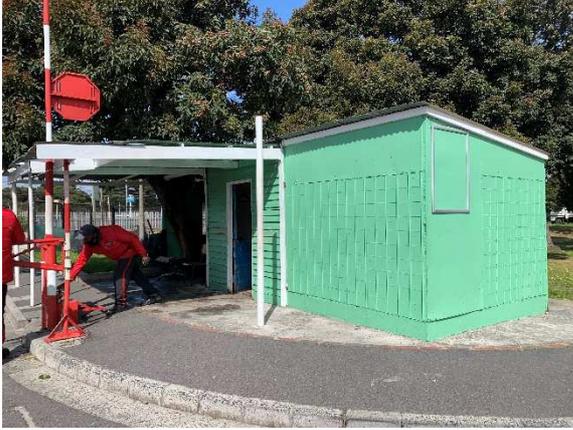
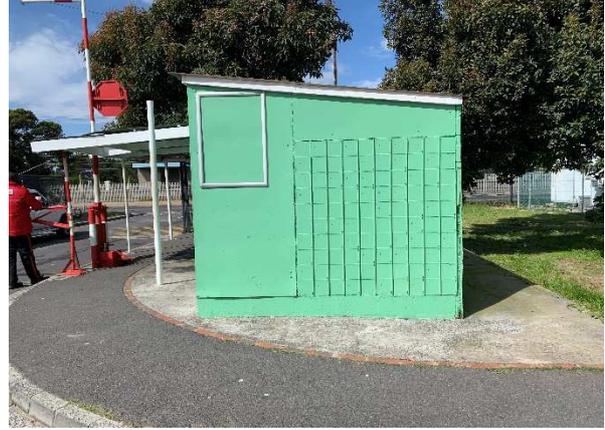
DESCRIPTION OF PLACE / CONTEXT	
Single-storey modest plastered brick structure	
GENERAL NOTES:	
Structures are in fair condition overall	
RECOMMENDATIONS:	
General roof and exterior maintenance.
