DESKTOP STUDY OF EXISTING BUILDINGS

OUDE MOLEN PRECINCT, CAPE TOWN

08 December 2020

Draft Report - Revision 03

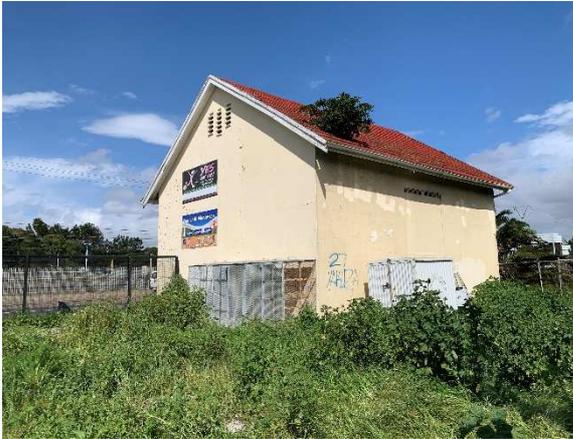
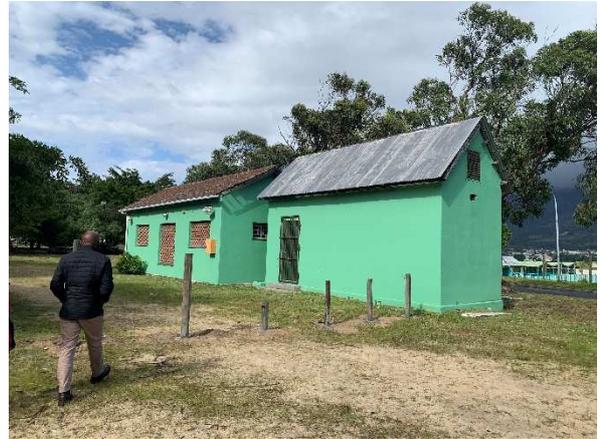
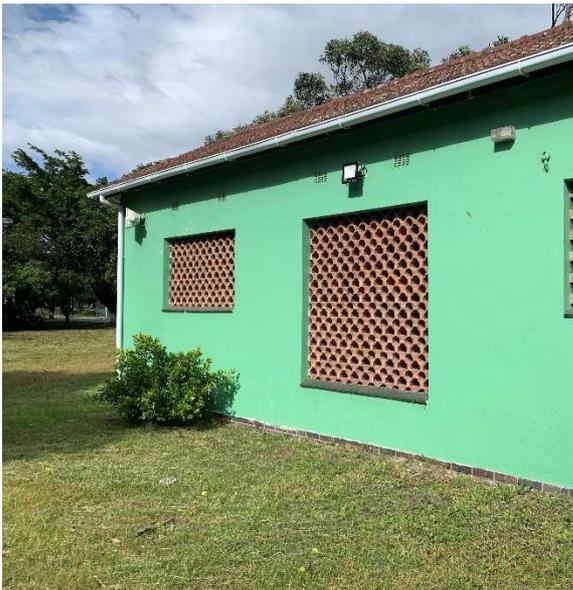
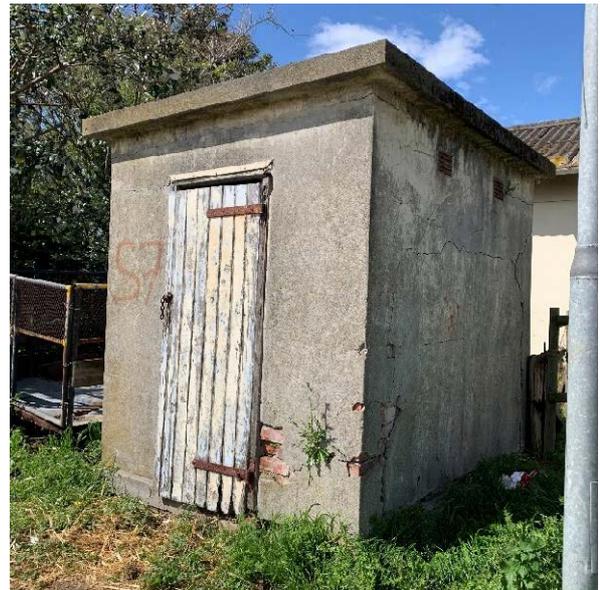
NAME AND LOCATION:	
Stand number/s	26439
Township	Pinelands, Cape Town
Street address	Oude Molen Eco-Village - Sub-Stations
GIS reference	33°56'19.98"S / 18°29'19.47"E
Name of place	Sub-Stations - Various
Previous/alternative name/s	n/a
Unit Number	SB
ARCHITECT	DATE OF COMPLETION
Unknown	1920s to 1980s
BUILDING STYLE	BUILDING TYPE
Utilitarian	Sub-station
TITLE DEED INFORMATION	
n/a	
NOTABLE SITE FEATURES	
Substations are located within the large open green area on the west.	
ENVIRONMENT	
Surrounding buildings are of larger scale - including original Hospital Wards which are 2 storeys in height.	
PREVIOUS USE	CURRENT USE
Sub-Stations	Sub-Stations
GENERAL CONDITION - EXTERIOR:	
Roofs	Fair/Poor
Walls	Fair
Doors / Windows	Fair
General Comments:	
Exterior is in fair condition overall.	
GENERAL CONDITION - INTERIOR:	
Interior	Fair
General Comments:	
Interior is in fair condition overall.	
RETAIN / DEMOLISH STRUCTURE	Retain
OCCUPIED / VACANT	In Use

DESCRIPTION OF PLACE / CONTEXT	
Single-storey modest plastered brick structure	
GENERAL NOTES:	
Structures are in fair condition overall	
RECOMMENDATIONS:	
General roof and exterior maintenance

Figure 316: Substation. (SVA, 2020).

Figure 317: Substation. (SVA, 2020).

Figure 318: Substation. (SVA, 2020).

Figure 319: Substation. (SVA, 2020).
